**Report on the Brooklyn Museum's 2005 Season of Fieldwork at
the Precinct of the Goddess Mut at South Karnak**
by Richard Fazzini, Brooklyn Museum

Abstract

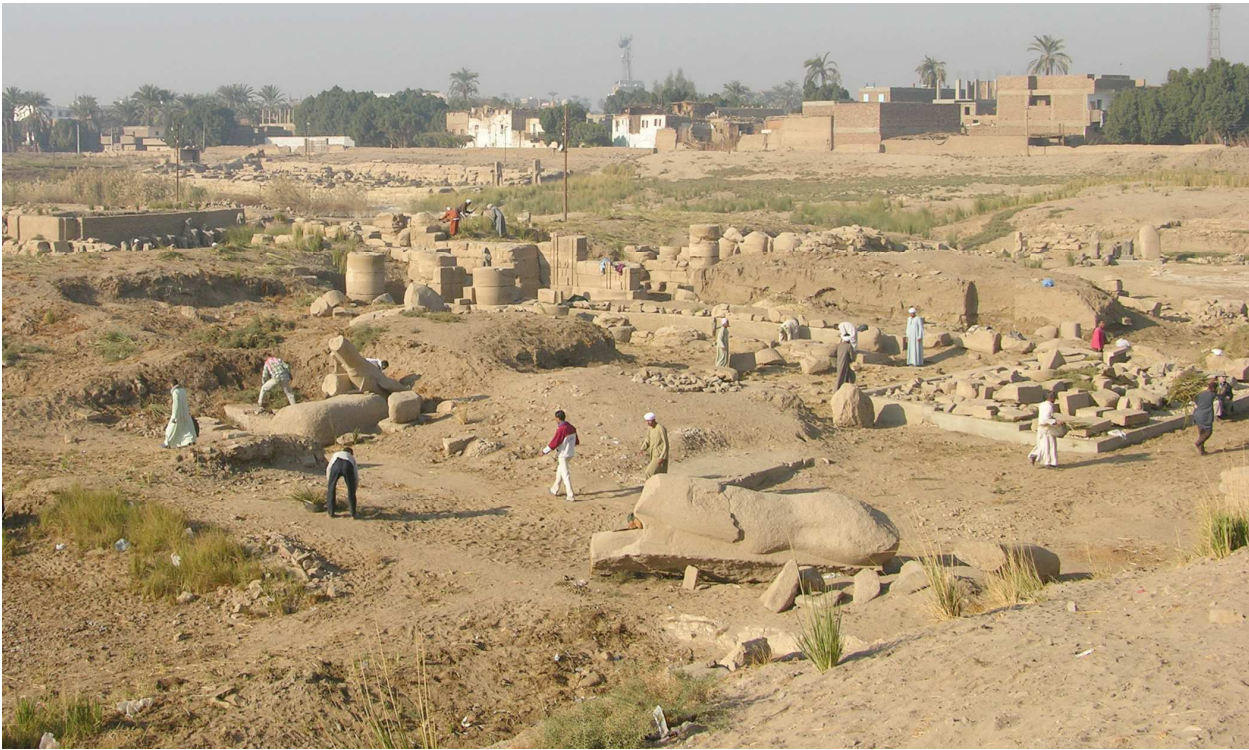
Fig. 2 The front area of the Precinct at the start of the 2005 season, looking to the southwest. The West Porch is visible in the upper right.

In 2005 the expedition continued its planned program to explore the front area of the Mut Precinct (fig.1), between the site's Propylon and the Mut Temple's First Pylon (fig. 2). The goal of the work is to develop a clear understanding of the history of this area so that appropriate restoration of monuments may be carried out, making the site more accessible to scholars and visitors. Excavation this year took place in three areas.

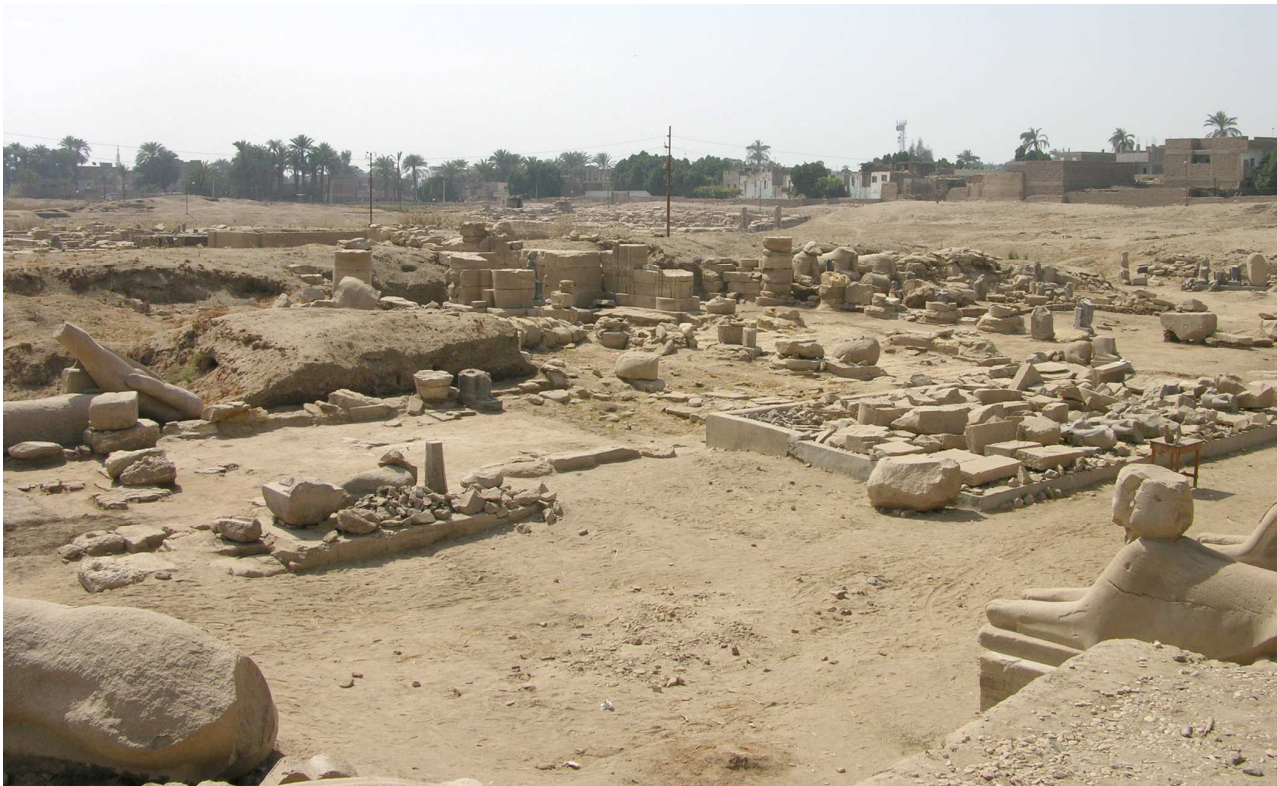
Fig. 3 The same area at the end of the season, after excavation of Temple A's small Porch (center), the Mut Temple's West Porch, and the processional way to the Mut Temple. The sphinx restored by the expedition is visible in the lower right.

During the 2005 season the expedition excavated the remainder of the porch (fig. 3). This year's work confirmed that both the West and East Porches are composed of two rows of seven sandstone columns. Both are works of the Twenty-fifth Dynasty, rebuilt and largely redecorated during the Ptolemaic Period. It has long been known that the south end of the west porch's west side includes re-used column drums inscribed for Taharqa.⁸ The expedition recovered one significant element of the porch's mostly destroyed figural decoration: a relief (once part of an

In the course of the removal of the two alabaster stelae from the Precinct, the CFETK uncovered the well-preserved head of a sphinx. This year the Mut Expedition was able to identify the sphinx from which the head had come and restore it to its body. The restored sphinx (fig. 3) is the easternmost of the row of sphinxes that stands east of the Precinct's entrance.

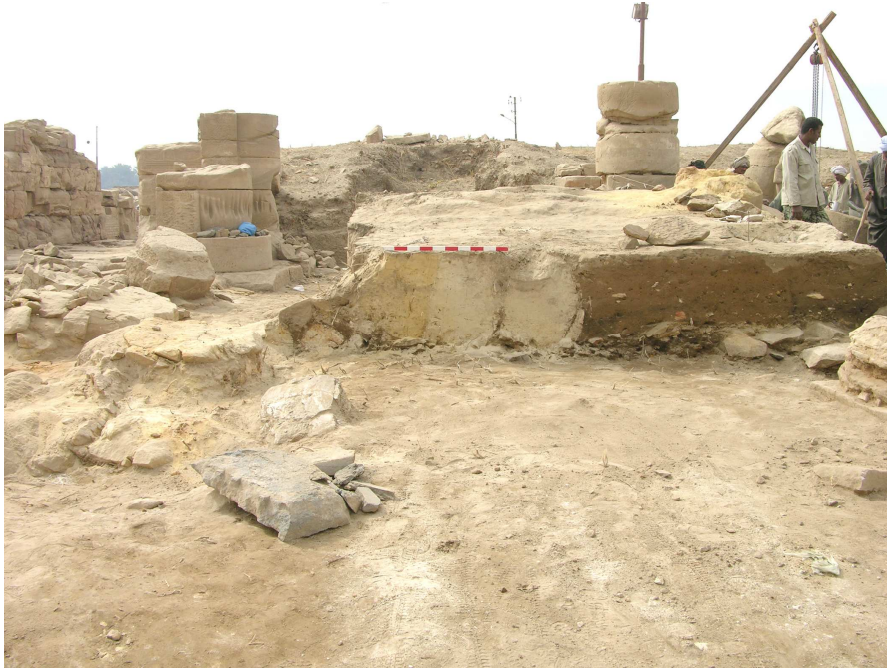
Fig. 4 The three fallen but contiguous column drums visible in the baulk have completely decayed to sand. They appear to have collapsed directly onto the floor of the West Porch.

There is evidence that quarrying activity went on at the north end of the West Porch as it had in the East Porch. Immediately above the remains of the ancient surface the expedition found quantities of stone chips, large pieces of broken stone, and the remains of four Sakhmet statues (three lower halves and one torso) that had clearly been broken up where they were found. The east row of columns and the first three columns of the west row seem to have fallen directly onto the floor of the porch (see fig. 4 above). South of column 3, the situation was different.

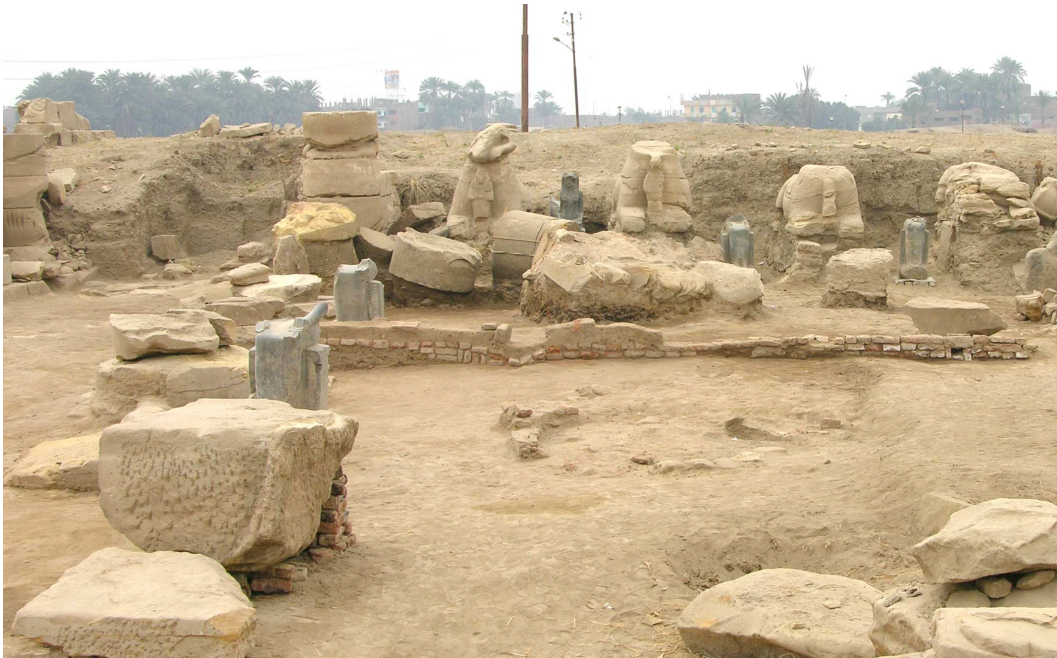
Fig. 5 The narrow wall running west from column 3 of the West Porch's west row, and the stone and brick feature are visible in the center of the photograph. South of the wall, columns from the south end of the porch lie atop a pottery-filled layer of burnt debris. The Sakhmet statues between the sphinxes were moved forward this year and placed on temporary bases.

In 2001, the Mut Expedition and the SCA in Luxor agreed that the SCA could work in the front west area of the Mut Precinct, between the Propylon and Chapel D. In clearing the area in front of the west wing of the Mut Temple’s First Pylon, west of the West Porch, the SCA uncovered part of a thin east-west wall of mud brick atop baked brick. The Mut Expedition’s work this year revealed that the wall abuts the west side of the 3rd column (counting from the north) of the West Porch’s west row and extends 7 meters to the west, where it is robbed out. It may be associated with a circular feature of brick and stone immediately to its north (fig. 5); excavation of this area will be continued in the next season. South of this wall, a thick layer of pottery in black, ashy earth runs up to the preserved top of the wall but not over it. This burnt debris extends south almost to the Mut Temple’s First Pylon and east to the west side of the Porch, but does not intrude into the Porch itself. This stratum of debris predates the destruction of the West Porch as it runs under the west row’s fallen columns. The pottery from this stratum seems to date to the late Ptolemaic-early Roman Periods.

As the work of the SCA had removed most of the debris from before the west wing of the Mut Temple's first pylon, the expedition was also able this year to move several Sakhmet statues that had stood among the ram sphinxes before the pylon to more visible positions and place them on temporary bases to raise them from the earth (see fig. 5). The clearance of earth and possible restoration of the ram sphinxes protecting kings will be a priority for the Expedition in future seasons.

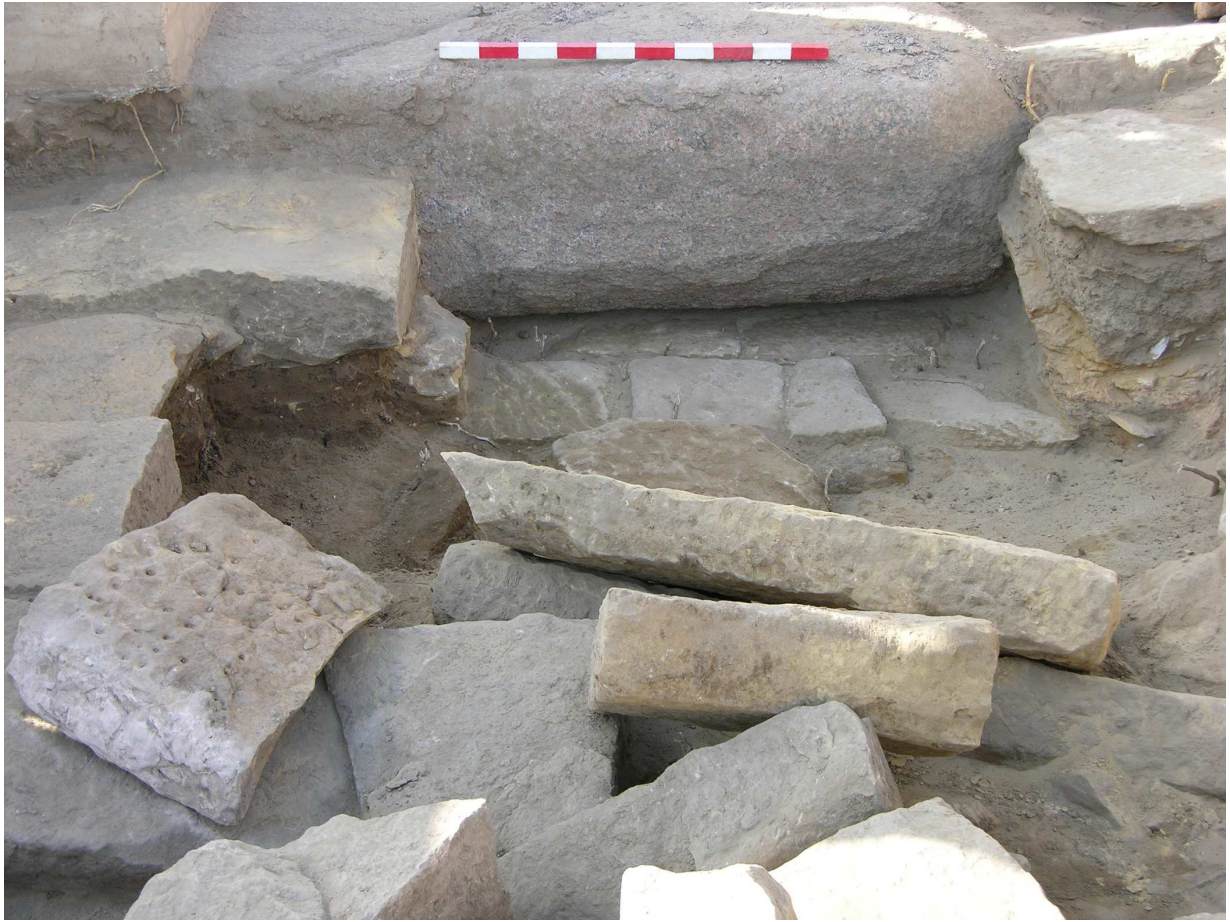
Fig. 6 The granite threshold of the Mut Temple's gateway (top of the picture), with the earlier paving running under it. The later *in situ* paving is visible to the left and right, with disturbed paving blocks in the foreground.

The upper course of the sandstone paving, particularly north of the Mut Temple's Porches had reverted to sand, possibly due both to repeated flooding from the Sacred Lake¹² and the rising water table over the years, but the lower course of large blocks laid horizontally is quite well preserved. At the southern end, where it meets the Mut Temple's gateway, the road was in generally better condition although paving stones had broken and tipped when the Porches collapsed on them. Here there appear to have been three phases of construction (fig. 6). The lowest course of the paving (phase 1) clearly runs under the temple's granite threshold, which sits atop a clean sand foundation (phase 2). The expedition was unable to remove the granite threshold block to determine if the early paving runs up to or under the quartzite paving of the Mut Temple's gateway. The latest phase of the paving, which may date to the Ptolemaic restoration of the temple and porches, lies atop a layer of packed earth and preserves the remains of a pink cement/mortar. Unfortunately, no pottery was associated with this phase.

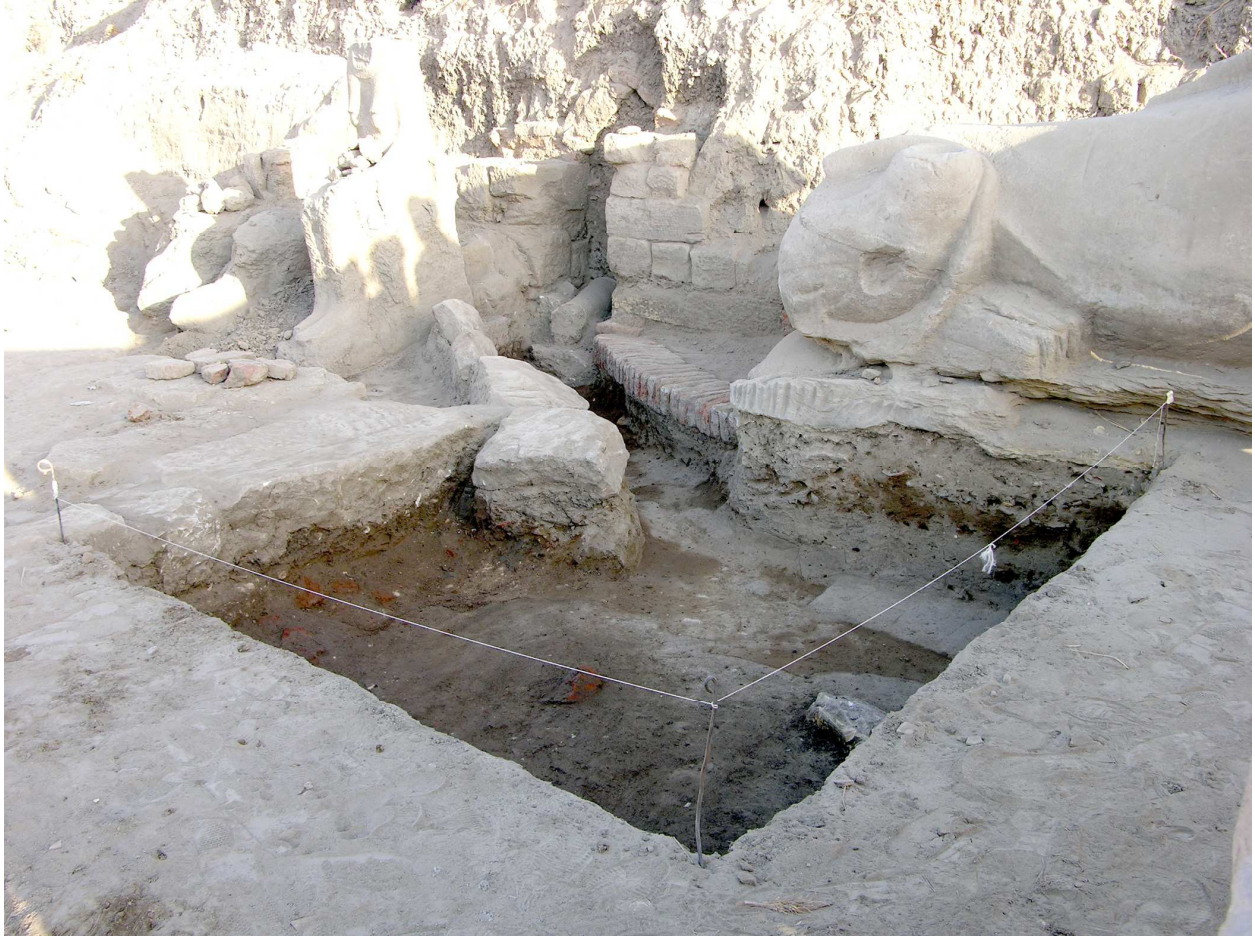
Fig. 8 The excavation at the north enclosure wall. The stone feature and vault are in the background, with the ceramic drainpipe feeding into a channel flanked by baked brick and stone. The remains of the earlier mud brick wall are visible in the upper right of the square.

West of the Precinct's entrance the expedition investigated a stone feature at the inner face of this enclosure wall first revealed by the SCA's work. Their work made it clear that the entire south face of this wall is of mud brick on top of baked brick, which could relate to Roman Period brickwork elsewhere in the Precinct.¹⁵ The stonework frames a narrow opening and supports a baked brick vault that appears to be an access tunnel for a drain running through the enclosure wall into the Precinct (fig. 8), although we did not follow the vault all the way through the wall. Pottery from around the one preserved ceramic drainpipe suggests a date of the first to third centuries AD. The expedition excavated the area into which the one ceramic pipe fed and discovered that the trench for the drain cuts a mud brick wall that may be part of an earlier

enclosure wall for the Precinct. There is evidence that Taharqa expanded the Mut Precinct to the north, incorporating the present front area of the precinct and Temple A into the precinct,¹⁶ and perhaps this is a wall constructed during his reign. The expedition plans to investigate this area further in future seasons.
