Report on the Brooklyn Museum's 2006 Season of Fieldwork at the Precinct of the Goddess Mut at South Karnak

by Richard Fazzini, Brooklyn Museum

Abstract

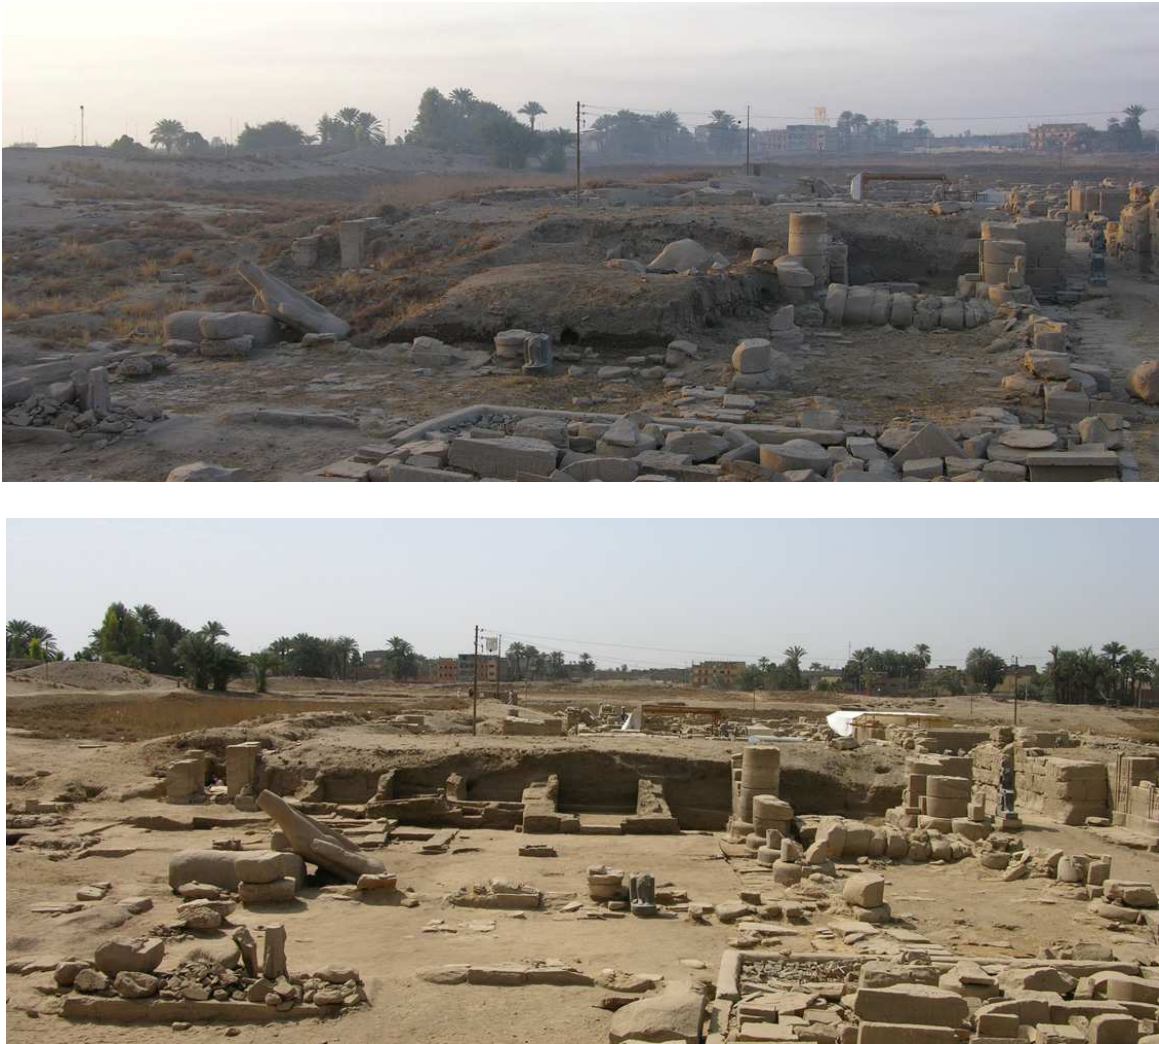
Fig. 1 (a) view to the south of the area where the expedition worked at the start of the season; (b) the same area at the end of the season. The southwest corner of Temple A's Forecourt is visible at the left side of both pictures.

In 2006 the expedition continued its planned program of exploring the front of the precinct north of the Mut Temple. Fig. 1a-b shows the area at the beginning of the season and at the end. The results of this season's excavation are outlined below, followed by a brief description of conservation and restoration efforts.

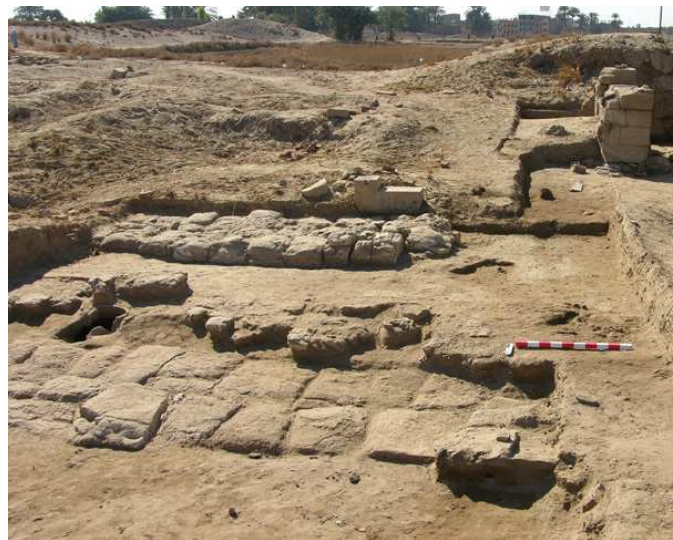
Fig. 2 Plan (a) and photograph looking south (b) of the southwest corner of Temple A's forecourt uncovered in 2006.

The Mut Expedition first worked in this area in 1978-1979, uncovering the remains of the colonnade and south wall of the forecourt and the foundations of the first pylon, which had been destroyed down to its lowest course.² This year we removed a portion of the earlier baulks in the area, revealing the inner face of the forecourt's southwest corner where the colonnade meets the limestone facing of the east side of the pylon. Fig. 2 is a plan and photograph of this area at the end of the season. Between the foundations of the colonnade and the forecourt's outer wall we uncovered a later limestone paving of smaller, roughly-laid blocks into which three large storage jars had been set. One of the jars was full of pottery, primarily cups/beakers and broken storage jars of the Ptolemaic or early Roman Periods, while the other two jars contained less pottery. Extending the area of excavation to the west, we also uncovered the mud brick foundations of the pylon.

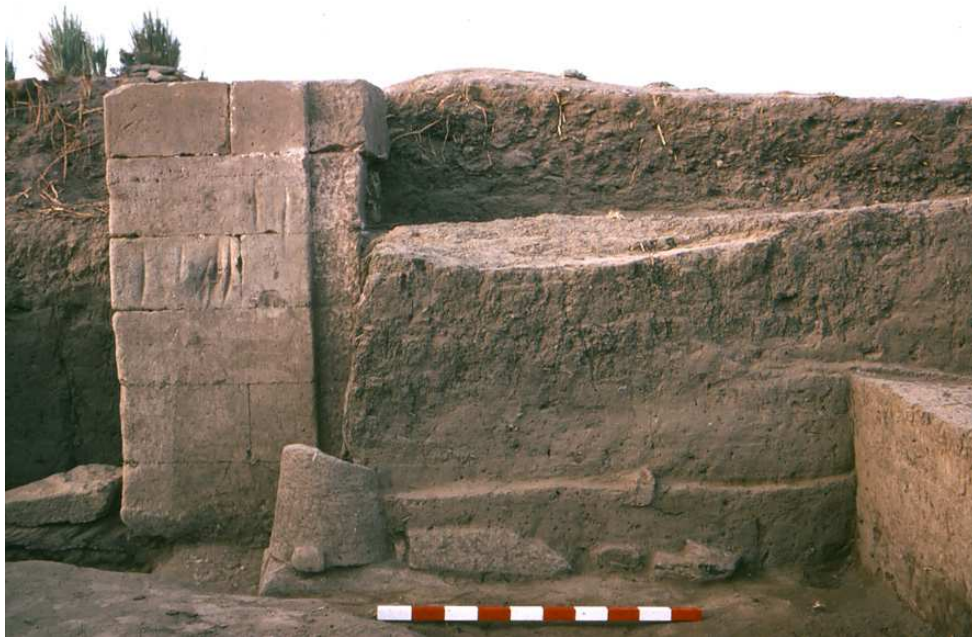
Fig. 4 The east end of the Mut Temple's First Pylon showing the Roman repair to the torus moulding. The Lepsius Gate is on the left, and the east wall of room 1, with evidence of burning at its lower courses, is to the right

The bricks of the wall/stairway and the bricks bounding the bins north of rooms 2-3 were also blackened in the burning. The most intense area of burning was north of rooms 1-3, where a thick stratum of red and black burnt debris extends several meters north. As we discovered in 1979, the outer face of room 1's east wall was burnt and ash covered the surface north of the Lepsius Gate as well (see fig. 4). The ash spread as far west as the east wall of the East Porch and several meters north of rooms 4-5. A layer of sherd-filled earth accumulated over the ash layer at least north of room 4, suggesting it may have been less damaged in the fire and continued in use after the collapse of rooms 1-3. Since the ash ran over the remains of the wall of room 5, it was probably in ruins by the time of the fire.

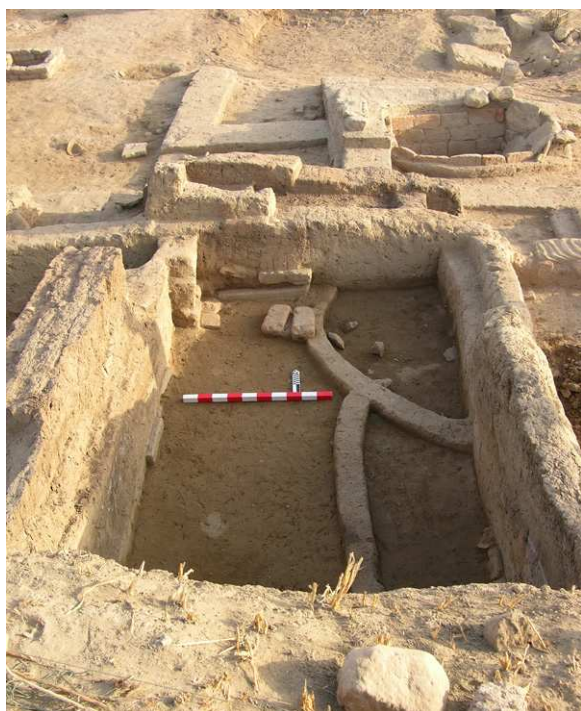
Fig. 5 The single-course mud brick features in Room 2 are probably an earlier phase of the room. The doorway was probably blocked when the wall north of the room was built. The cistern(?) and walls around it can be seen in the center of the photograph..

Rooms 1-3 are smaller than rooms 4-5. The vaults in rooms 1-2 were partially preserved, but room 3's vault had collapsed entirely. Rooms 1 and 2 were entered by doorways at the west end of their north walls. We found no threshold in room 3 nor any evidence of openings between it and its neighbors. The doorway of room 2 shows at least two phases of construction before it was blocked with mud brick: over the original stone sill is a layer of earth on which a second sill has been laid (see fig. 5). The sill of room 1 does not seem to have been altered.

In room 2, below the burn level and defined on each side by it we discovered a single row of mud brick parallel to the east wall. It intersects a semicircular brick feature in the northeast corner that appears to run under the north and east walls, but we have not yet found any trace of it beyond the room (fig. 5)⁹. Baked brick and stone uncovered below the foundations of the room may be part of the same phase as the odd brick features, which may in turn be associated with the buildings to the north (see below). Further excavation is required to determine the relationships of these features.

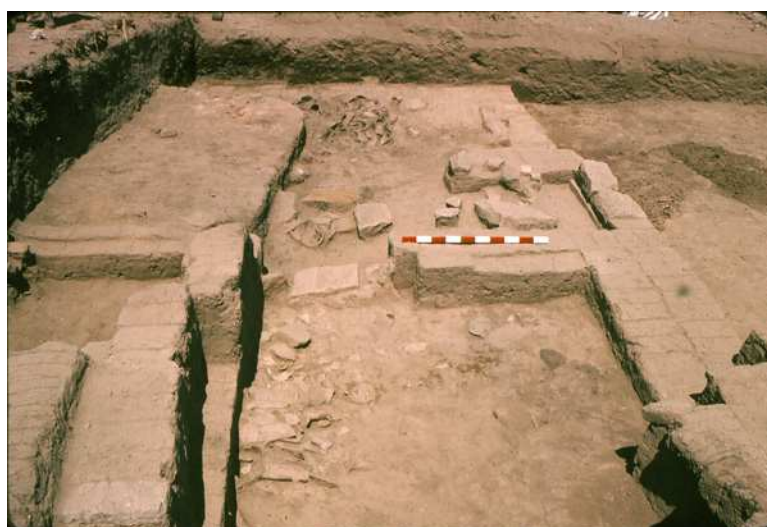
Fig. 6 View north of room 1 in 1979. The wall with the 2-phase sill that runs north from the room's northeast corner is visible on the right.

In 1979 we uncovered the lowest courses of a wall that ran north from the northeast corner of room 1. Set into its south end is an east-west sill that is also of two phases, this time sandstone on granite. North of the sill the wall turns to the west, but was robbed out after a few meters (fig. 6). No further traces of this wall were found in 2006. Within the space framed by these walls and on top of the remains of the short east-west wall were sandstone blocks and fragments and one limestone column drum; all seem to be displaced.

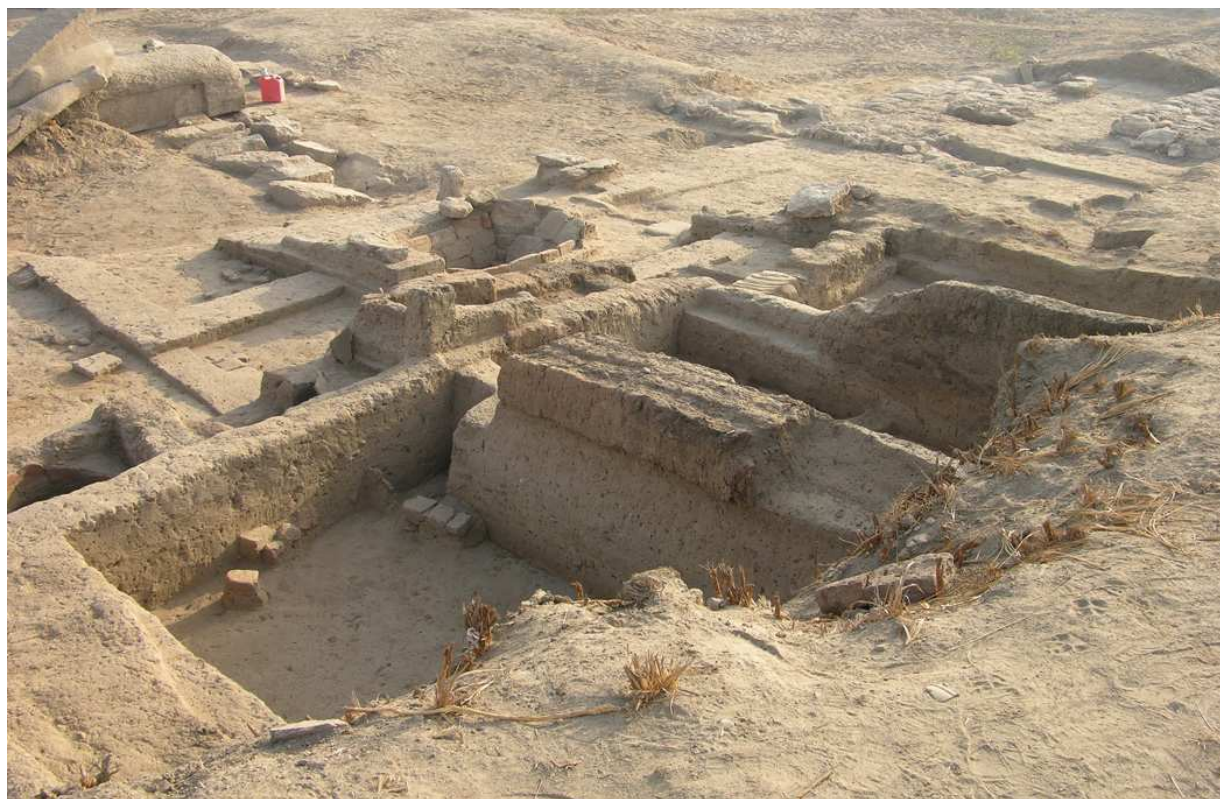
Fig. 7 A view to the northeast over rooms 3-1, with the cistern(?) and associated walls visible north of room 1.

from the feature's south wall under room 1's north wall. A wall perpendicular to the west wall meets another wall further to the west. Fig. 7 illustrates the cistern(?) and walls.

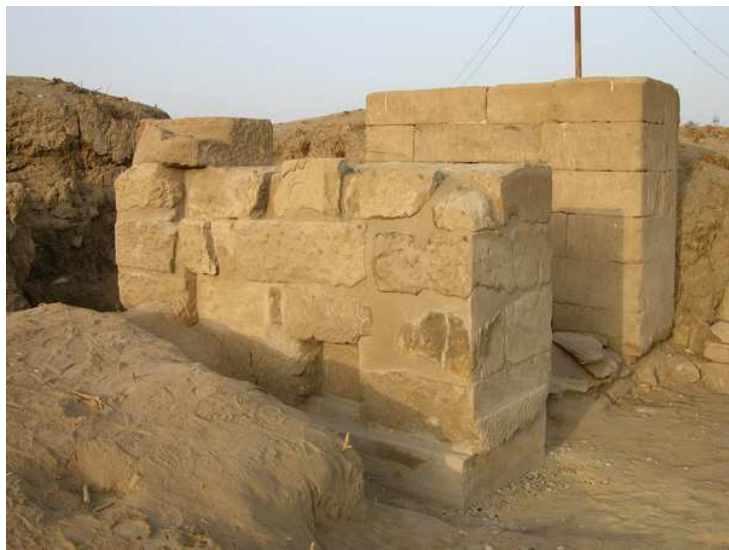
Fig. 8 The Lepsius Gate after the restoration of the east wing. The block with Merenptah cartouches is the recessed block in the lowest course, and the re-used relief of Mut is visible in the center of the top course.

In 1979 the expedition partially excavated this small, undecorated gateway abutting the east end of the Mut Temple's First Pylon. When we cleared the gateway completely in 2006, we discovered that the north end of its east wing was leaning at a dangerous angle because its limestone foundations were severely deteriorated. We dismantled the gate, treated the blocks as necessary, constructed new foundations that included moisture barriers and then rebuilt the gate (fig. 8). This jamb contained several re-used decorated blocks, including one with partial cartouches of Merenptah, otherwise unattested in the Precinct. Another was a relief, possibly of the Ramesside Period, of a female wearing a Double Crown, presumably an image of the goddess Mut. In a hollow carved into the upper surface of a lower course of stone we found a Late Period falcon amulet, probably Horus, and a small strip of bronze. The amulet and the date of the reused blocks confirm that the gate is post-Ramesside.

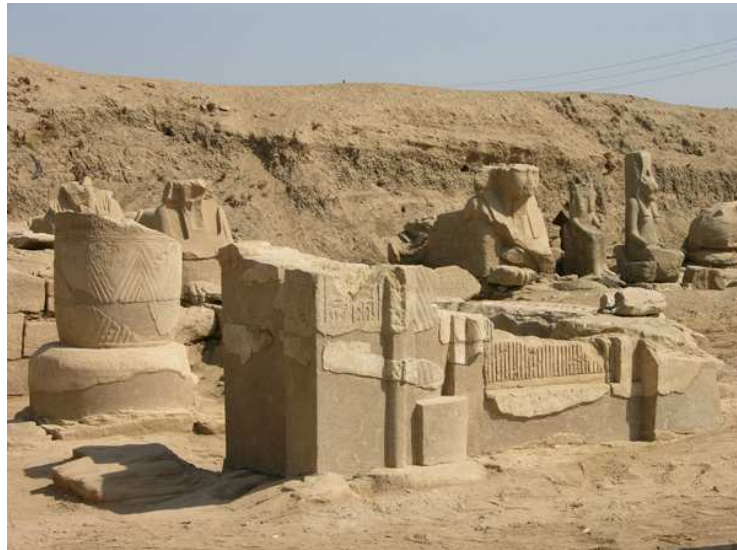
Fig. 9 The re-assembled east jamb of the entrance to Chapel D and one of the restored columns.

In 2005 Dr. Jacobus van Dijk identified several fragments of the east jamb of Chapel D's entrance among the blocks uncovered during work at the site by the SCA in 2001-2003¹⁷. In 2006 the expedition reconstructed this part of the entrance and consolidated the foundations of the chapel's entrance and of two columns in its first room (fig. 9). It is hoped that more such reconstruction will be possible in the future, in part from blocks already known and in part from blocks waiting to be excavated from the debris next to Chapel D.

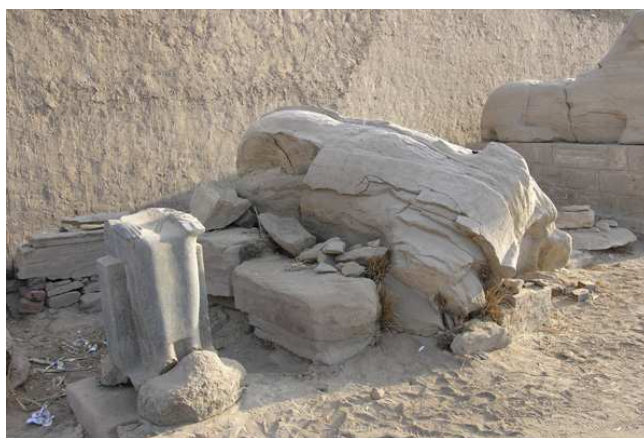
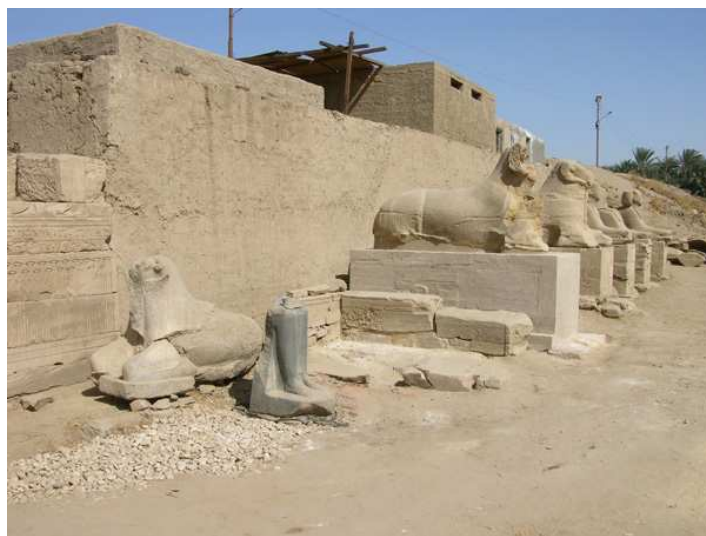
Fig.10 (a) The ram east of the precinct entrance at the start of the season; (b) the conserved sculpture on its new base, and the restored remains of the small chapel to its west.

A row of five sandstone rams and sphinxes stands in front of the enclosure wall east of the precinct's main entrance. Four of these sculptures sit on bases restored by Maurice Pillet in the 1920s. The fifth, the ram nearest the entrance, was left lying on its side and was badly weathered and quite fragile, with large cracks along the bedding layers of the stone. In 2006 conservators from the Mut Expedition and the SCA consolidated the stone and inserted stainless steel rods to stabilize the layers of rock further.¹⁸ The statue was successfully righted and placed on a new base built on the foundations of the original base. Righting this statue also permitted treatment of the lowest courses of the small chapel immediately to its west. As can be seen in fig. 10a-b, the restoration of the ram this year and the reuniting last year of the head and body of the sphinx at the east end of the row of sculptures¹⁹ have made a great improvement in the appearance of the front area of the precinct.

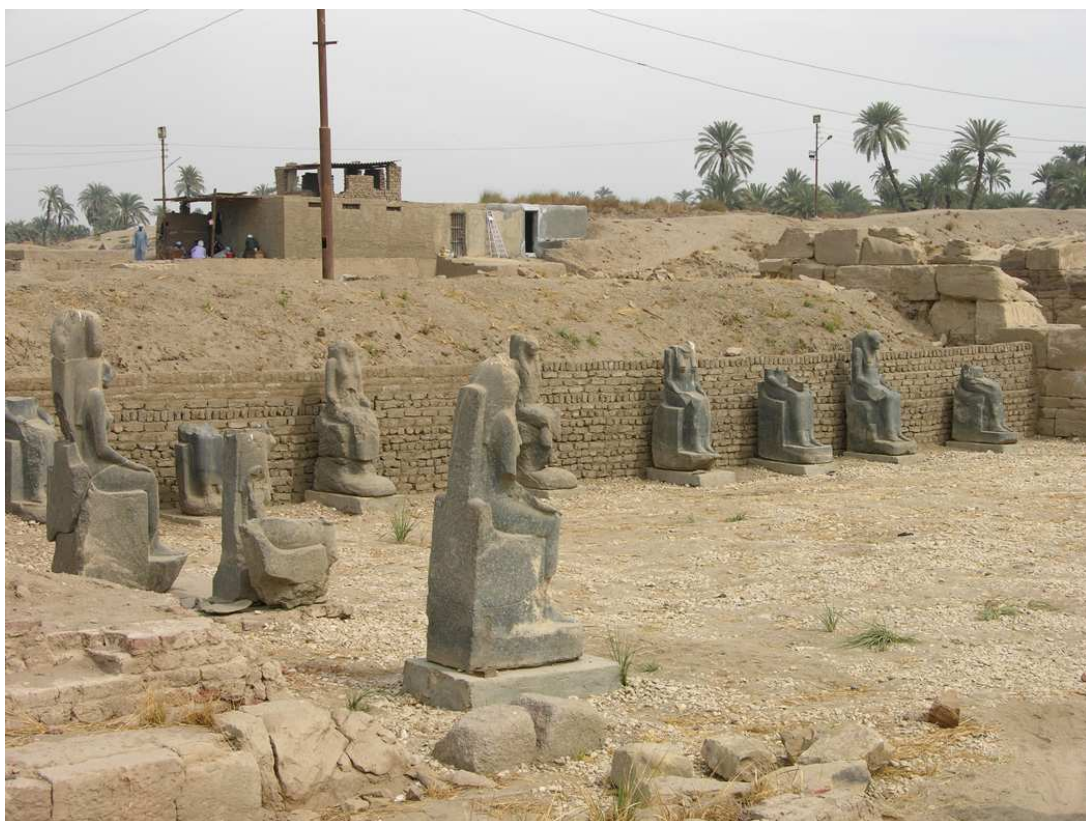
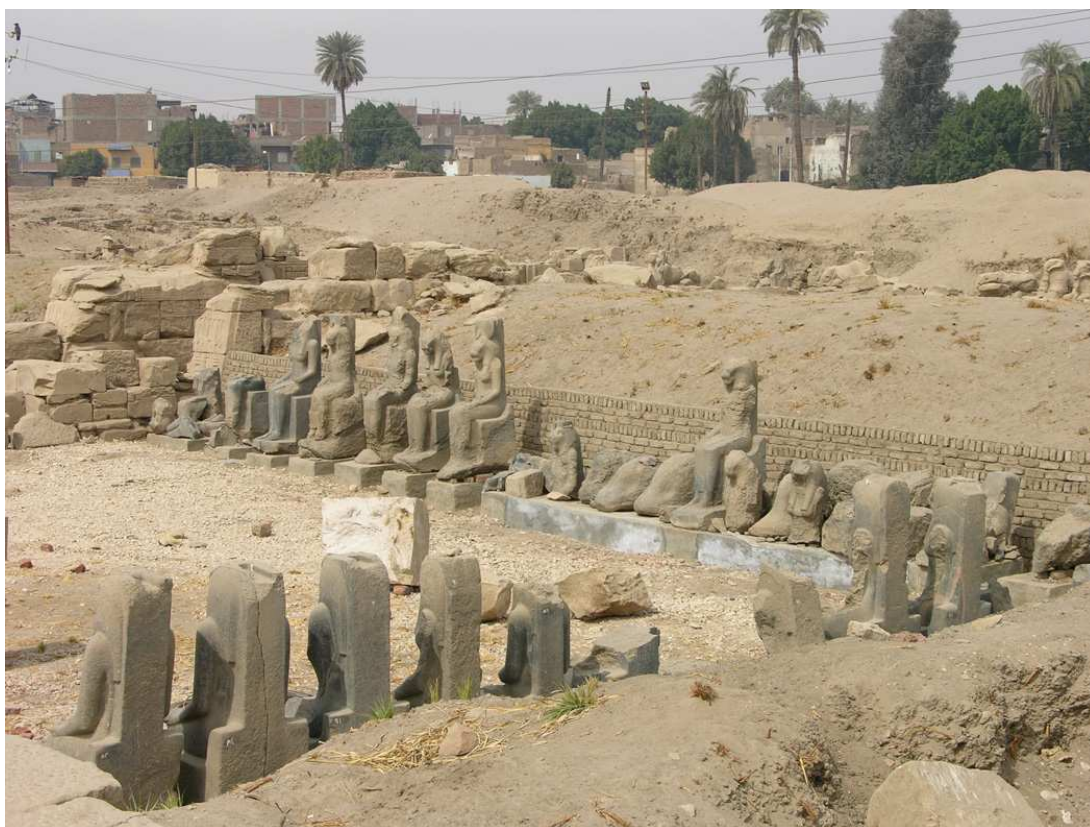
Fig. 11 The Sakhmets along the north wall of the Mut Temple's First Court on the west (a) and east (b) sides at the end of 2006.

During 2006 the expedition placed the last of the Sakhmet statues on the north side of the Mut Temple's First court on new bases that isolate them from ground water. To prevent drifting dirt from reburying the bases of the statues and to provide a suitable backdrop for these sculptures the expedition built mud brick walls along the line of the south face of the temple's mud brick second pylon (fig. 11).
