**Report on the Brooklyn Museum's 2009 Season of Fieldwork at
the Precinct of the Goddess Mut at South Karnak**
by Richard Fazzini, Brooklyn Museum

Abstract

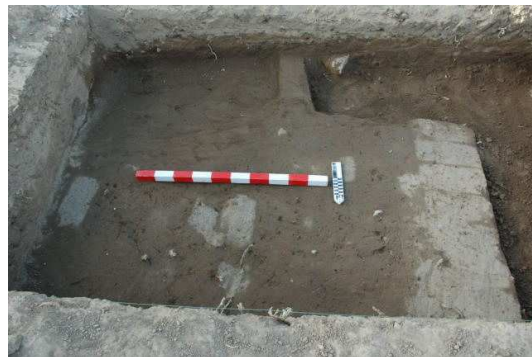
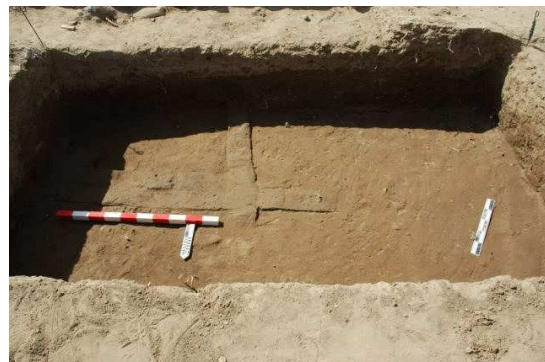
Fig. 2b (top) and 2c (bottom): two strata of mud brick walls under the sand foundation. Both suggest domestic rather than temple structures.

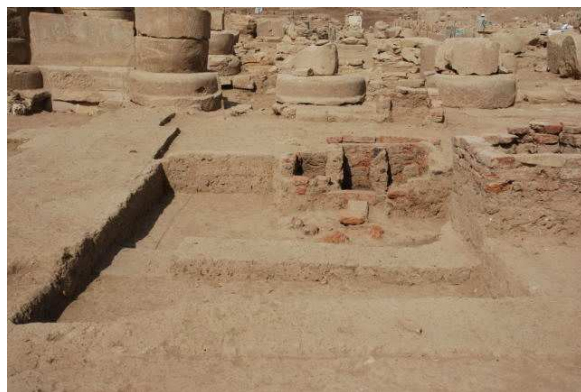
Fig. 5: View to the west of the kiln/oven north of the Mut Temple's 1st Pylon. The lower level wall is visible on the left.

forms the west side of the oven/kiln continues to the south and may have run over the earlier mud brick construction uncovered this year north of the room 4, built against the face of the pylon⁷ (see fig. 4 and below). A mud brick wall 2 courses wide and at least 2 courses deep runs from the north to the south baulk along the east side of the oven/kiln square. This wall's northern end is cut by the ashy debris from the oven/kiln, suggesting that the wall pre-dates the oven and was damaged when (or possibly after) the oven was installed. Both this east wall and the installation's west wall run over another east-west wall that extends the length of the south baulk c. 30 cm below the preserved top of the oven/kiln (fig. 5).

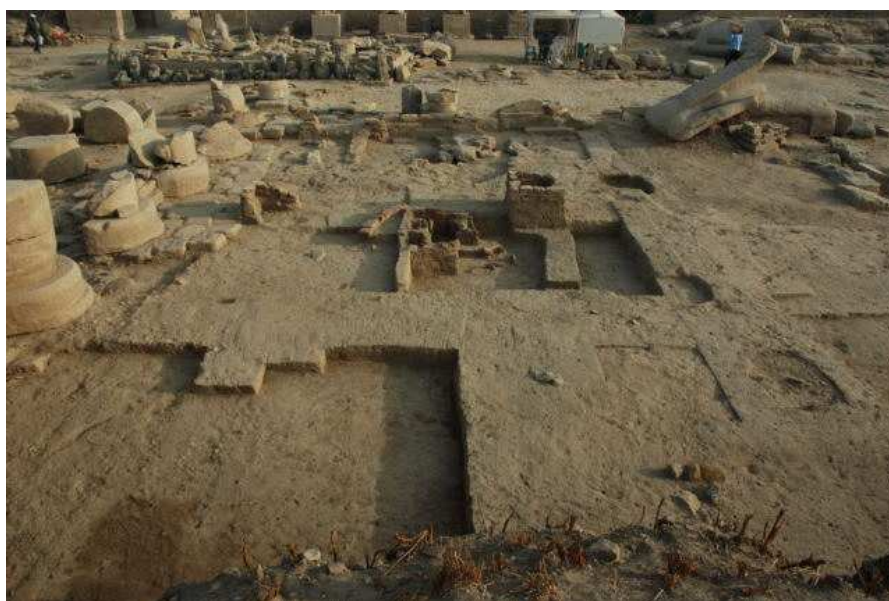
Fig. 6: View to the north of the area north of the Mut Temple's 1st Pylon at the end of the season.

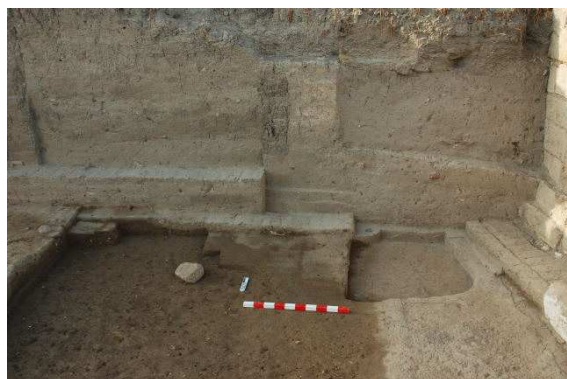
Fig. 7: The brick at west end of pylon with East Porch to right.

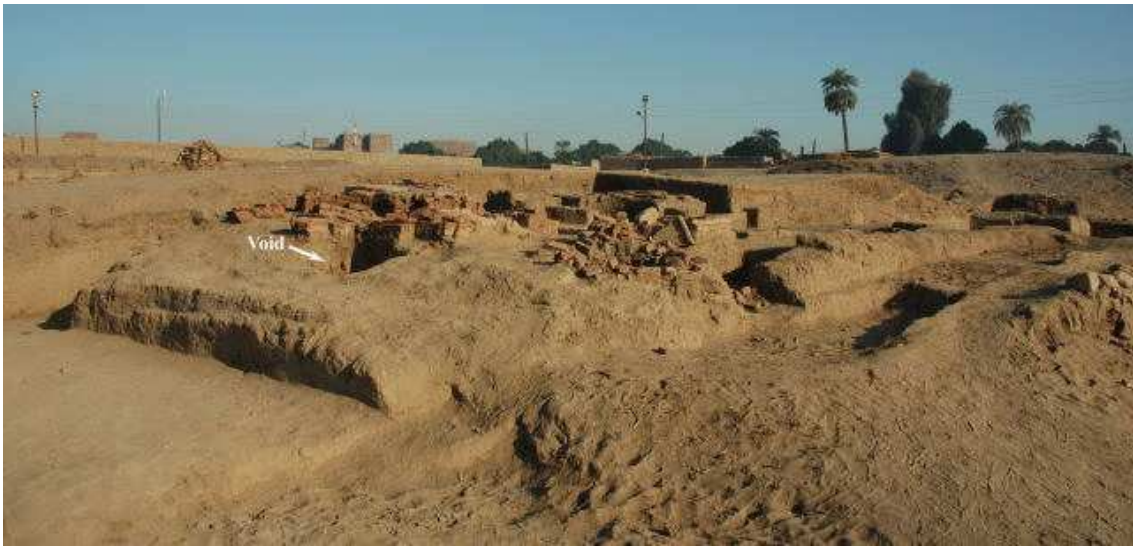
Fig. 10a: View to the NW showing the south face of the northern Tuthmoside enclosure wall with the baked brick building built on it. The wall that forms the eastern boundary of the structures associated with this building is visible in the center of the picture.

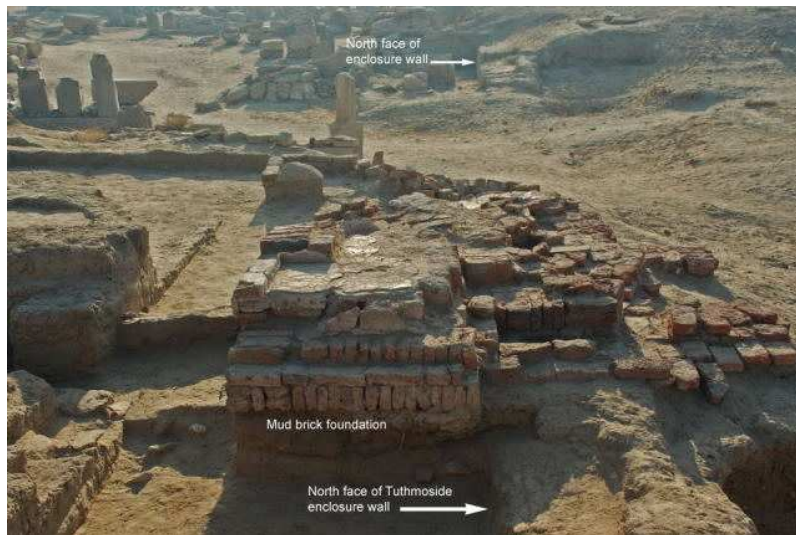
Fig. 10b: View east of the same area showing the mud brick foundations of the north part of the building, the gap between it and the mud brick structures to the north, and the north face of the Tuthmoside enclosure wall, which lines up with the Mut Temple's 1st Pylon.

The building's function is still uncertain. It does not seem large enough to have been a bath (our first thought), and the suggestion that it may have been a place for fulling or dyeing textiles¹⁷ cannot be confirmed. What is certain is that building sits partially atop the remains of the Tuthmoside Mut Precinct's north enclosure wall, whose south face we cleared this year along the length of the building (fig. 10a). Its north wall, which extends beyond the north face of the Tuthmoside wall, rests on a foundation of mud brick (fig. 10b), with evidence of a sand foundation bed under the north face.

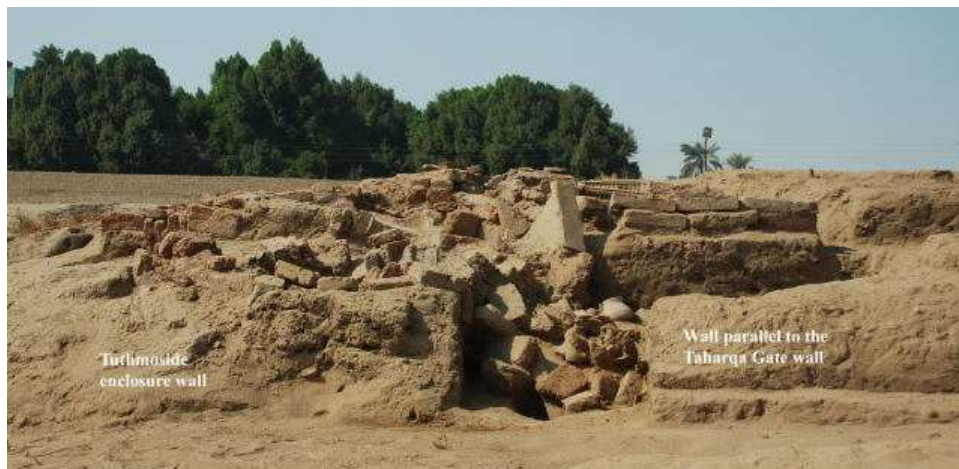
Fig. 11: View to the west of the collapse of stone, baked brick and pottery on the N side of the well cutting through the south end of the wall parallel to the Taharqa Gate wall.

East of the building is a deep well made of baked brick whose north side has collapsed, sending a spill of baked brick, stone and pottery into a gap between the Tuthmoside enclosure wall and the south end of the wall parallel to the Taharqa Gate wall (fig. 11). The broken stone visible in the photograph may be parts of a short wall that once ran between the well and the baked brick structure to its north, of which only 2 courses remain.

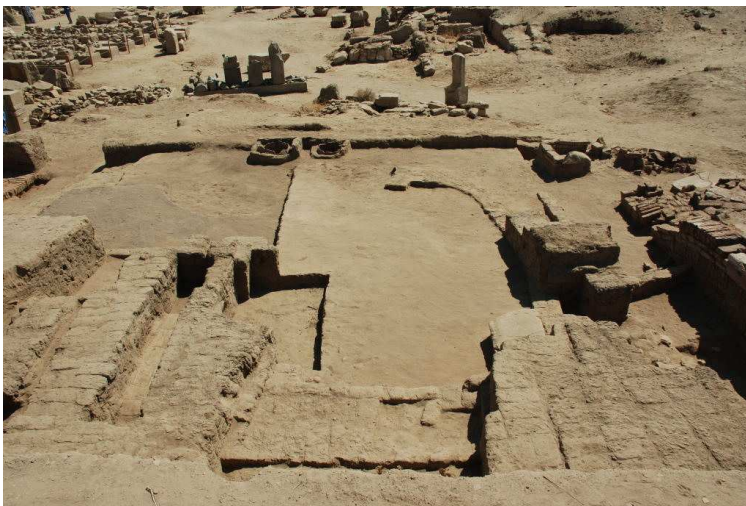
Fig. 13a: A view east of the mud brick walls of Area 1, north of the baked brick building. The plastered floor is in the center of the photo with the bins in the rear.

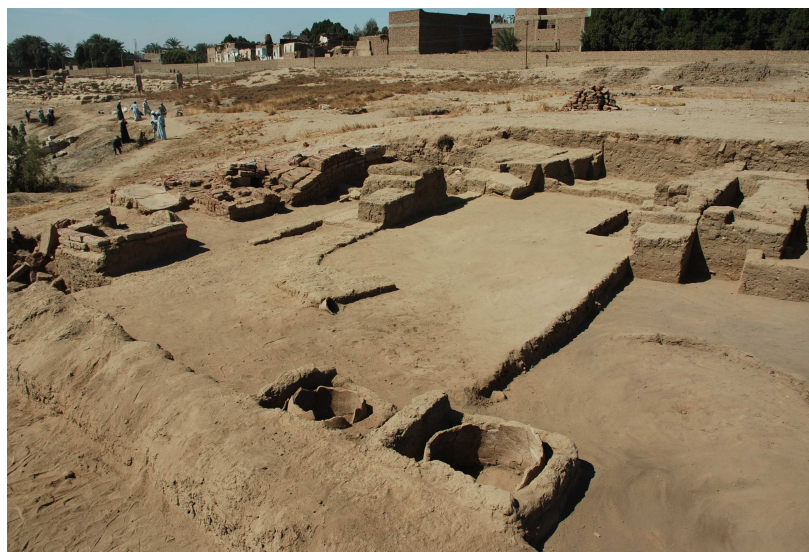
Fig. 13b: General view to the southwest of Area 1.

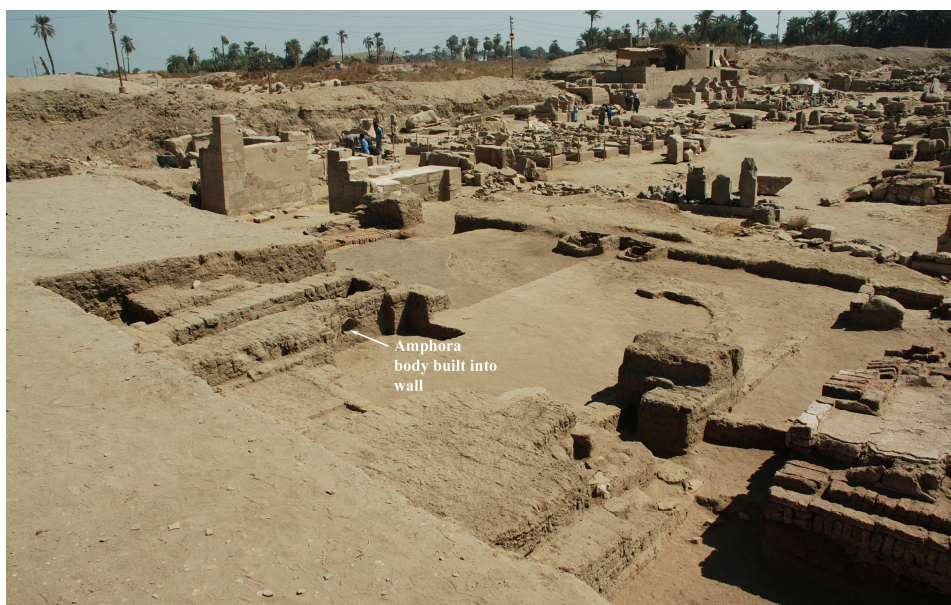
Fig. 13c: The same area, looking northeast

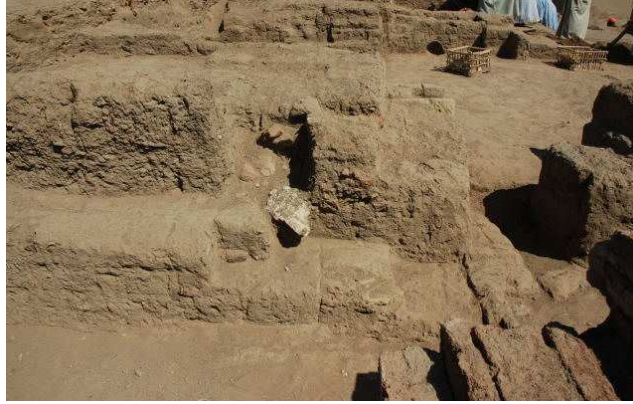
Fig. 14: The gap in the south side of wall (c), with tumbled stone and brick; wall (a) is in the foreground.

The south side of (c1) (yellow) sits directly on (a). There was a flat sandstone block set into the projecting course at the east end (a). A gap in the south side of (c1) in the area of this slab was filled with broken brick and stone (fig. 14). When we removed the (c1) brick in the southeast corner, we found more disturbed stone fragments, and there was additional broken stone in the gap between (a)/(c) and (d). Perhaps the sandstone slab and the stone and baked brick debris are remains of an entrance threshold and stairway into building (a) that was later destroyed when (c1) was built.

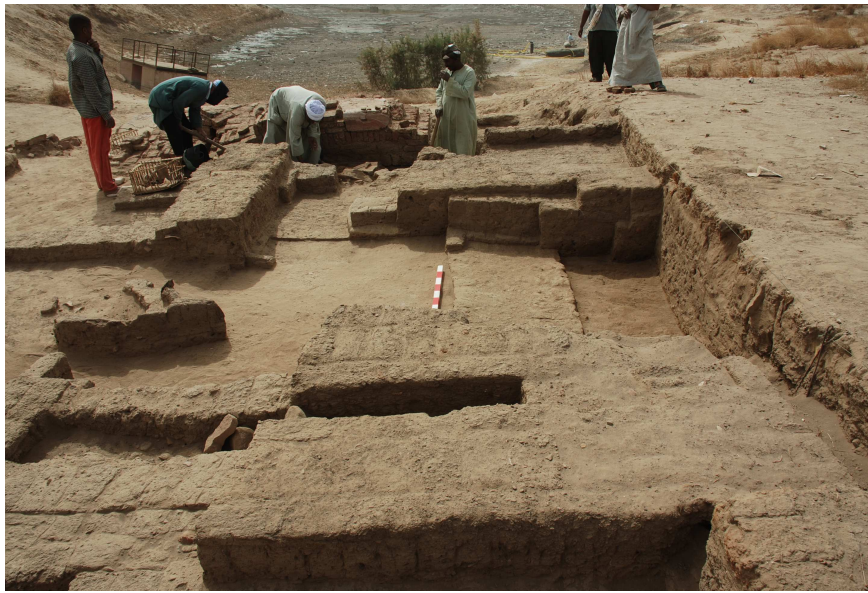
Fig. 15: View south across the western half of Area 1. Wall (b1) (to the right of the meter stick) runs between walls (c1), in the background, and (c2). The foundations of (c1-2) are deeper east and west of (b).

The three areas of brick labeled (b1-3) (blue) may be contemporary with (a). They definitely run under the center of the walls labeled (c1) and (c2), although the foundations of these two walls east and west of (b1) continue down at least 2 courses, as is visible in fig. 15, which also shows (b2). (b2) does not continue under the (d₁) as we discovered when we removed the northern part of that structure.

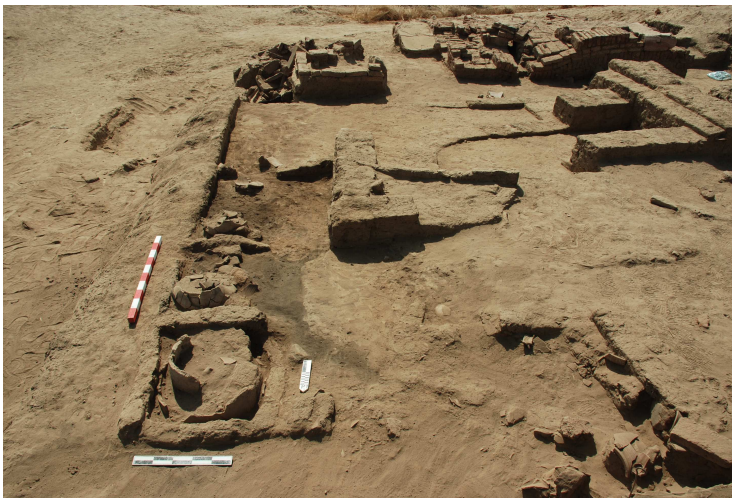
Fig. 16a: View south along the east side of Area 1 showing the 2nd phase of the ovens built against the wall parallel to the wall running south from the Taharqa Gate.

At the east side of the area we found a group of ovens built against the west face of the wall parallel to the wall running south from the Taharqa Gate that were in use long enough to have burnt the face of the wall against which they sit and produced a heavy accumulation of ash in the vicinity around them. Figs. 12 and 16a show the 2nd phase of this installation. Three mud brick compartments enclose the ovens, and there are remains of a fourth compartment to the north of the oven 1, although no trace of an oven or bin remains. In this phase, oven 1's surround is the only complete one; the west sides of ovens 2 and 3 and the south side of oven 3 are missing. Oven 1 consisted of a small oven set into a larger bin or oven whose rim and shoulder are missing, the space between the west side of the two vessels being filled with mud brick, which extends over the top of the lower vessel. The center compartment contained two small vessels, their west and south sides also supported by mud brick. Oven 3, the most damaged,

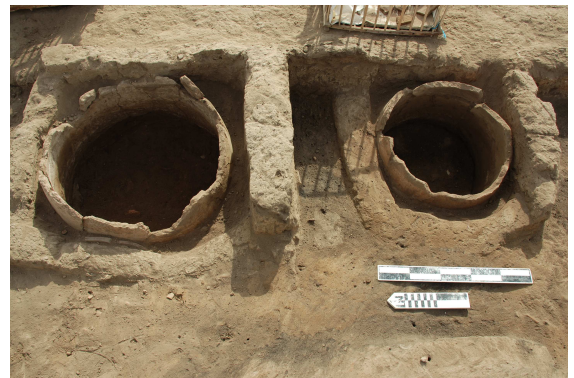
Fig. 16b: View east of the 2 ovens/bins of the earlier phase.

In the earlier phase of this installation there were only two ovens or bins: the large vessel into which oven 1 had been set, and a second, somewhat smaller vessel that had been completely covered by the two vessels of oven 2. This earlier version of oven 2 was set in its own mud brick surround, some centimeters south of oven 1 (fig. 16b). There is no sign of burning on the inside of the two earlier vessels, so it is possible they were storage bins rather than ovens. When the cooking area was expanded, the old bins were filled in, new ovens built on their remains, and additional ovens added to the south (oven 3) and possibly the north, although only one side of the surround of this latter oven remains.

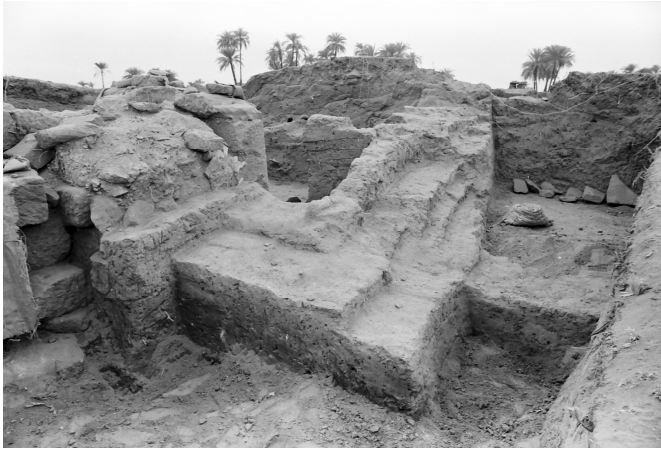
Fig. 17a: The wall running north and west from the Taharqa Gate at the end of the 1977 season (photograph: D. Loggie).

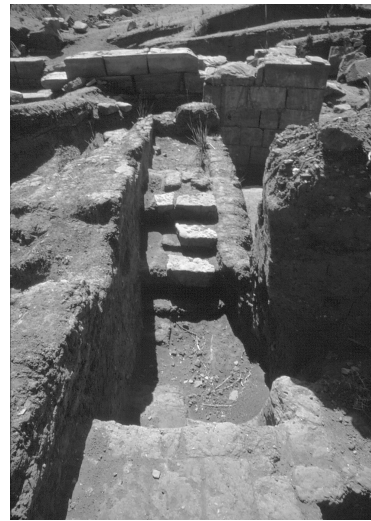
Fig. 17b: A 1977 view to the east of the stairway built against the wall running west from the Taharqa Gate. (photograph: R. Bianchi)

In 1977, built against the north boundary wall we uncovered an east-rising stairway with stone treads (fig. 17b); it was enclosed by mud brick along its south and east sides. Fig 18a shows the same area partway through the 2009 season. It seems likely that the sandstone block on the left of the photograph is the threshold of the entrance to the stairwell, which would have been entered from the south and turned immediately to the east. The stairwell itself has now completely collapsed: the two mud brick casements east of the sandstone sill are all that remain of its support. The northern casement was built over a heap of broken stone against the face of the north boundary wall and was filled with dirt. The southern casement was partially filled with broken pottery, probably dumped in as fill (see fig. 26). A Ptolemaic or possibly early Roman date seems appropriate for this pottery.

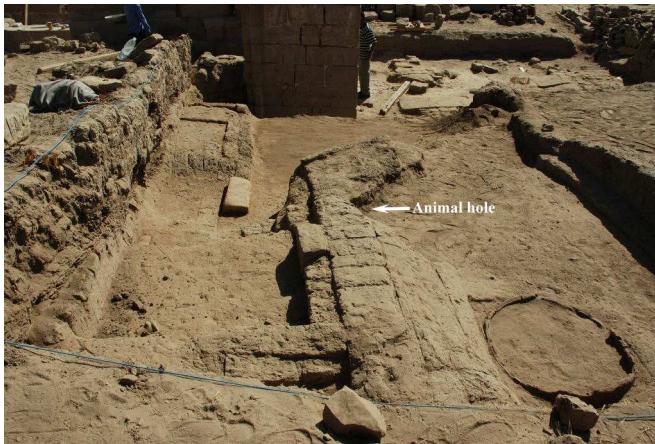
Fig. 18a: The northern portion of Area 2 North, looking east to the Taharqa Gate. The stone threshold is on the left, with the remains of the support of the stairway to its east.

The oven with a mud brick surround built against the south face of the wall dividing Area 2 north (fig. 18a) seems to confirm the domestic nature of the building. This oven had been partially exposed in 1977, under an ashy surface that ran across the space between the two walls, so it is not clear if it is exactly contemporary with the room to the north. Running over the top of the oven was a layer of earth containing many small white flecks of plaster or decayed lime/limestone. This same layer was found to the south (see below). The large, irregular gap in the wall east of the oven is an animal hole, dug since the 1977 season. The animal hole was useful in allowing us to examine the construction of this wall. As with the (c2) and (f) walls of Area 1, this wall began as two walls separated by a gap that was later covered with a row of mud brick to create a wider, stronger wall.

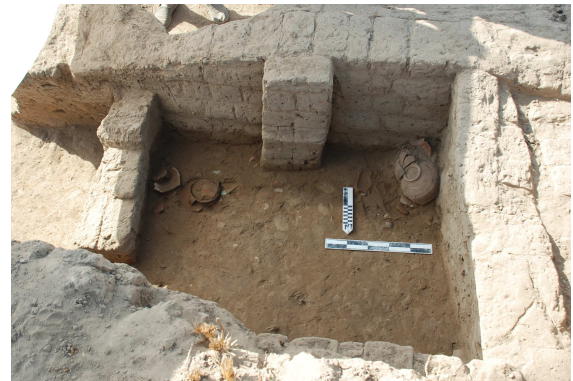
Fig. 18b: The room in the northwest corner of Area 2 north, looking to the south.

West of the stairway was a small room built in the NW corner of Area 2 north. It went through at least 2 phases of construction, the second phase consisting of adding a row of bricks to the existing north, south and west sides of the room (plan, fig. 12 and fig. 18b). The original west wall of this room is partially under the west baulk. A narrow cross wall to the east that abuts the south wall may have created a doorway into the room, and there is a projecting stub of brick halfway along the south wall (and also not bonded to it) that seems intentional. We found a considerable amount of pottery, particularly along the south side, sitting on an ashy surface, suggesting the area was used for food storage or preparation (fig. 26). G. Schreiber has recently published a detailed study of painted pottery from Thebes from late dynastic to Ptolemaic times.³⁴ The two bowl fragments illustrated resemble G. Schreiber's simple floral style of carinated bowl, which he dates "from the Late Persian period at least to the 2nd century BC,"³⁵ while the body sherds with bands of black/purple on a light background appear to fit in the

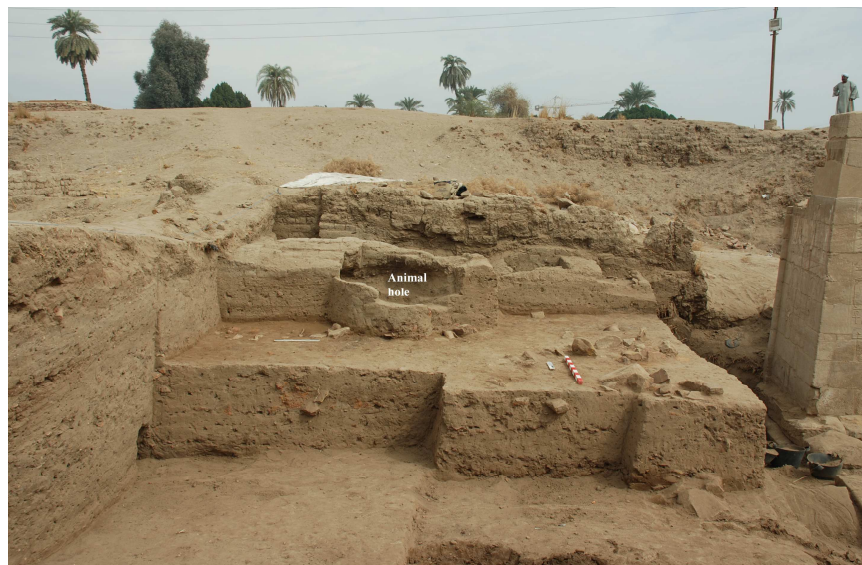
Fig. 19: View north across area 2 north with the dividing wall between the areas removed and the top of the dump of stone and pottery clearly visible.

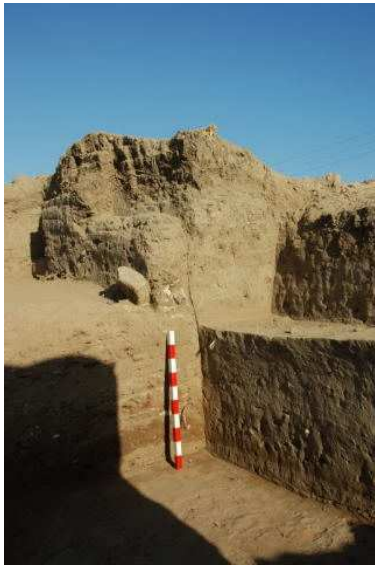
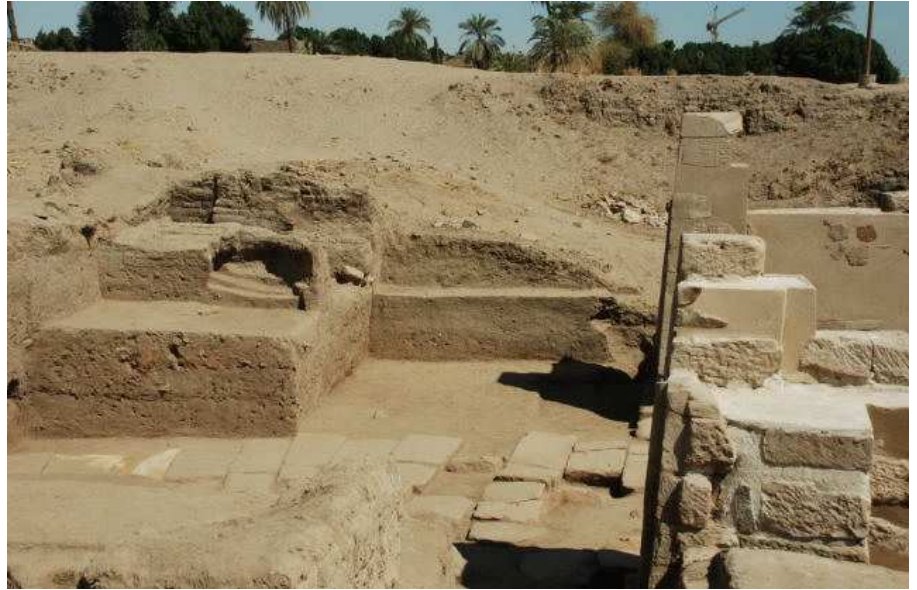
Fig. 20a (left) shows the join between the wall of the Ptolemaic/Roman house (to the right of the meter stick) and the earlier wall. Fig. 20b shows the north wall of the area extending down to the level of the paving and running east to the wall that abuts the north wing of the Taharqa Gate.

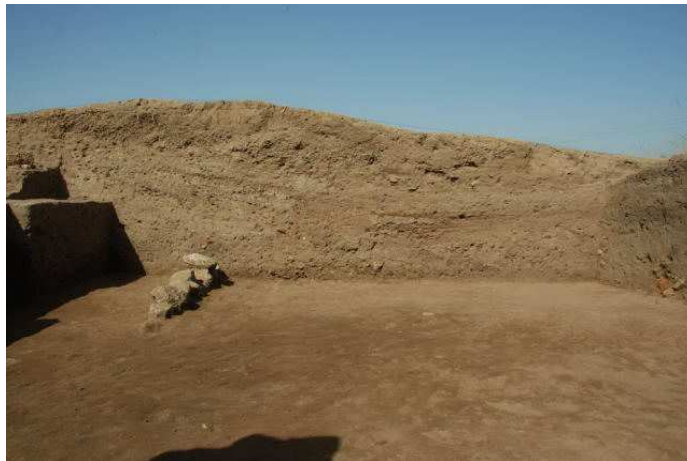
Fig. 21a: The west baulk of Area 2 south in mid-season, showing the strata of debris; the row of limestone is the only architectural feature found in the center of the area.

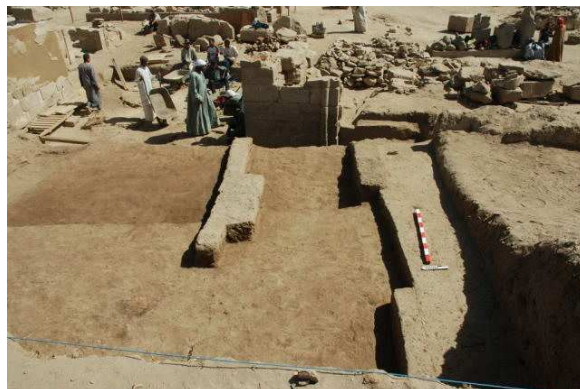
Fig. 21b: The north and south walls of the small structure west of the south wing of the Taharqa Gate, first found in 1977. Its south wall was built on top of the earlier brick wall forming the southern boundary of this area.

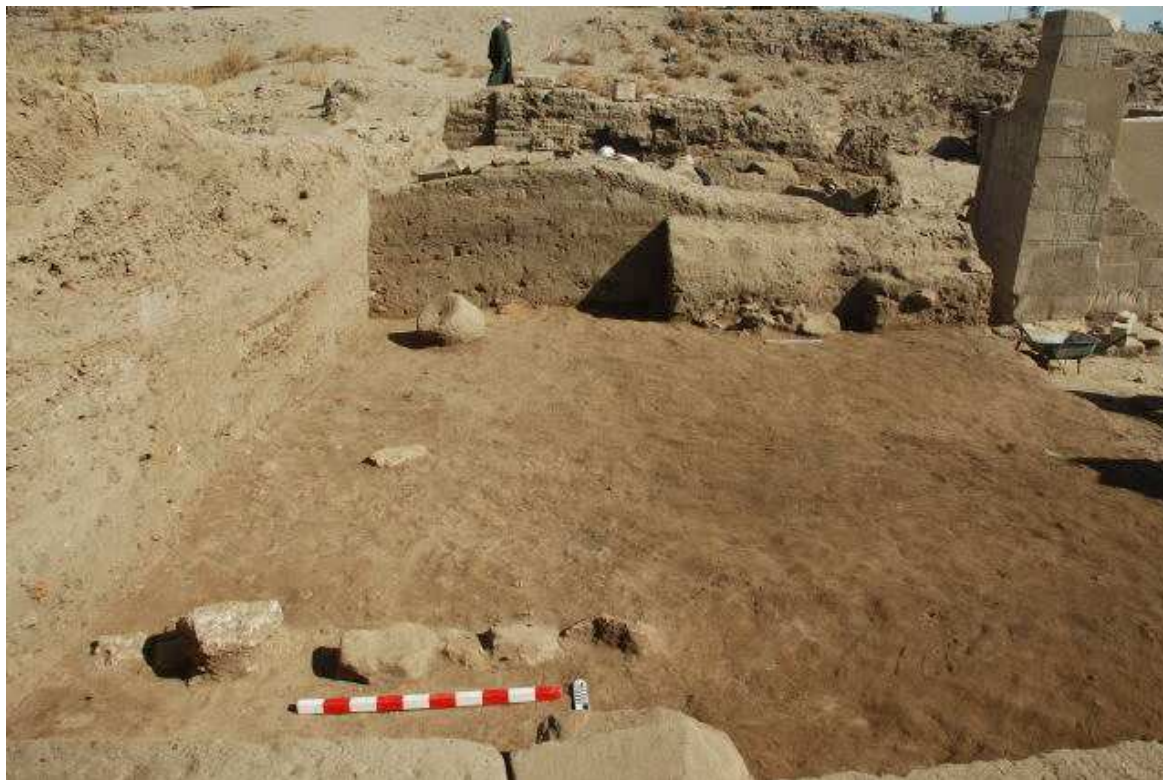
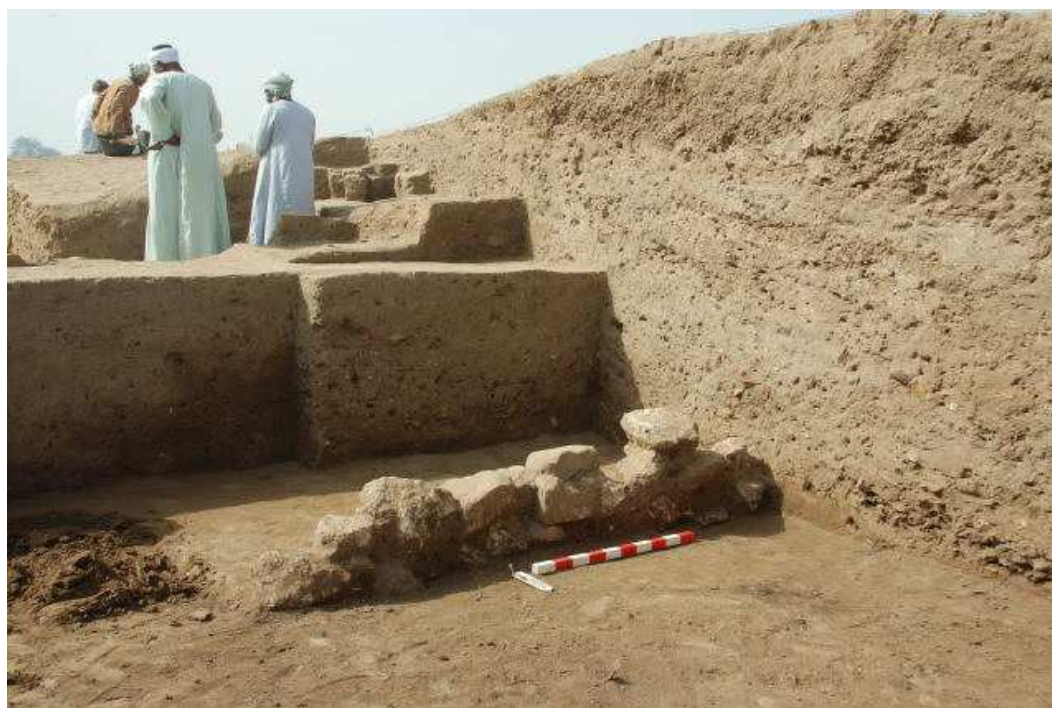
Fig. 22a-b: Two views of the crudely-built stone wall at the south side of Area 2 south: (a) looking north to the wall dividing Area 2 north and south; (b) looking south to the south wall of the area.

The two phases of the dividing wall between Area 2 north and south can also be seen in fig. 22a. The eastern portion of the wall, broken at the west end, was built atop the landfill described above; its lowest course is c. 1.2 m above the paving of the approach to the gateway. The top of this phase serves as the foundation for the later, narrower phase whose western portion was built on and cuts into, the top of the white-flecked layer, the same stratum that ran over the oven north of the dividing wall.

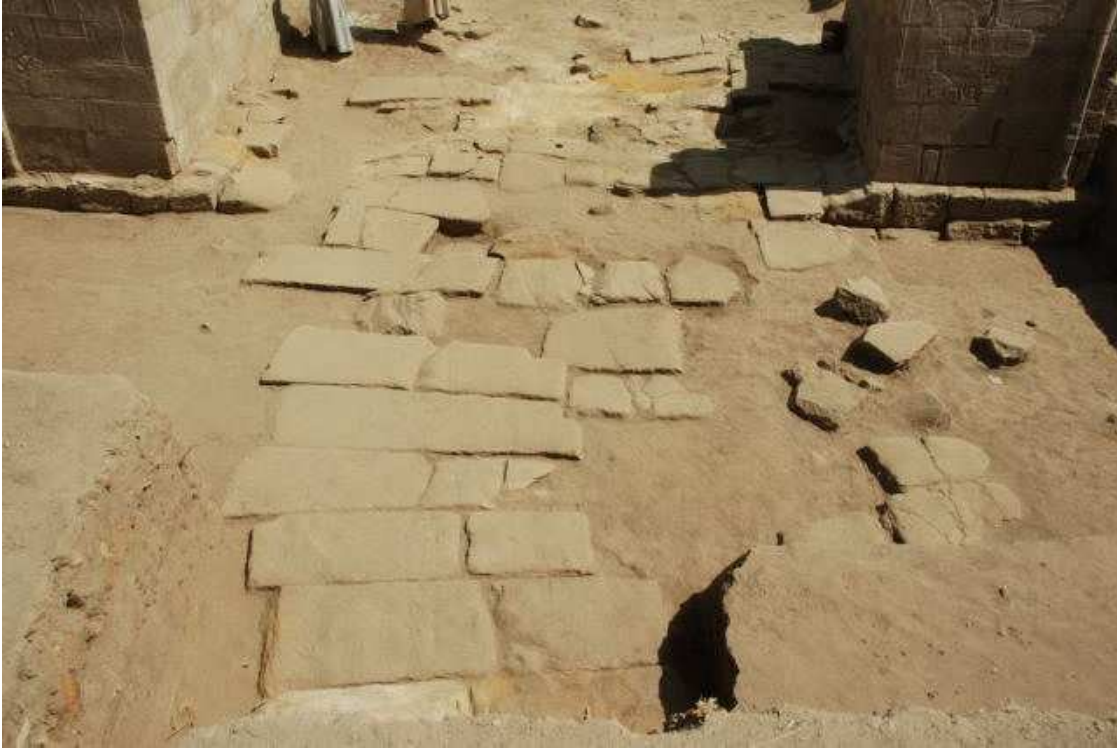
Fig 23: The paving west of the Taharqa Gate, seen from the west. The central part of the paving is well-preserved, but the blocks to the south are disturbed.

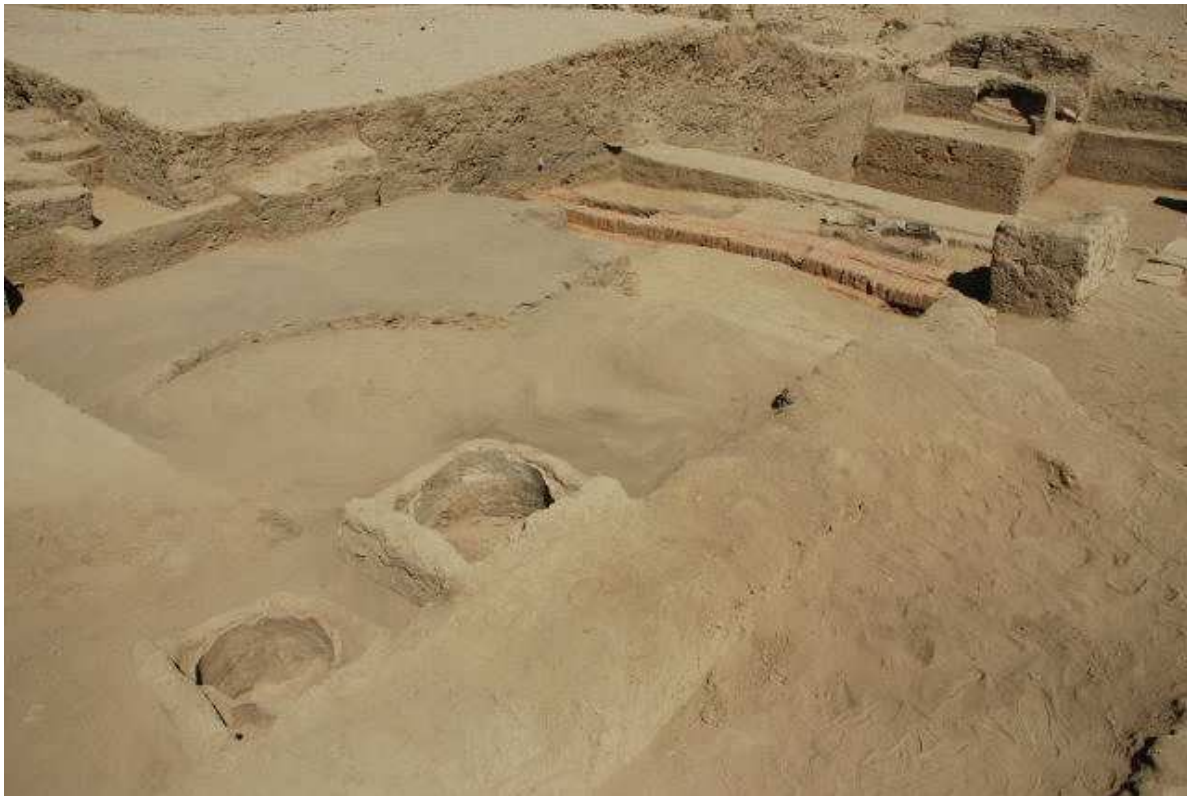
Fig 24: View to the northwest of Area 3 showing the rows of baked brick with mud brick on either side and the thick layer of grey ash (center) at a higher level than the bricks. The wall forming the southern boundary of the paved area west of the Taharqa Gate is in the background and the 2 original bins of Area 1 are in the foreground.

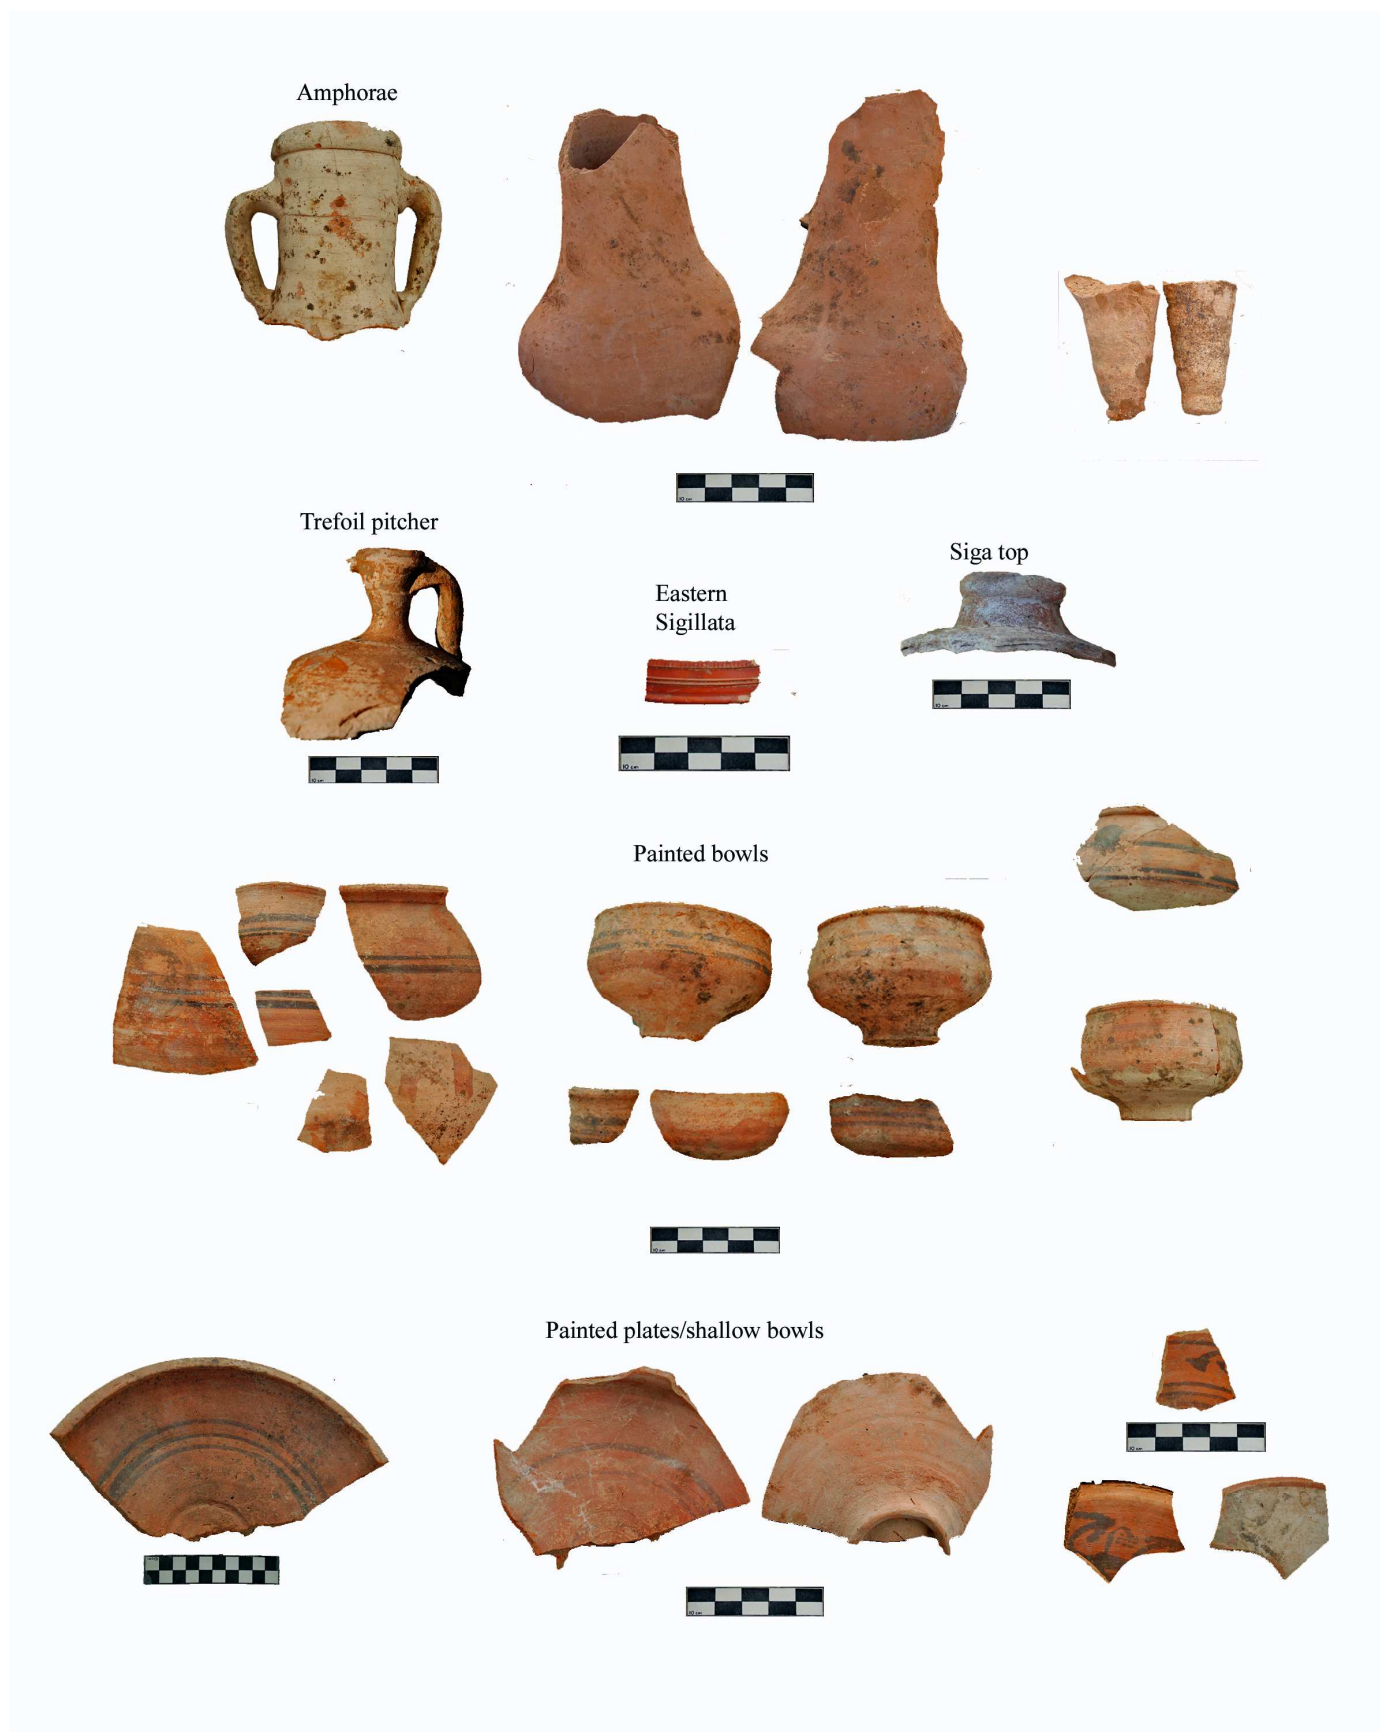
Fig. 25: A selection of pottery from Area 1.

The pottery found throughout the area seems to support a date in the 1st-2nd centuries AD; a selection is illustrated as fig. 25. In fact, there is a considerable consistency between the pottery in Area 1 and that found in association with the structures built against the Mut Temple's first pylon.²² As it is also in Karnak, it is not surprising that the closest parallels with the pottery found this year and in previous seasons continues to be found in the material from the Chapel of Achoris.²³

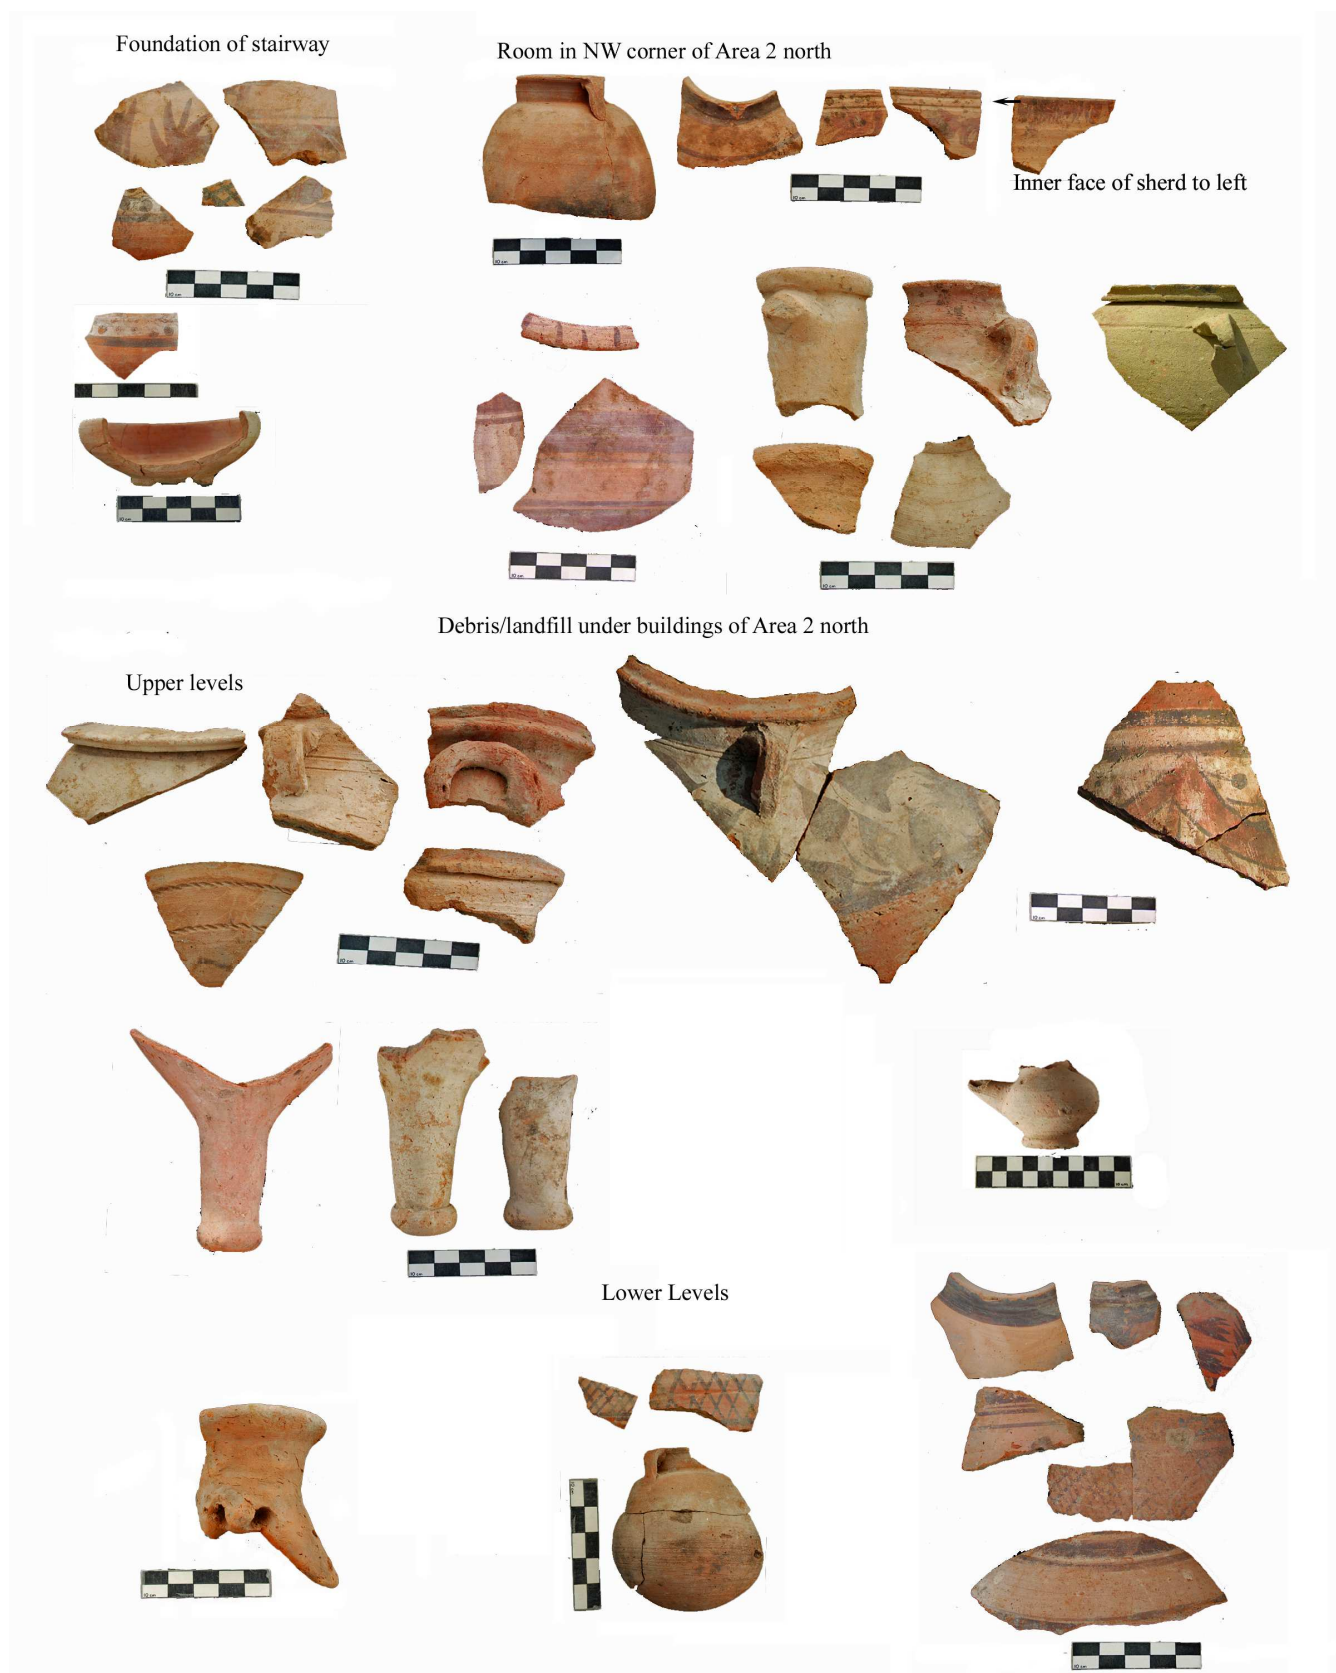
Fig. 26: Pottery from Area 2 north.

which to build the houses west of the Taharqa Gate. A selection of the pottery from this landfill is shown in fig. 26. The high proportion of painted sherds in this material argues strongly for a Ptolemaic date for its deposition.

(fig. 26), suggesting a possibly Ptolemaic date at least for the latter. Very similar objects were found at Edfu in 1938 (called “aiguières” by their excavator), and those that most resemble the ones found in Area 3 are dated to the Ptolemaic Period.⁴⁷ From the same stratum came a fragment of a Nile silt vessel with a motif of vines above a band of cross-hatching, executed in red and black paint on a white background, and a piece of imported black-glazed pottery (fig. 27).

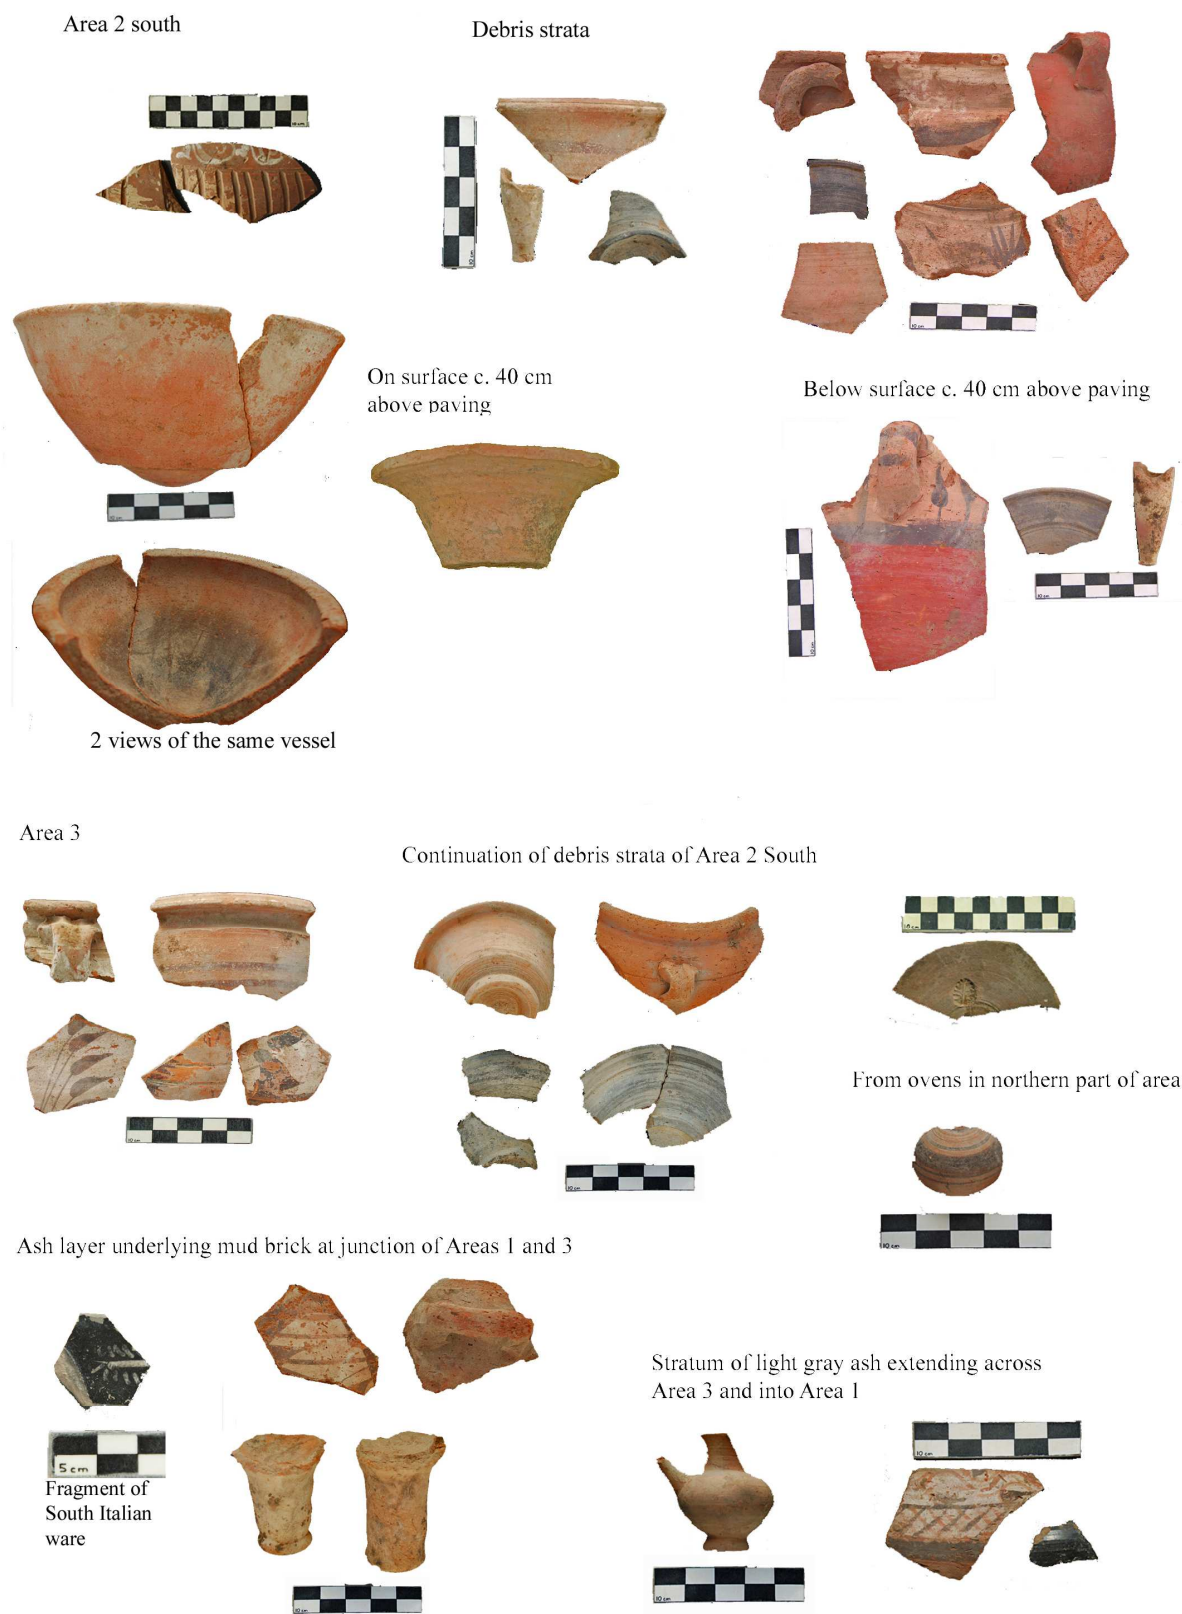
Fig. 27: Pottery from Area 2 south and Area 3.

From the gray ash layer came a spouted vessel (fig. 27) of a type with which we were not familiar⁴⁶. A very similar vessel was found in the lower levels of the debris in Area 2 north⁴⁷

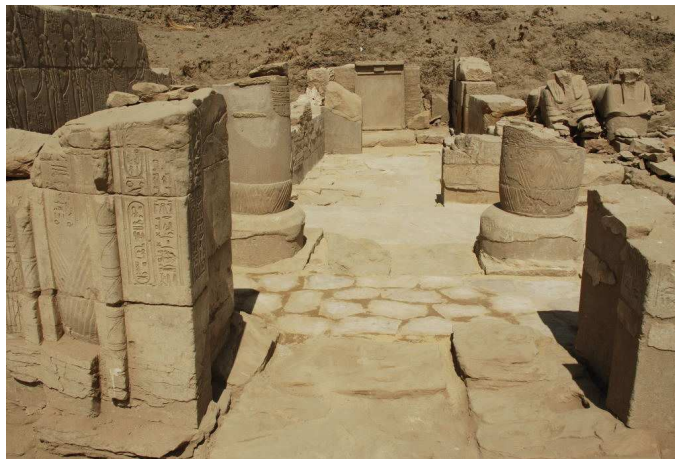
Fig. 28: Chapel D at the end of the season, with the walls restored and new paving installed.
