**Report on the Brooklyn Museum's 2009 Season of Fieldwork at
the Precinct of the Goddess Mut at South Karnak**
by Richard Fazzini, Brooklyn Museum

Abstract

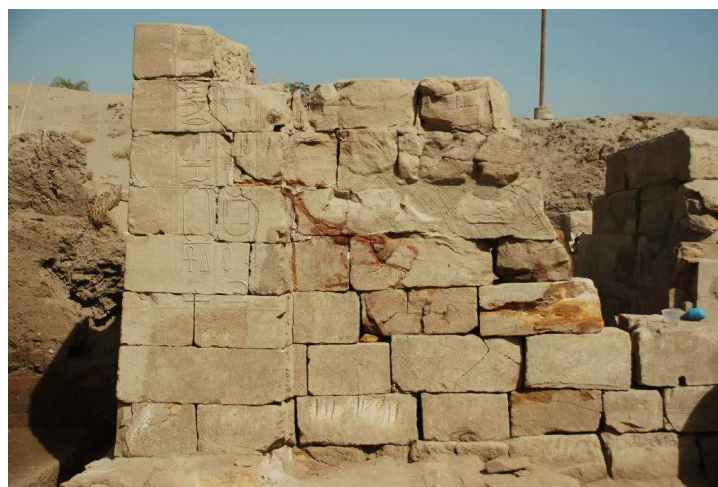
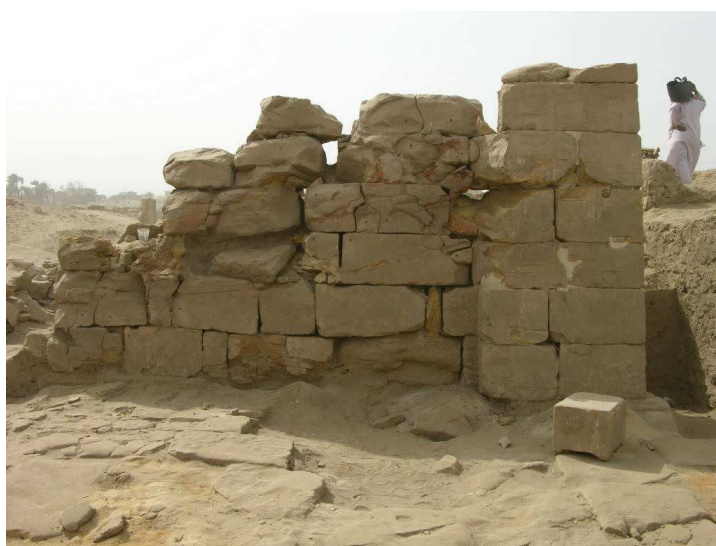
Fig. 29a-b: The inner faces of the north (top) and south wings of the Taharqa Gate at the beginning of the 2009 season.

The season’s major conservation project was to restore both wings of the Taharqa Gate to the extent possible. Fig. 29 shows the north face of the south wing and the south face of the north wing at the start of the season and fig. 30 after completion of the work. The blocks making up

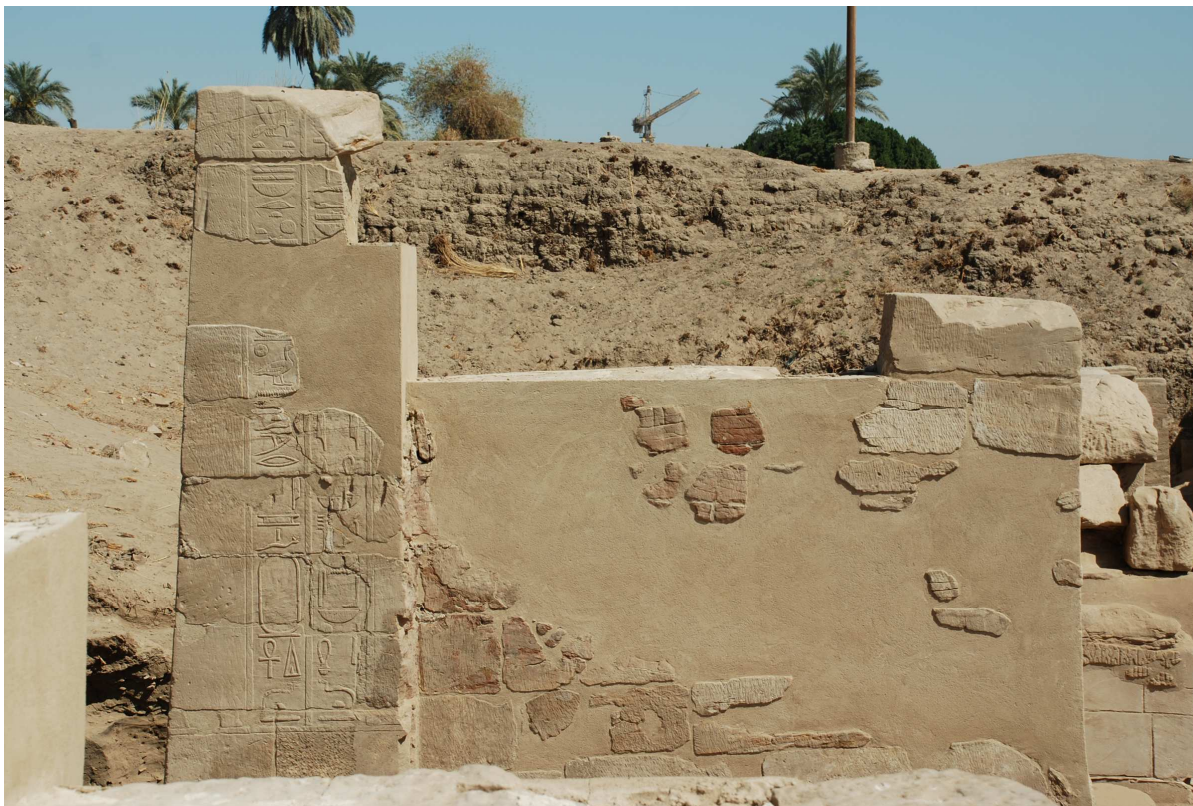
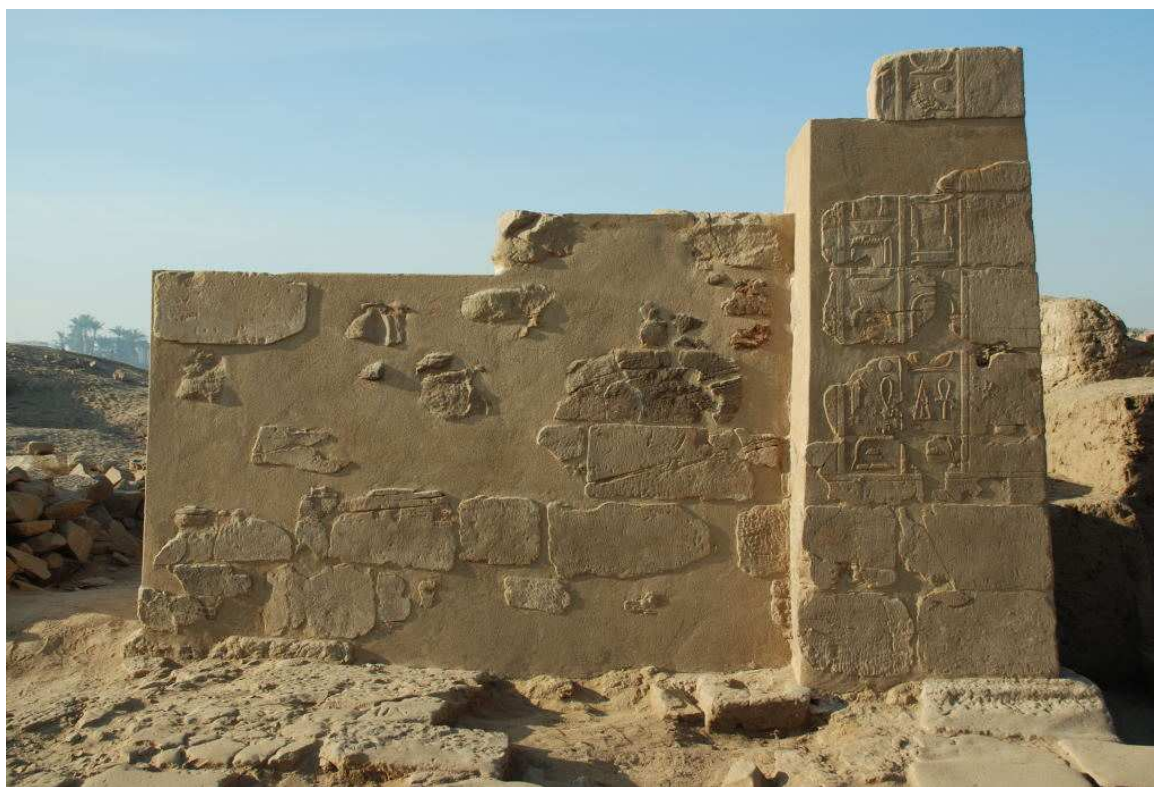
Fig. 30a-b: The same area at the end of the season. Damaged blocks have been conserved or replaced and blocks fallen from the gate restored to their original positions.

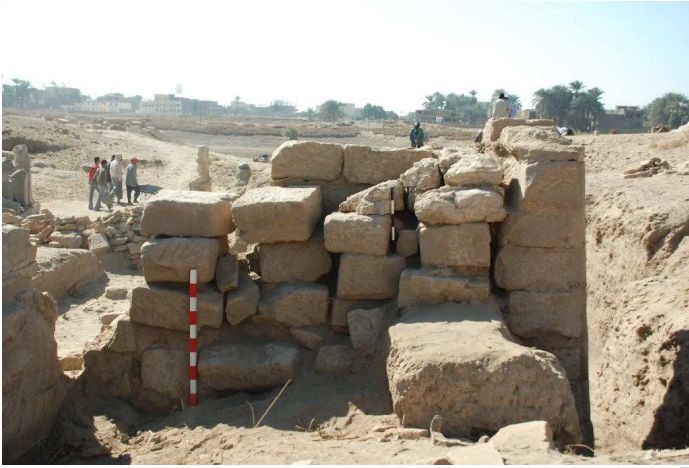
Fig. 31 a-b: The core of the north wing at the start of the season (left). The precarious condition of the blocks is clear. Below is the core at the end of the season.

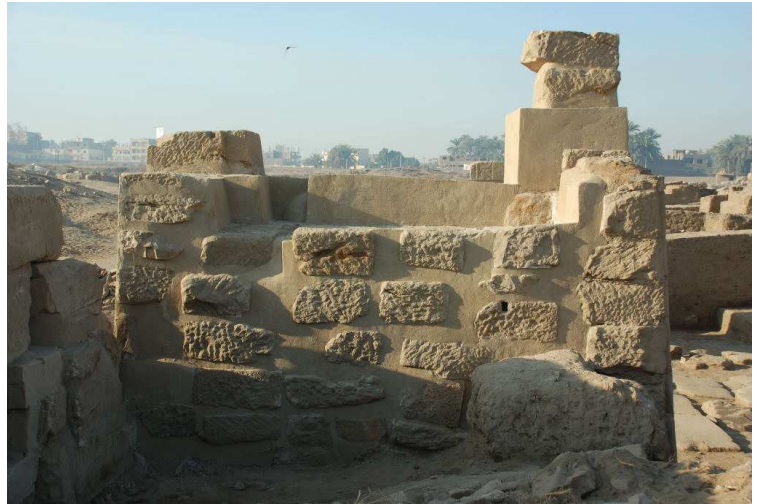
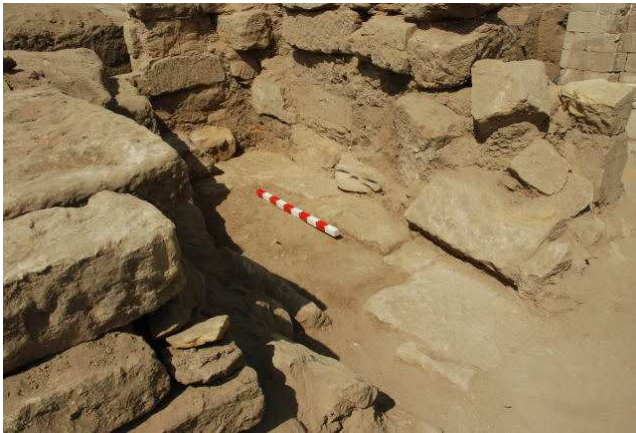
Fig. 32a-b: In the south wing all that remained was the foundation course of the rear of the gate (top). On the right is the new core of the south wing, built on the original foundation to support the facade.

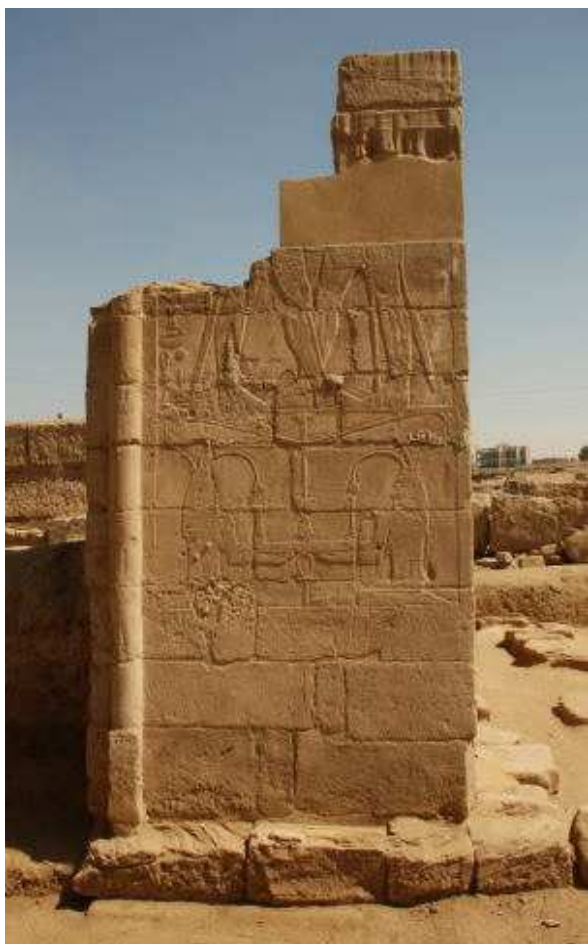
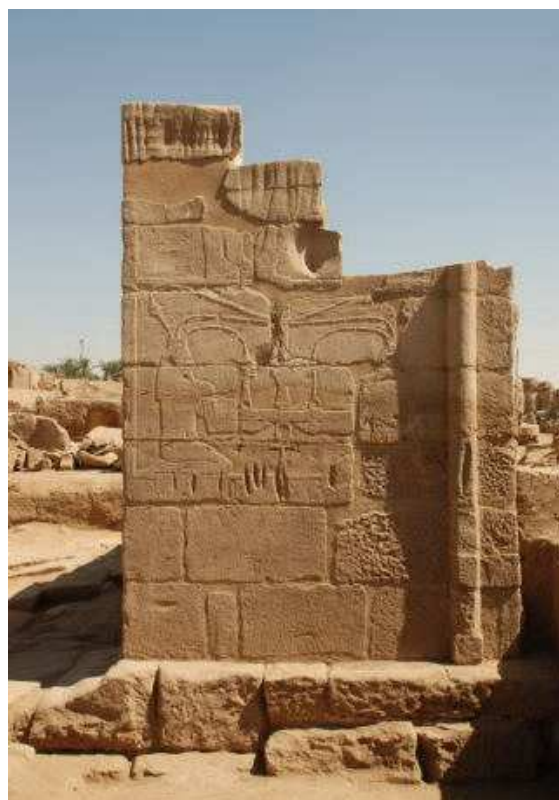
Fig.33a-b: The west faces of the north (left) and south wings of the Taharqa Gate at the end of the season with fallen blocks restored to their original positions.

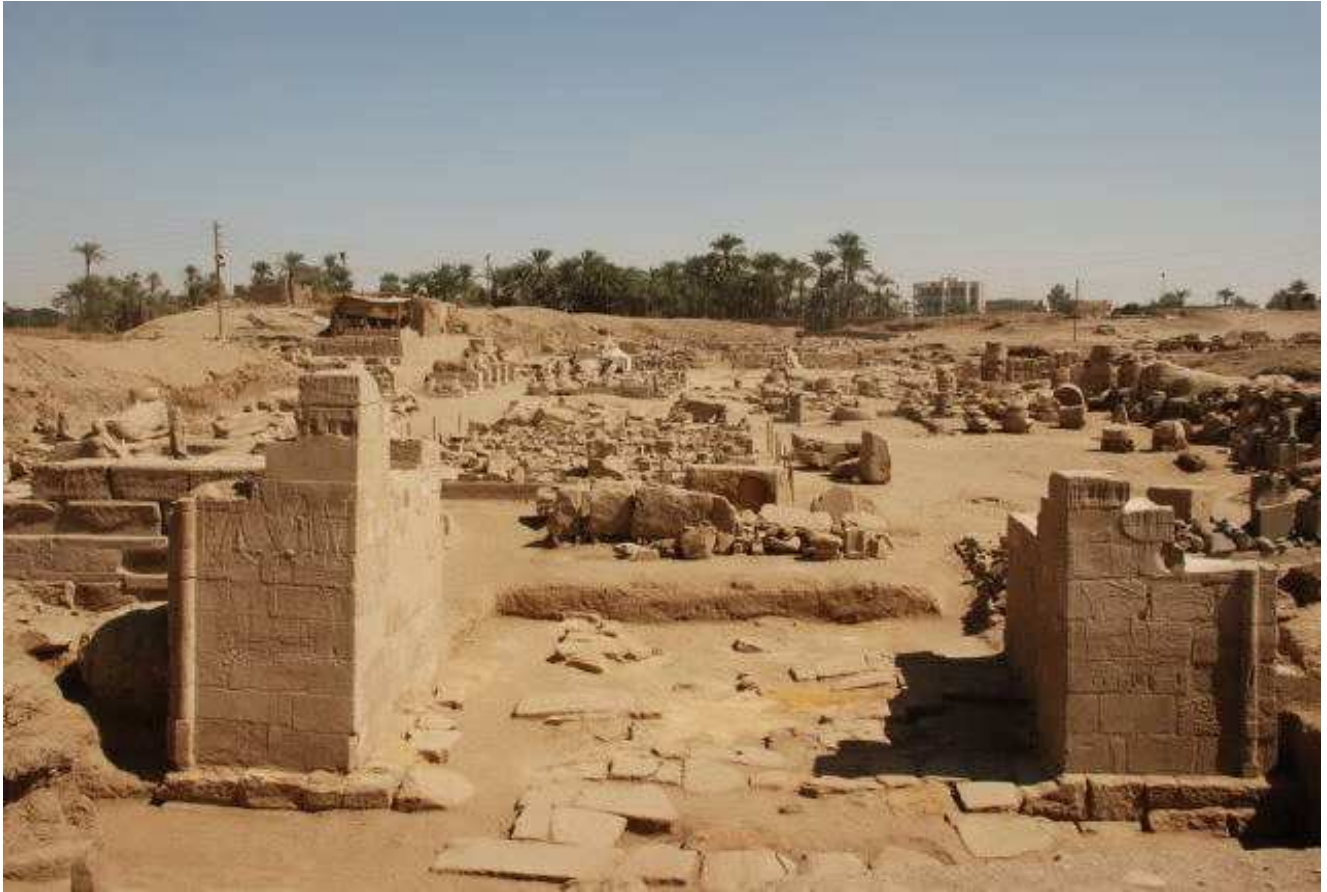
Fig. 35: Looking east through the restored Taharqa Gate, which opened a processional way to Temple A in the rear of the photograph.

Fig. 35 looks east across the paving of the approach to the Taharqa Gate and to Temple A to which the processional way led.
