The Brooklyn Museum's 2010 Season of Fieldwork at the Precinct of the Goddess Mut at South Karnak

by Richard Fazzini, Brooklyn Museum

The main emphasis of the Expedition's fieldwork in the 2010 Season was on the area of Chapel D and the Taharqa Gateway. We further excavated the walls built in and around both stone structures and between the Taharqa Gate and the baked brick building (probably a bath) to the south. The most significant result was confirmation of what we had long believed was true of the history of the Mut Precinct: it was not until the reign of Taharqa that the precinct was expanded to include the area between the First Pylon of the Mut Temple and the later north enclosure wall. In fact, the wall running north from the Taharqa Gate ran up to (and possibly under) the enclosure wall, while its southern wall ran to join the earlier Tuthmoside precinct wall running to the west end of the Mut Temple's First Pylon.

The main restoration/conservation project was reconstruction and re-erection of the small healing magic chapel of Horwedja before the east wing of the Mut Temple's First Pylon.

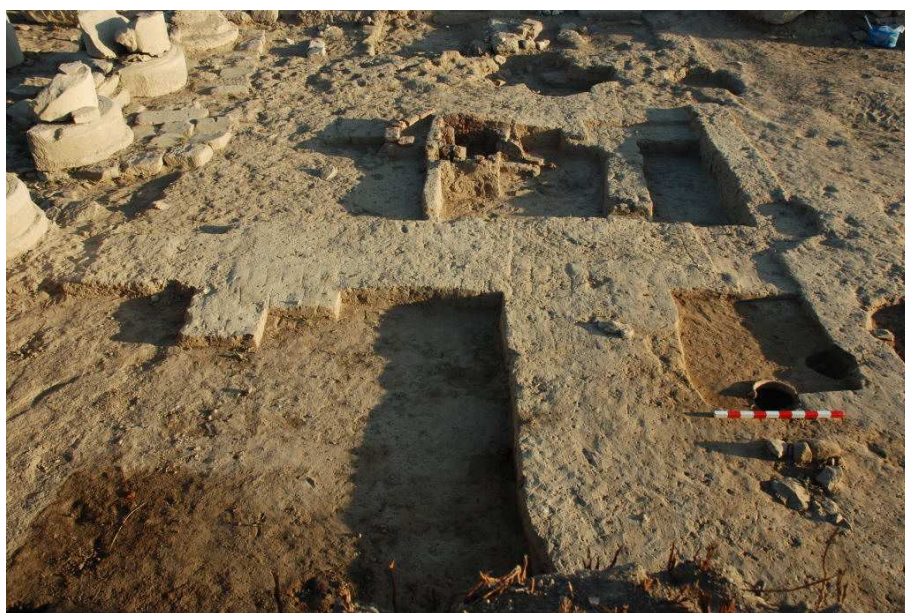
Fig. 2b View north of the area near the end of the season. The large bowl cut by the foundations of the later building is behind the meter stick.

what appeared to be the foundation level of the earliest structures. Our goal in 2010 was to define these remains further and map what is preserved. fig. 2a is a plan of the brick on this lowest level and fig. 2b shows the area at the end of the season, and.

The northern mass of mud brick seems to belong with the paving along its west edge, although that is not clear from the map as the western part of the brick was rather deteriorated. As can be seen in figs. 2b and 5a, the 2nd through 4th columns of the East Porch (counting from the north) were built directly on this paving, which continues across the width of the porch; it is a single course thick and rests on dirt. No trace of the paving has been found south of the 4th column within or east of the porch.

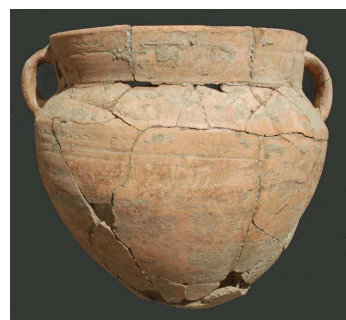
Fig. 2c The bowl restored.

The walls shown in grey on fig. 2a are a later phase, built partly over the earlier foundations. What is left of the south wall and southern part of the east wall are a single course deep, resting directly on earth. Projecting from the north side of the south wall was a large jar (visible in fig. 2b) whose rim was broken by the construction of the wall. The restored jar (fig. 2c) is 35 cm tall with a burnished orange slip inside the rim and over its edge.

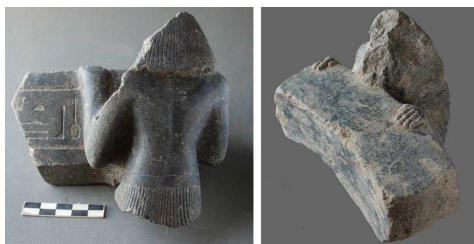
Fig. 3 Fragment of a diorite statue of a kneeling man holding a large bowl; found in the Roman Period pit north of the Mut Temple's First Pylon.

There are two main masses of brick. The northern mass was heavily damaged by Roman Period pits, in one of which this season we found part of a statue of a kneeling man holding a large bowl (fig. 3).³ Further exploration of the robbed out area confirmed that three courses of brick are preserved, with traces of the sand of the foundation trench.

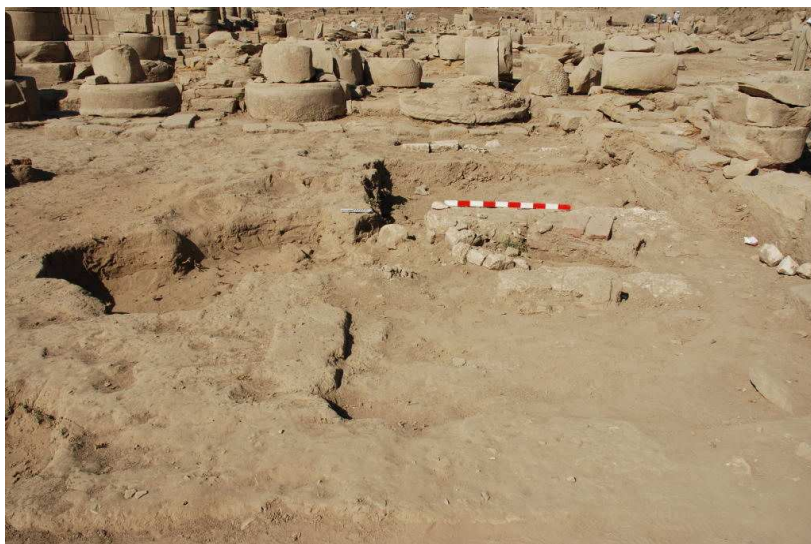
Fig. 4 View west across the northern mass of brick, with the East Porch in the background.

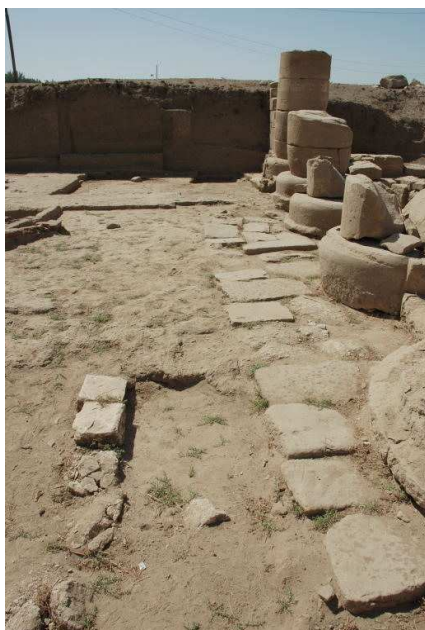
Fig. 5a (left) Looking south along the paving on which columns 2-4 of the East Porch was built.

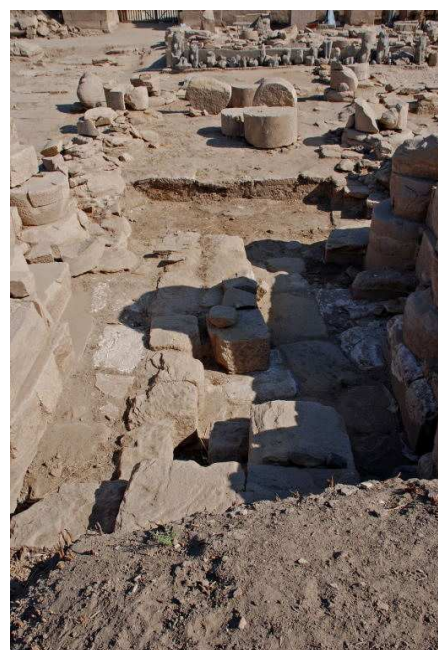
Fig. 5b (right) View north of the massive foundations of the southern section of the East Porch.

The west edge of the southern mass of brick, opposite the 5th column of the Mut Temple's East Porch, was probably cut during the construction of the southern part of the porch, which rests on a foundation of three courses of large blocks (fig. 5b), some bearing the name of Ramesses II. The brick here ends raggedly in a line of stone chips and debris that was also found further to the south. The patch of brick shown on the plan running north from the west end of the pylon is most likely a fragment of the wall of which only a stub remains running south from the south side of this part of the foundation.

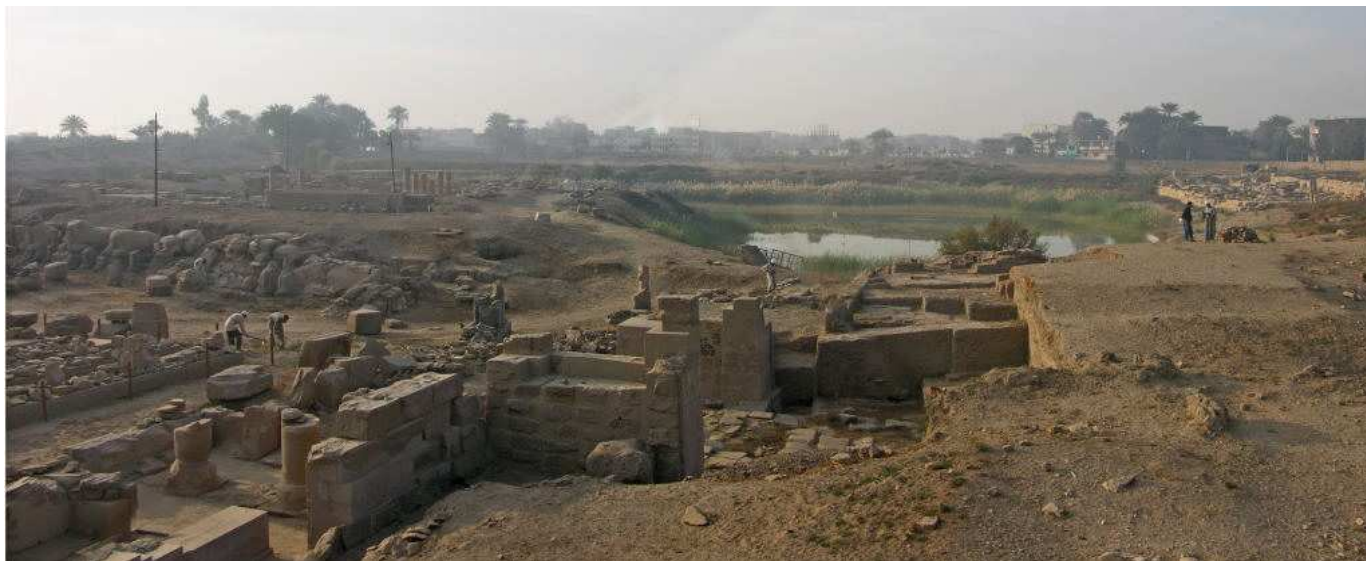
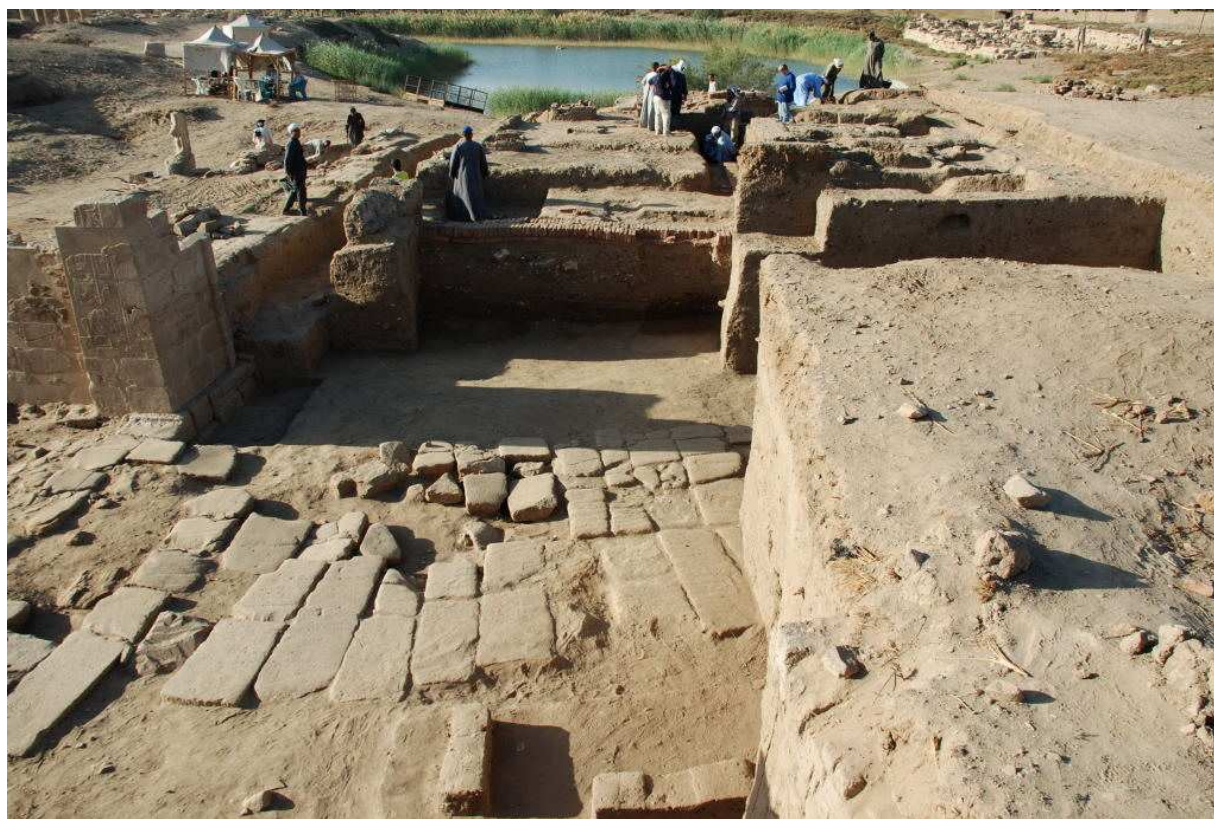
Fig. 8 A view to the south of the area of the Taharqa Gate at the beginning (top) and end of the 2010 season (bottom).

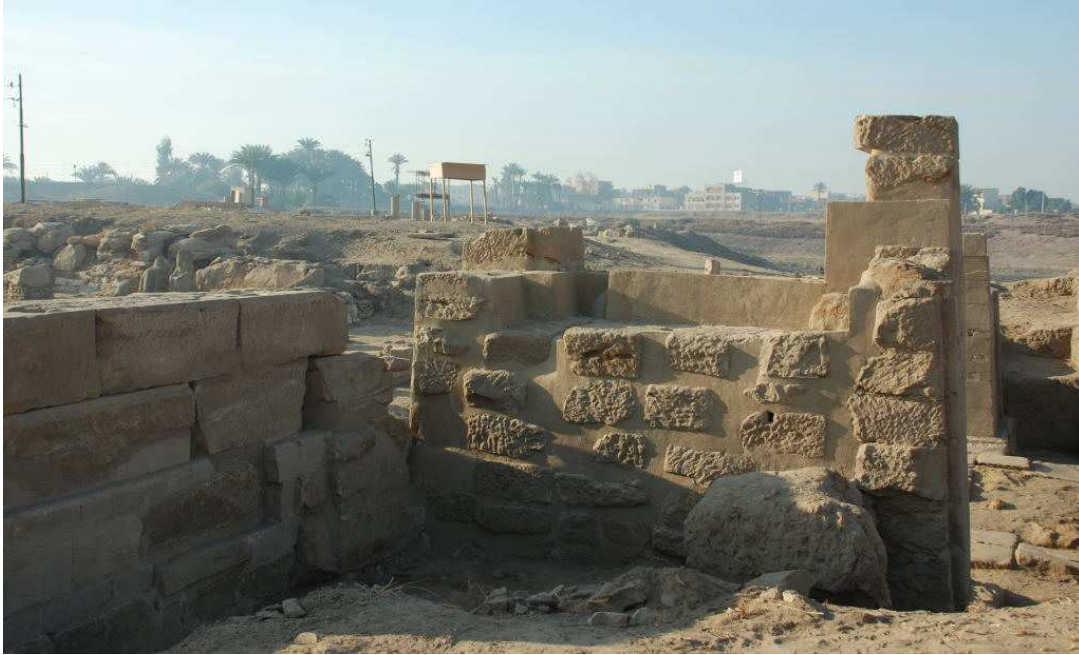
Fig. 9a North face of the Taharqa Gate at the start of the season. The patch of brick on the right is all that remained of the wall running north from the gate.

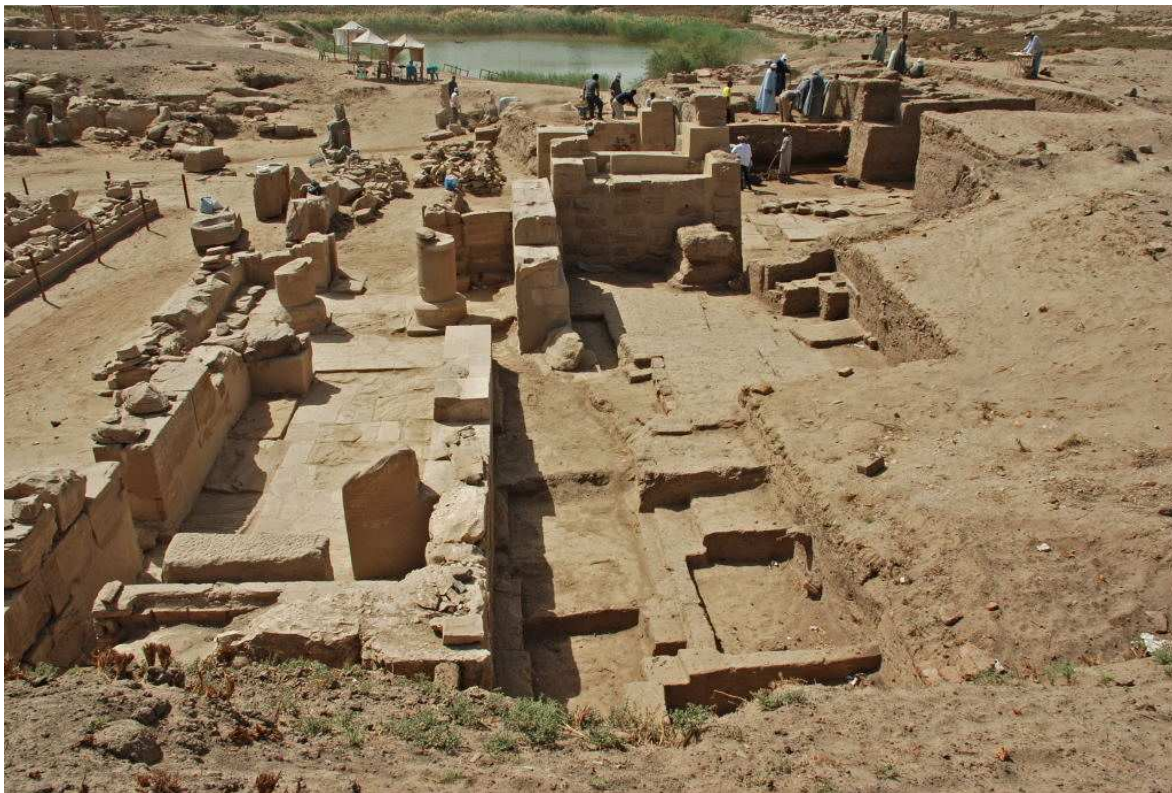
Fig. 9b The same area at the end of the season, seen from the northern enclosure wall. It shows the full width of the wall and the relationship between Chapel D (left) and the Taharqa Gate. The wall runs all the way to the current enclosure wall, built in Dynasty 30 or the early Ptolemaic Period.

In the southwest corner of the excavation two more walls projected from the west baulk and ran at generally the same angle as the north boundary wall of the approach to the gate (see figs. 6, 9b). The northern wall seems to have been cut by the construction of the Taharqa Gate wall. The southern wall, constructed of large, dark grey bricks, was built after the Taharqa wall was in ruins; its sand foundation lies on a layer of debris c. 30 cm above the preserved top of the Taharqa wall.

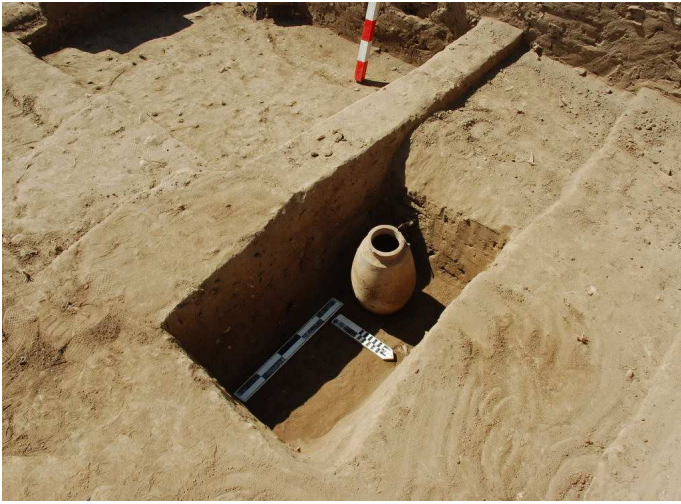
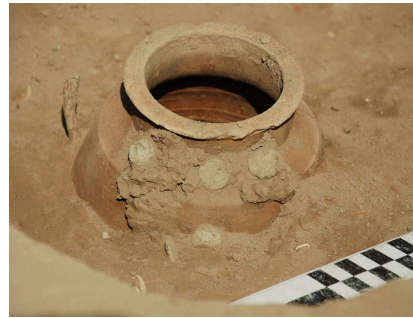
Fig. 10a shows the pit at the northern end of the Taharqa Gate wall and the jar against whose neck 13 Ptolemaic coins were found; (b) is some of the coins as found.

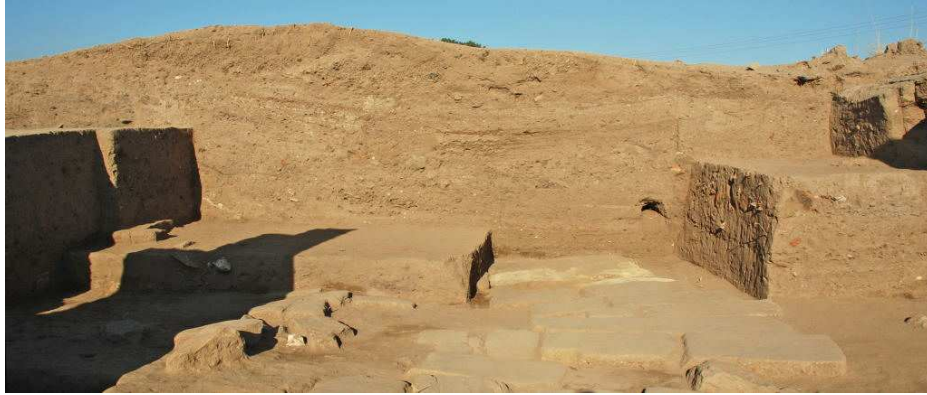
Fig. 11a A view west of the approach to the Taharqa Gate at the start of the season showing the unexcavated areas from 2009 on the left and right.

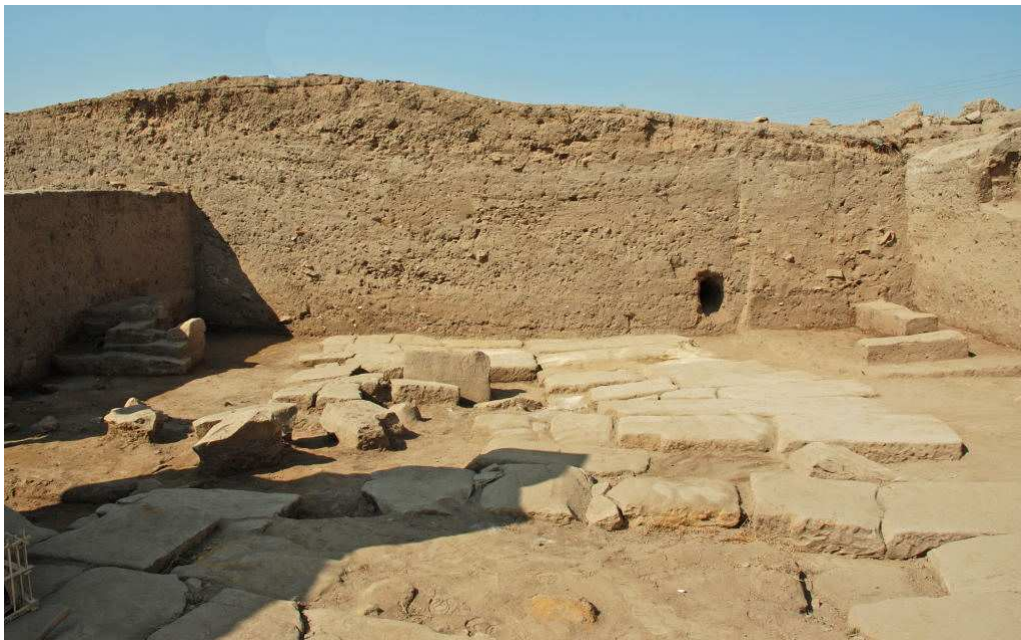
Fig. 11b The same area, cleared to the level of the paving; on the left are remains of an earlier mud brick structure over which the roadway's later south boundary wall was built.

On the surface north of the paving were stubs of three mud brick walls (figs. 6, 11b), but not enough is preserved to determine how they relate to each other. Traces of a layer of packed stone chips and small pot sherds similar to the very clear stone chip layer found in Area 2 south (described below) were also found.

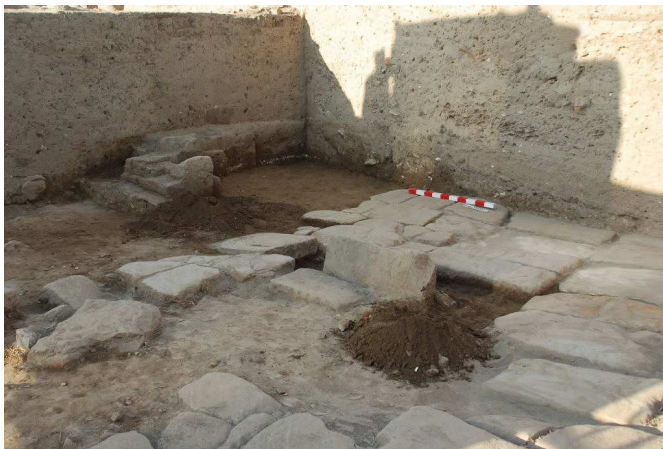
Fig. 12 A more detailed view of the earlier brick structure and the surface of packed earth and stone chips on a thin layer of sand at the level of the paving.

In *Area 2 south* we found the south edge of the paving under the remaining debris, as expected¹². It was in generally good condition, but with one block (visible in fig. 12) standing on edge. Rather than running directly west from the Taharqa Gate, the paving angles toward the south. Excavation further to the west (see below) confirmed this direction, which is clearly visible in figs. 6 and 20.

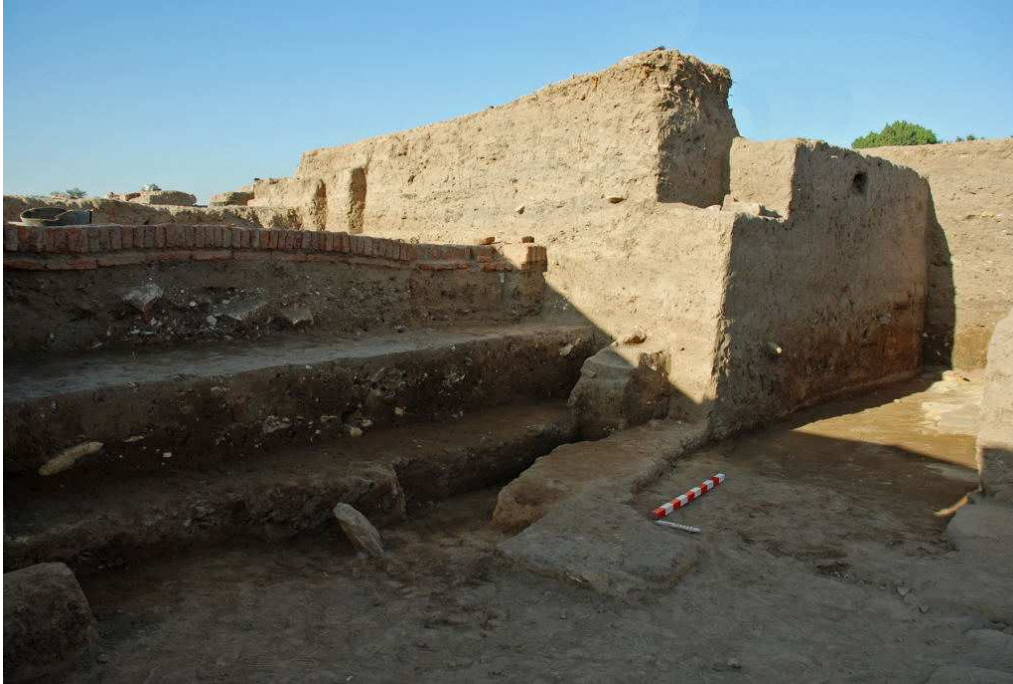
Fig. 14 This view to the southwest was actually taken after fig. 15. The stone chip, packed earth and sand on which the earlier mud brick structure stood (foreground) continues along the south baulk of Area 2 West.

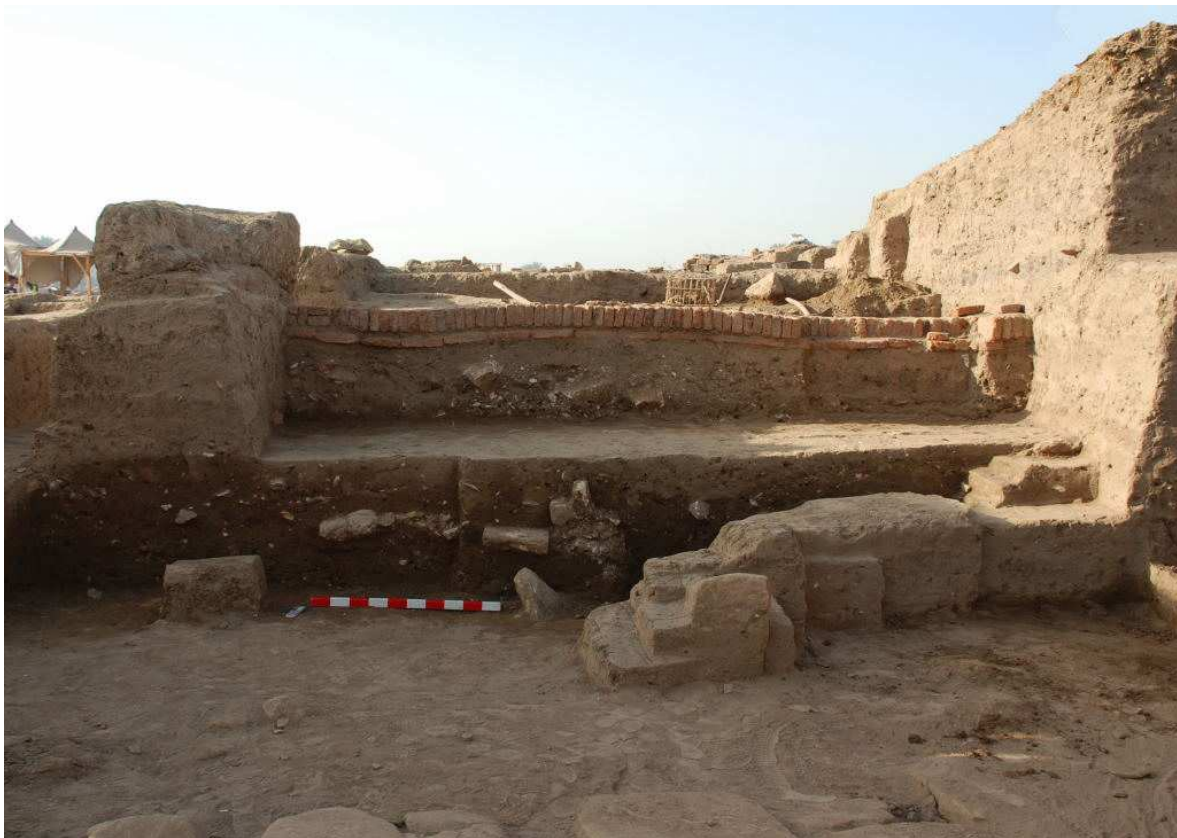
Fig. 15 With the south boundary wall removed, the stone-filled earth on which it was built can be seen clearly. All that remains of the earlier building are the stub on the left and the longer portion on the right.

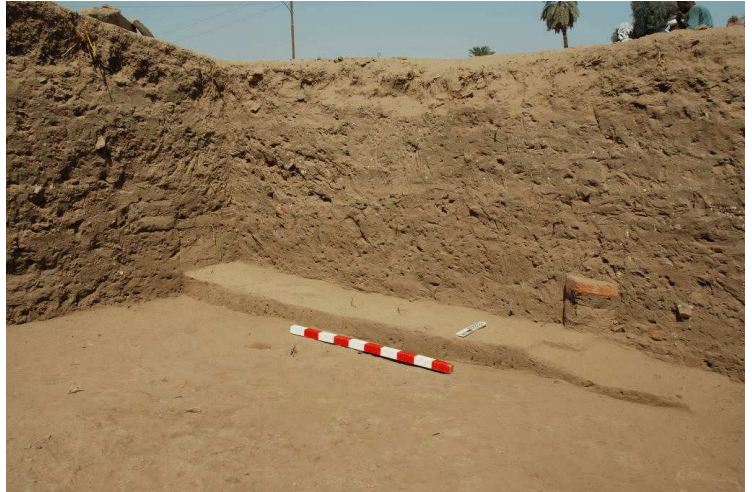
Fig. 17 The mud brick wall along the north baulk of Area 2 West.

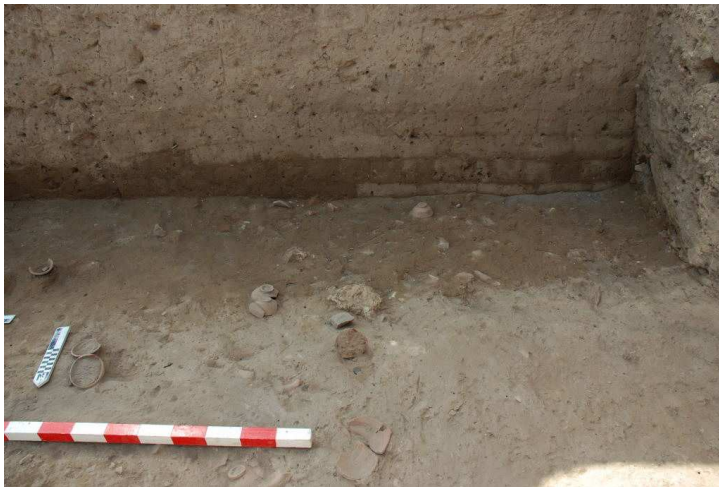
Fig. 18a The pottery concentration at the south side of the square west of the Taharqa Gate opened in 2010.

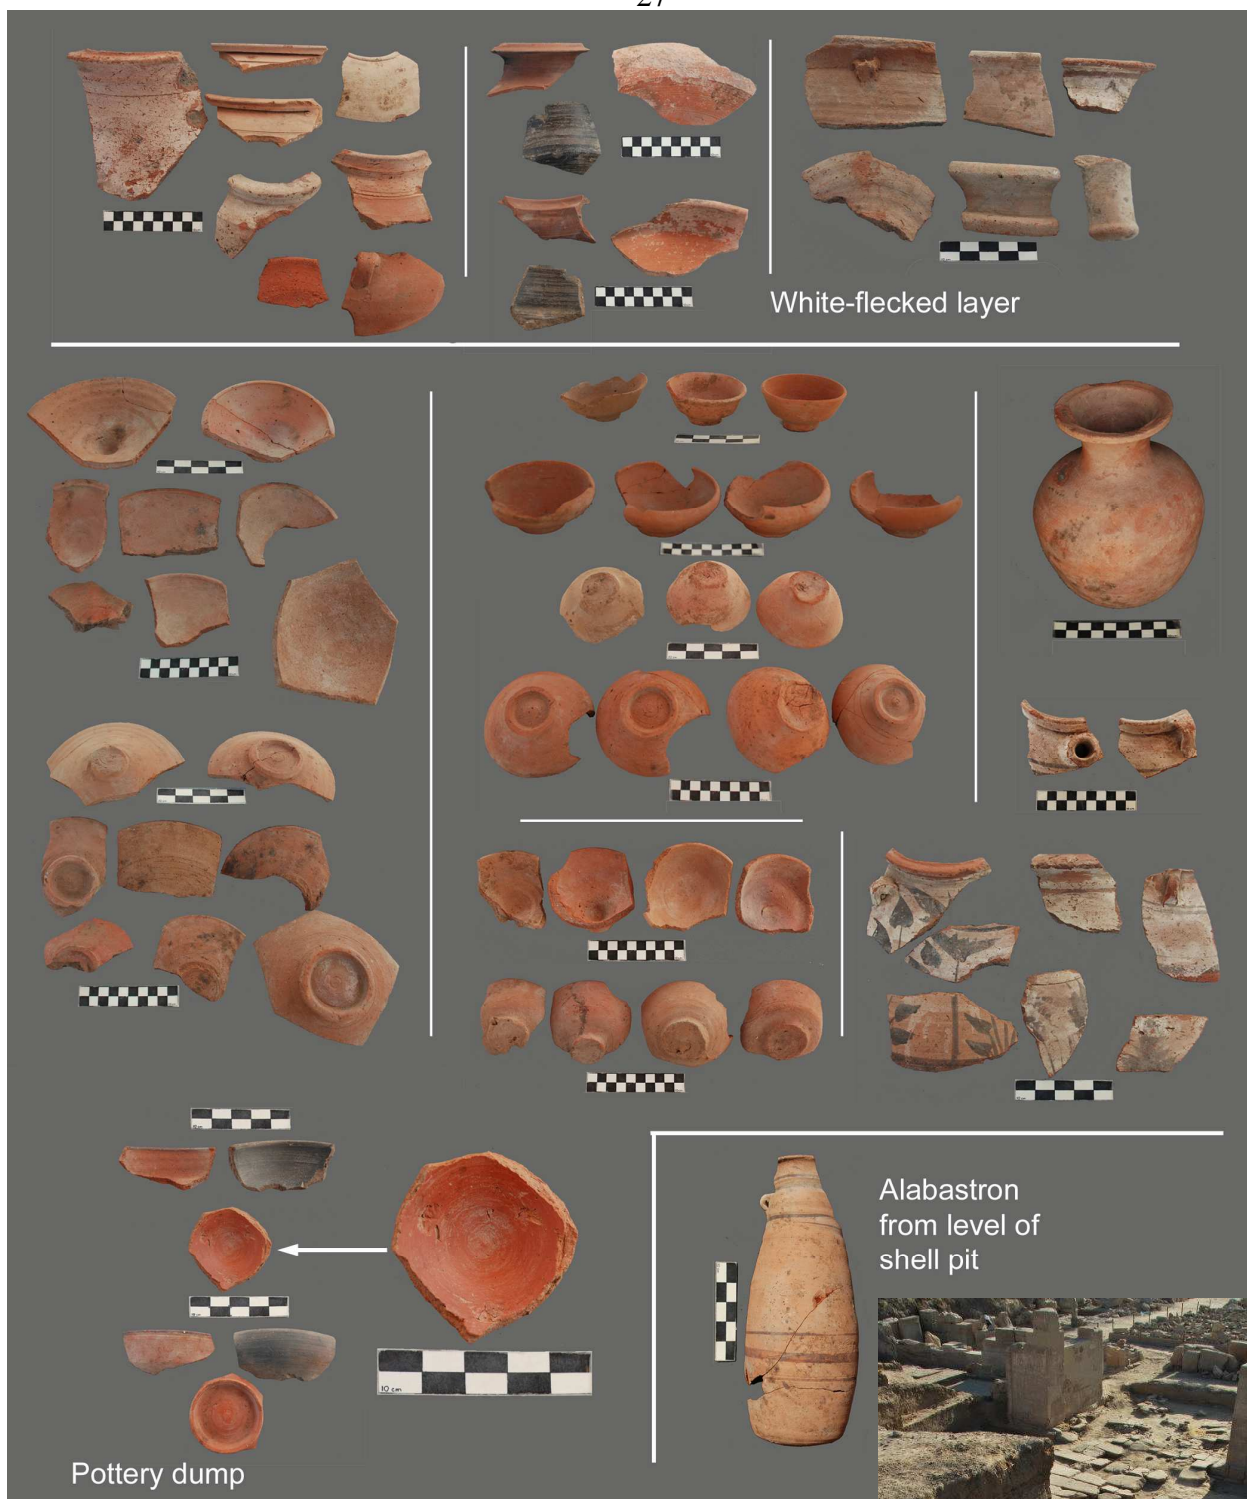
Fig. 19 Pottery from Area 2 West. The jar and the fragment of a bowl with stamped decoration are at a larger scale. For some vessels both interior and exterior are shown.

Below the modern surface was over a meter of the same white-flecked fill that we found in *Area 2* in 2008-2009. It contained a number of broken and unidentifiable bits of faience, bronze (including 4 indecipherable small coins), glass and bone as well as a few more complete objects illustrated here as fig. 17: a faience amulet of a kneeling ram, the crossed paws of a reclining lion figure, and a fragment of a bronze aegis (very corroded) of Mut and possibly Horus¹⁴. The pottery from this stratum seems generally to be late Ptolemaic-early Roman (see fig. 19).

(fig. 18d), and a ceramic alabastron very similar to examples published by Schreiber¹⁵ (fig. 19). To the east a similar clay-lined pit projected from the north baulk. At 30 cm below the “oyster pit” (i.e., c. 40 cm above the paving) was a scattering of broken baked brick, some of which formed 2 apparently parallel rows running north from the boundary wall. A few large pieces of broken sandstone and large potsherds were also found at this level, recalling the mixture of pottery, brick and stone found at the same level in Area 2 last year.¹⁶

A selection of pottery from Area 2 West is shown in fig. 19. Parallels to these vessels were found at Karnak, Elephantine, Coptos and Athribis.¹⁷ The painted sherds seem to be Schreiber’s early Floral Style A,¹⁸ although the shoulder fragment with the floral decoration painted directly on the uncoated clay rather than on a white slip is unusual¹⁹. The fragment of a spouted vessel resembles his linear style A²⁰. All of these parallels suggest a possible date of late 3rd-early 2nd century BC, which fits with pottery found in the area in earlier seasons.

We were only able to excavate the southern half of this square all the way to the paving, which continues the southward curve noted earlier (fig. 19).

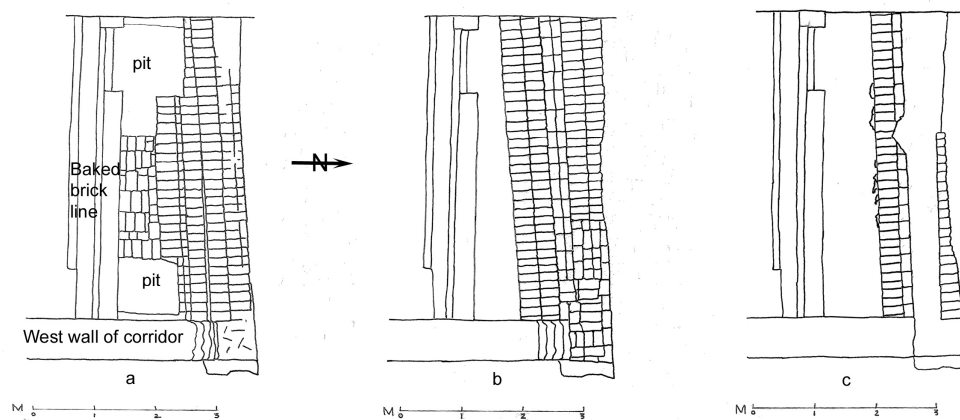
Fig. 21a-c Three phases in the construction of the eastern portion of the south boundary wall from latest (left) to earliest (right). (Plans drawn by W.H. Peck)

This part of the boundary wall was constructed in several phases, shown in figs. 21a-c (plan) and 22a-c. At the highest level preserved, the northeast corner, where the boundary wall should intersect the corridor wall, had sustained some damage. Once this was cleared, however it could be seen that the boundary wall and the west wall of the corridor were contiguous, suggesting the two walls are contemporary.

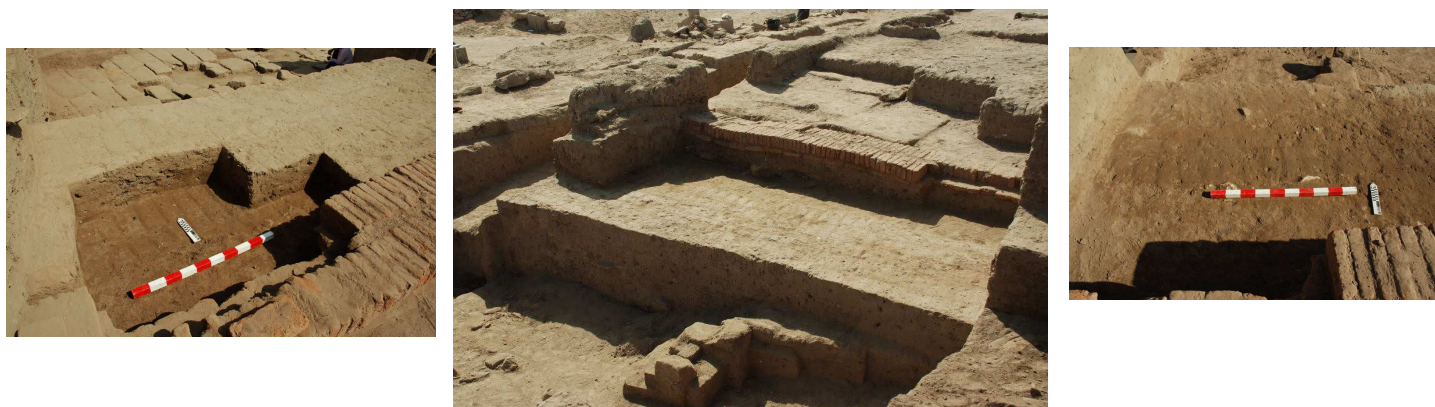
Fig. 22a-c Three phases in the construction of the south boundary wall, corresponding to fig. 21a-c. (a) Shows the brick at the bottom of the west pit of fig. 21a.

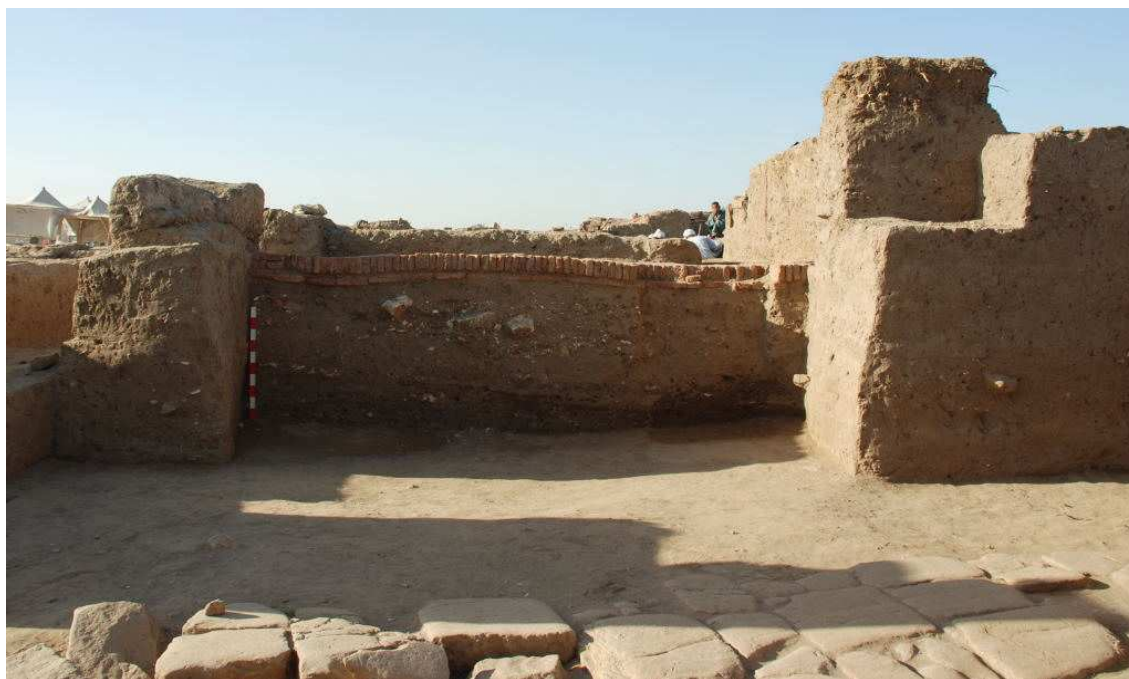
Fig. 23 The area of the south boundary wall at the end of the season showing the west wall of the corridor (left), the line of baked brick (center); and the continuation of the boundary wall to the west (right).

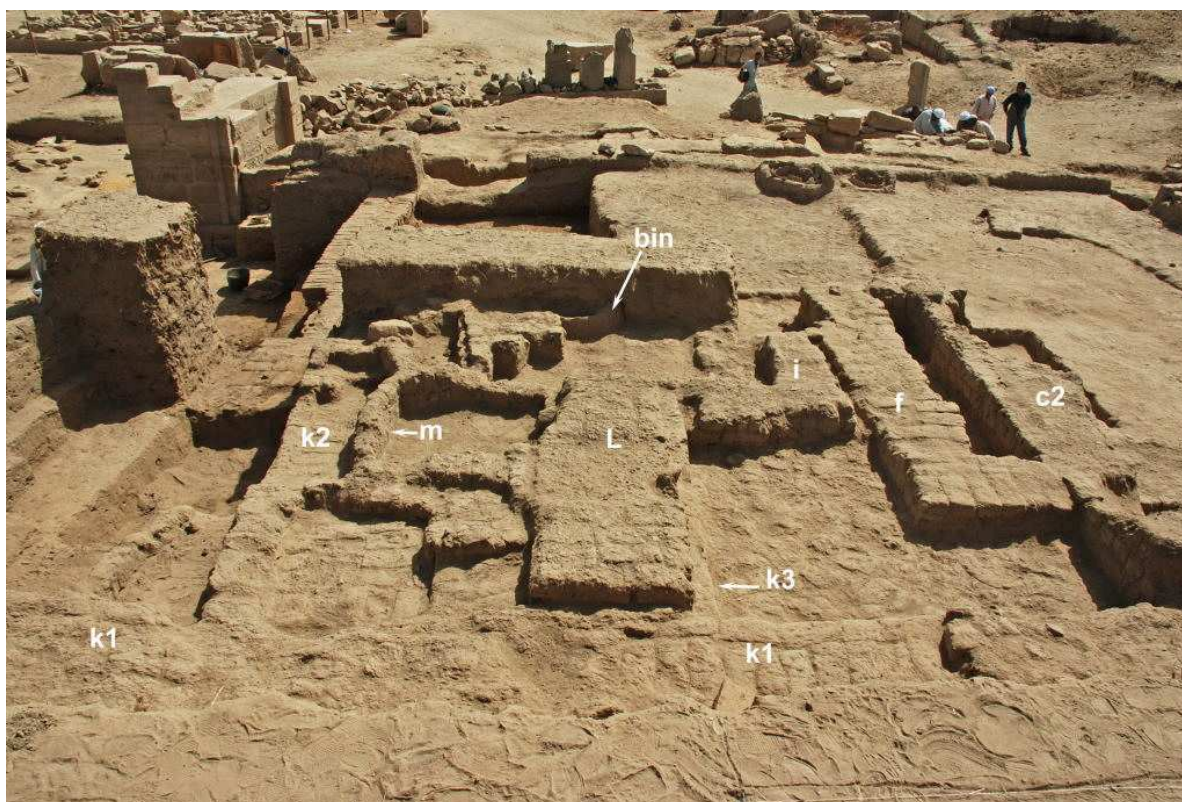
Fig. 24 Looking east across Area 3 West (left) and Area 1 West near the end of the season, with the lowest level of the south boundary wall is at the left. The section through the baulk exposed the corner of the baked brick line.

In 2010 we laid out a 5 m E-W x 4 m N-S square (*Area 3 West*) south of *Area 2 West* (fig. 7). The south baulk, between Area 3 West and Area 1 was removed early on in order to allow us to link the structures being uncovered with those found last year in Area 1. Eventually we expanded the west baulk of Area 1 to the line of the west baulks of the rest of this season’s excavations; this area is referred to as *Area 1 West*. Fig. 24 shows Area 3 West and the northern part of Area 1 West near the end of the season.

Wall (i), protruding from Area 1's north baulk, had decayed since 2009; the portion in grey on fig. 7 indicates all that remains. Although damaged, it did turn north and meet the south face of wall (L) (fig. 24).

Below wall (n) the mud brick collapse spilled into the space between walls (k1) and (f) from the south face of wall (L) to the extended north face of (c2). This brick contained a heavy concentration of thick, white plaster with traces of red, black and yellow paint (fig. 28) although no plaster was found on the east face of wall (k1) itself; additional traces of plaster were found atop the N-S portion of (i) as well. This plaster seems to be the same in thickness and composition as the plastered portions of the probable bath²² to the south. Beneath the plaster debris we found the south face of the earlier wall (k3) on which wall (L) was built (visible in fig. 24).

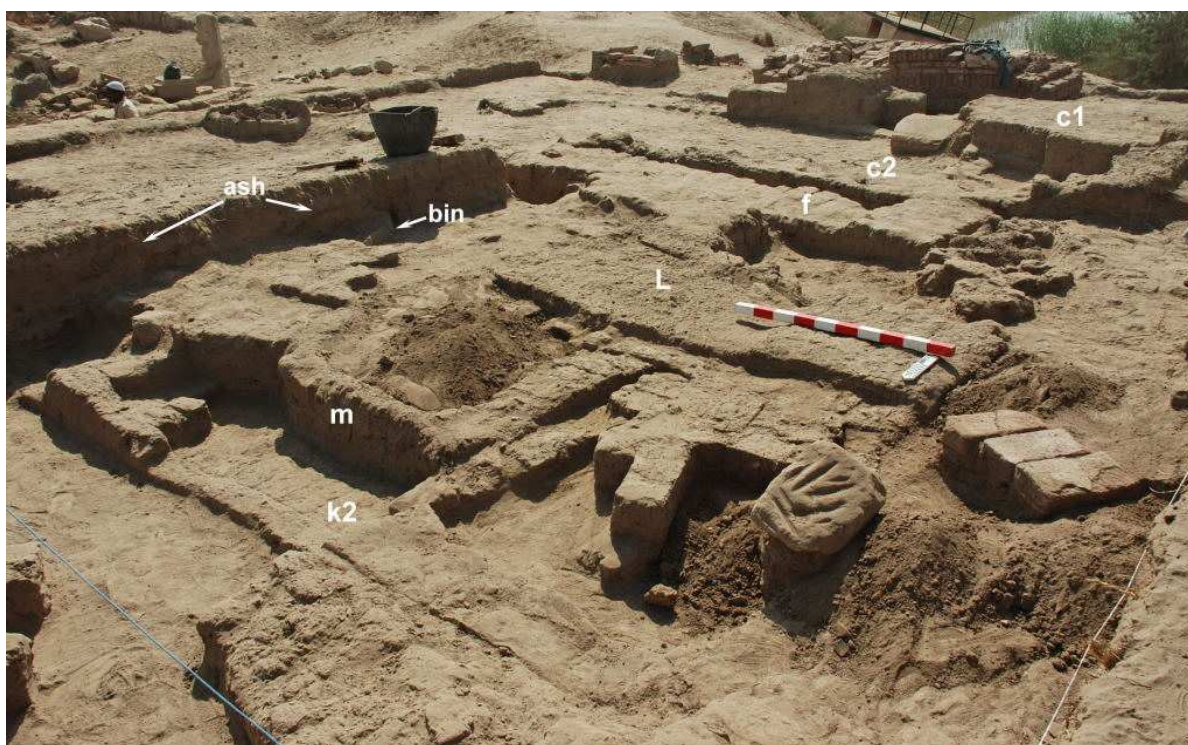
Fig. 25 Area 3 West seen from the northwest early in the season. The north part of wall (L) has been removed, revealing more of wall (m), with collapsed brick to the right and left.

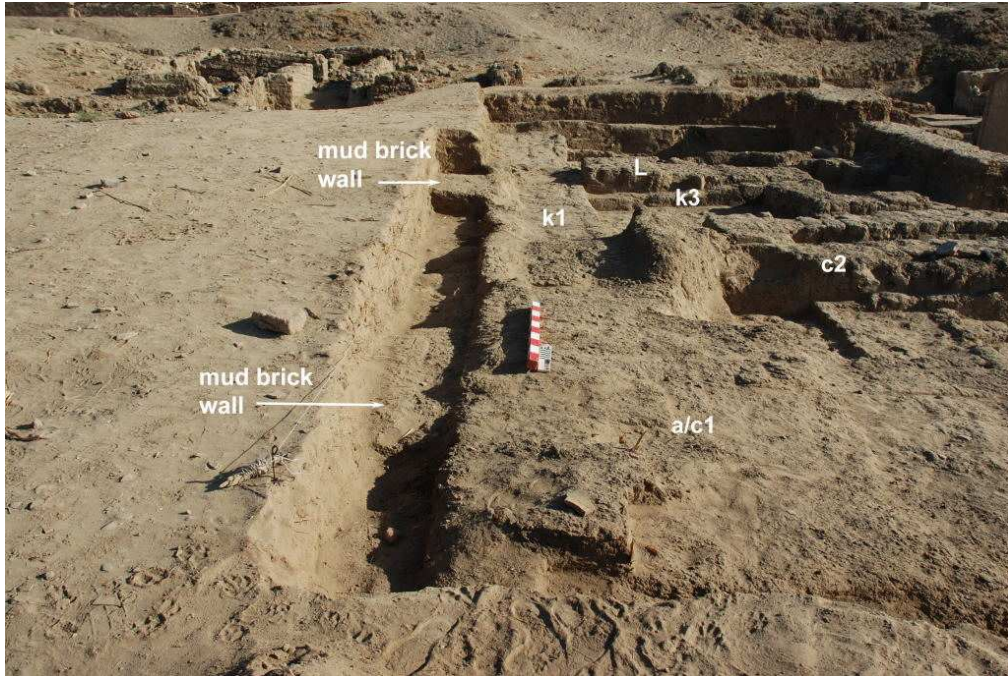
Fig. 26 A view north along the west face of wall (k1), with two lines of brick running into the west baulk. The corner with wall (a)/(c1) is in the foreground.

Below the decayed brick along the west baulk the well-preserved, 105 cm-wide wall (k1) eventually ran the full length of the area to the south side of walls (a)/(c1), with which it may form a corner (fig. 26); more of the decayed upper brick will have to be removed to confirm this. The cross wall linking walls (c1) and (c2), which had eluded us last year, was found under the 2009 baulk. Although partly cut by an animal hole it clearly meets the east face of (k1).

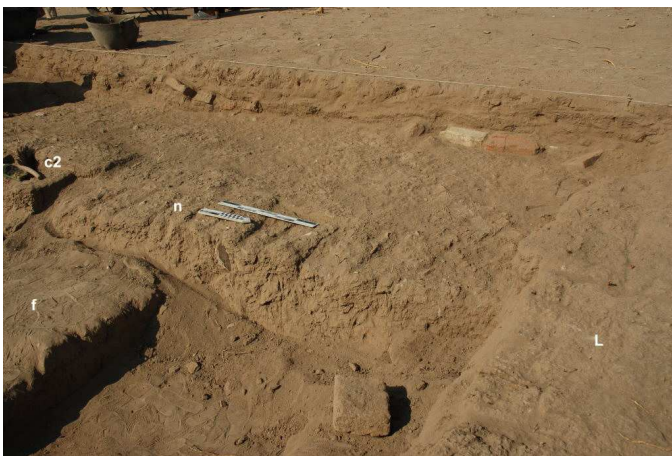
Fig. 27 The decayed brick of wall (n) running from (c2) to (L) and the row of baked brick and stone along the west baulk.

Fig. 27 and the inset of fig. 7 show the area between wall (L) and the extension of (c1) early in the excavation. Along the west baulk a line of baked brick and stone extends 4 m south from the southwest corner of wall (L) (with a 1 m gap between the north and south sections); it may be associated with the 1-course thick wall (n) to the east that runs from the north face of (c2) to the south face of wall (L). Only 3 rows of this wall could be distinguished with any confidence. When we extended Area 1 West 70 cm the west we found that the line of baked brick and stone sits directly on the stretchers forming (k1)'s west face. Two lines of brick run west from (k1) (fig. 26), but only the one north of the gap was distinct enough to be mapped precisely. It is 3 rows wide and, as can be seen in fig. 7, the northern row lines up with the stone of at the south end of the first section of brick, suggesting a threshold.

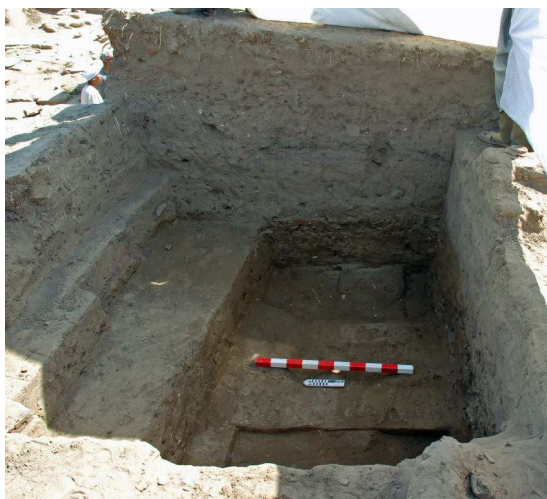
The sounding in the northeast corner of Area 3 West. The south face of the south wall is on the left, with earlier walls

A mud brick wall running from the south face of the boundary wall to the south baulk of the sounding was found a few courses lower with a second wall running into the east baulk from its east face (fig. 30). We found no trace of the mound of broken stone on which the eastern portion of the boundary wall was built.

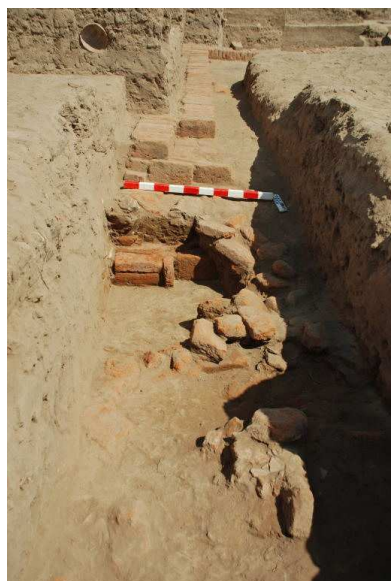
Fig. 31 The break in the N-S line of baked brick, where the feature is at least 5 courses deep.

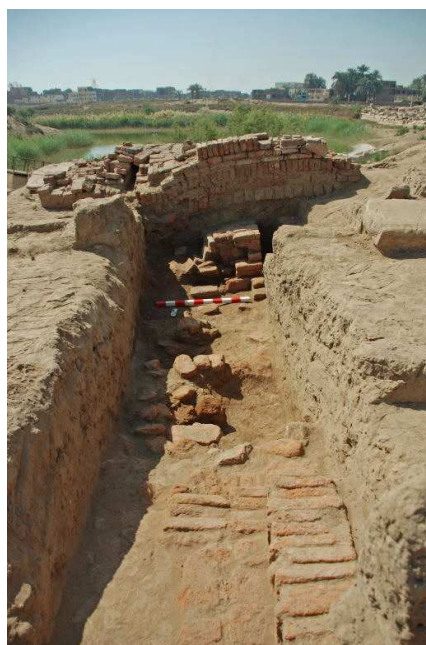
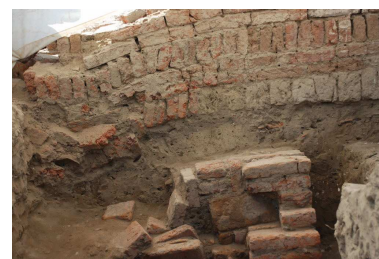
Fig. 32a (left) looking south along the break in the N-S line of brick to the rectangle of brick at the south end; (b) shows the slippage of the bath and rectangle of brick and the discontinuity in the ash layer more clearly.

The E-W line is made up of 2 headers laid on edge with a stretcher, also on edge, between them and a second course of stretchers laid flat; the N-S line omits the intervening row of stretchers (see figs. 6, 7) and is also 2 courses deep for most of its length. At c. 6 m from the northwest corner the upper course is missing, revealing a lower course that extends the east face of the line another half-brick. Where the line is finally broken slightly further south, it is not only wider than the northern section but is also at least 5 courses deep (fig. 31). For 4 m south of the break there is only a jumble of broken brick, terminating at baked brick rectangle 90 cm N-S x 70 cm E-W and lying c. 25 cm north of the bath and 30 cm below its foundations (fig. 32a). Eight courses of baked brick remain here, making the rectangle 4 courses taller than the rest of the wall. Its west face is on the line of the west face of the wall north of the break. The whole feature has slipped to the east along the same line as the collapse of the bath to the south and the discontinuity in the ash layer below the bath's foundations (fig. 32b).

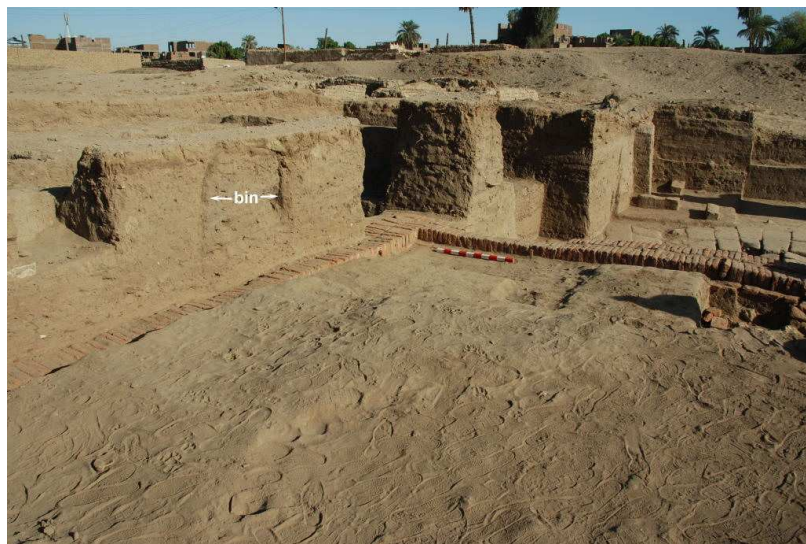
Fig. 33 General view to the northwest of the lines of baked brick at the end of the season. The profile of the large bin whose west side is in Area 3 West is visible in the baulk.

Fig. 33 shows most of the 2 baked brick lines at the end of the season. While these brick rows clearly define an area bounded on the east by the west wall of the Taharqa Gate corridor, they remain puzzling. The brick is solid, so cannot be a drain. The abrupt end of the N-S section not only north of but significantly below the bath provides no further clue, although it does suggest the bath is a later construction. No trace remains of any superstructure, whether baked or mud brick. It lies under c. 30 cm of earth above which is a thick layer of pale grey ash that runs across most of the area west of the Taharqa Gate corridor wall, becoming thinner toward the south. The pottery and small finds of 2009 from the ash and the earth below (including a stamped amphora handle),²⁴ and the faience bowl fragment from below the large storage bin, whose profile is visible in the baulk in fig. 33, all suggest a Ptolemaic date for its creation but not a purpose.

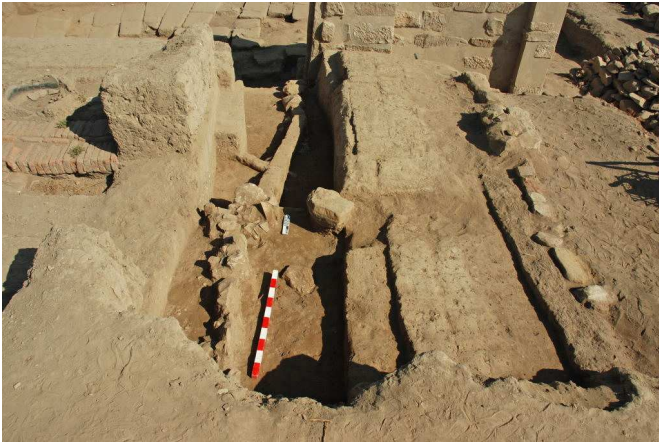
Fig. 34a The north end of the corridor at the start of work, showing the curving mud brick wall and its southern stone extension.

In 2010 the expedition cleared the corridor between the wall running south from the Taharqa Gate and the mud brick wall to its west that was the eastern limit of the 2009 excavations. At the north end we found the lowest course of the damaged east face of the south boundary wall. Abutting its south side is a row of mud brick laid as headers that makes the corridor narrower at its entrance than its otherwise uniform 130 cm width (see fig. 7). To the east of and about 2 courses below the top of this wall a curving line of mud brick one course deep with blocks of stone at its north and south ends ran NE-SW across the corridor, its southern end seems to continue in a ragged line of broken limestone (fig. 35a).

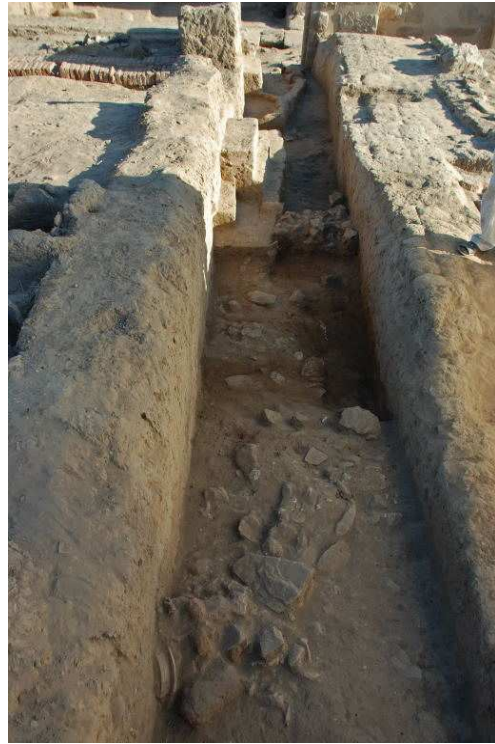
Fig. 34b Looking north along the corridor. At the north end (rear) mud brick walls partly block the corridor, with broken stone and earth around them continuing to the south (foreground).

An uneven stratum of large and small pieces of stone mixed with pottery filled the corridor, covering and surrounding both the line of brick just described and a mud brick wall to its south that was built against the face of the corridor's west wall and filled about half the corridor's width (fig. 34b). As can be seen in fig. 34b, this wall had been quite cut up. It was built on a thick layer of stone chips (distinct from the stony debris around it) that filled the width of the corridor and was the foundation for the central portion of the corridor's west wall as well (fig. 34c). This layer is probably part of the mound of broken stone on which the south boundary wall of the Taharqa Gate roadway was also built. The north and south ends of the corridor wall, however, were solid mud brick to the
