The Brooklyn Museum's 2010 Season of Fieldwork at the Precinct of the Goddess Mut at South Karnak

by Richard Fazzini, Brooklyn Museum

The main emphasis of the Expedition's fieldwork in the 2010 Season was on the area of Chapel D and the Taharqa Gateway. We further excavated the walls built in and around both stone structures and between the Taharqa Gate and the baked brick building (probably a bath) to the south. The most significant result was confirmation of what we had long believed was true of the history of the Mut Precinct: it was not until the reign of Taharqa that the precinct was expanded to include the area between the First Pylon of the Mut Temple and the later north enclosure wall. In fact, the wall running north from the Taharqa Gate ran up to (and possibly under) the enclosure wall, while its southern wall ran to join the earlier Tuthmoside precinct wall running to the west end of the Mut Temple's First Pylon.

The main restoration/conservation project was reconstruction and re-erection of the small healing magic chapel of Horwedja before the east wing of the Mut Temple's First Pylon.

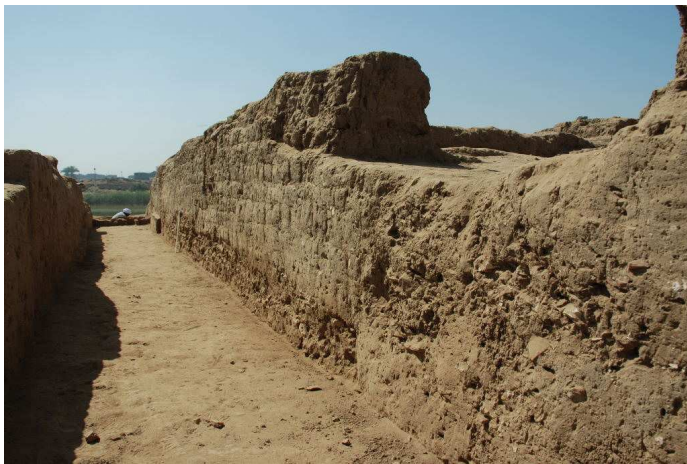
Fig. 34c The west wall of the corridor and the stone chip layer on which it was partly built.

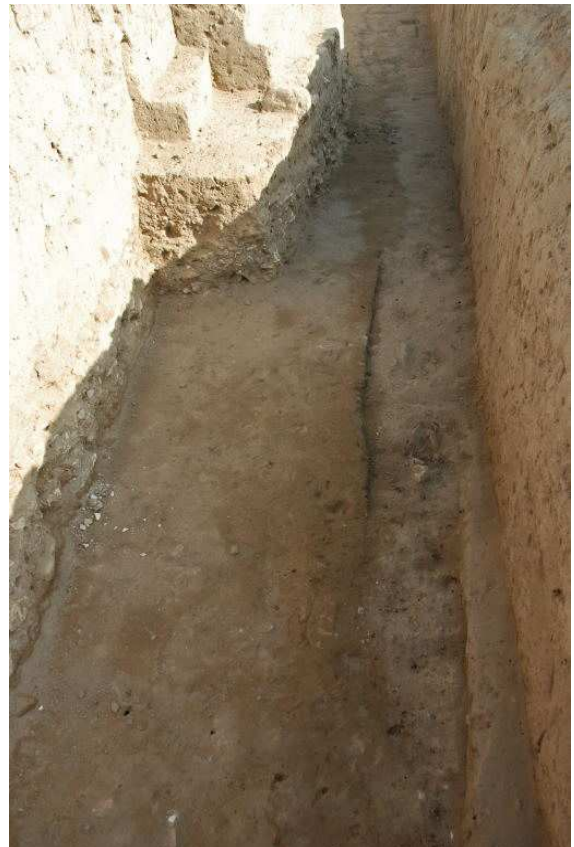
Fig. 34d View north of the relatively clean earth under the stone chip layer on which this part of the corridor's wall was built, cut on the east by a line of lighter earth with a few fragments of stone.

Beneath the stone chips was a layer of dark earth that ran east about 2/3 across the corridor before being cut by a line of greyer earth with some stone chips. This demarcation runs most of the length of the corridor (fig. 34d). It looks like a foundation trench for the Taharqa Gate wall, but is at about the middle of the lowest course of the gate itself.

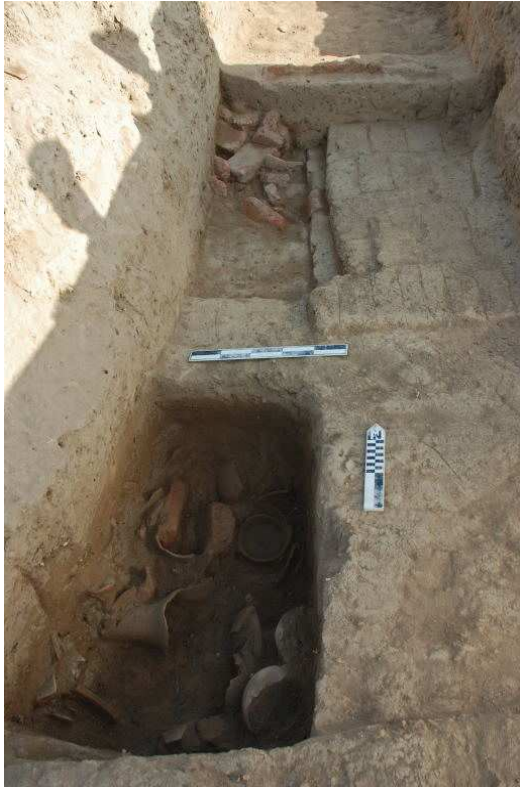
Fig. 35 The south end of the corridor cut by a pit with Roman pottery (foreground) and a fall of baked brick (center). A narrow line of baked brick runs across the corridor north of the pits.

In 2010 the expedition cleared the corridor between the wall running south from the Taharqa Gate and the mud brick wall to its west that was the eastern limit of the 2009 excavations. At the north end we found the lowest course of the damaged east face of the south boundary wall. Abutting its south side is a row of mud brick laid as headers that makes the corridor narrower at its entrance than its otherwise uniform 130 cm width (see fig. 7). To the east of and about 2 courses below the top of this wall a curving line of mud brick one course deep with blocks of stone at its north and south ends ran NE-SW across the corridor, its southern end seems to continue in a ragged line of broken limestone (fig. 35a).

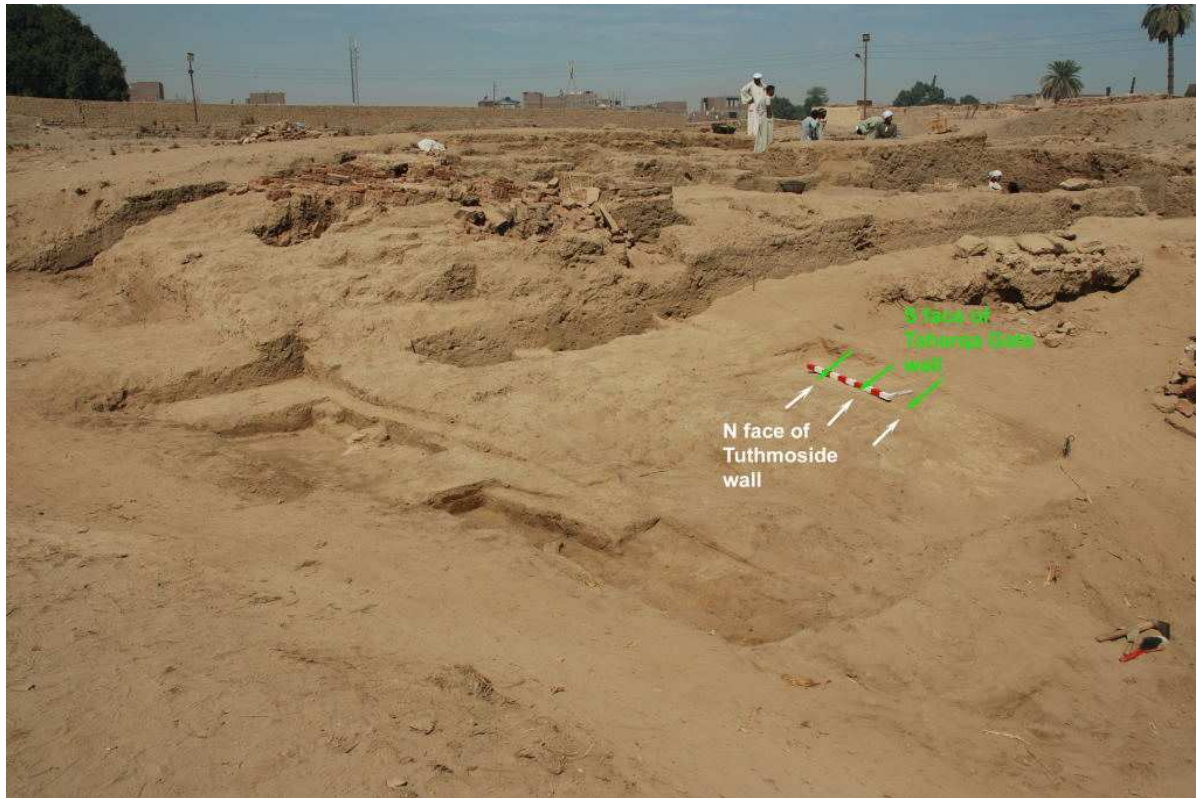
Fig. 36a The point at which the Taharqa Gate wall meets the Tuthmoside enclosure wall. Later mud brick walls built against the south face of the Tuthmoside wall are on the left.

The bath excavated in 2009 at the south end of Area 1 and visible in fig. 36a-b is built in part on top of the remains of the Tuthmoside enclosure wall. At least a portion of this wall was still in use during the Ptolemaic and early Roman Period as we found debris dumped over the south side, which we were able to trace to the east.

It has always been our theory that the Tuthmoside enclosure was still functioning as the north limit of the precinct when Taharqa built his gate, and that the gate's south wall abutted the Tuthmoside wall. In 2010 cleaning the tops of the preserved walls in the area revealed the point at which the Taharqa Gate wall meets the Tuthmoside wall (fig. 36a). Although the Tuthmoside wall was badly eroded, we were able to follow it further to the east than in the past (fig. 36b), confirming that its south face lines up with the wall running west from the present First Pylon of the Mut Temple (fig. 36c). Traces of later walls running south from the south face of the Tuthmoside wall are indicated on figs. 6-7 and are visible in fig. 36a-c.

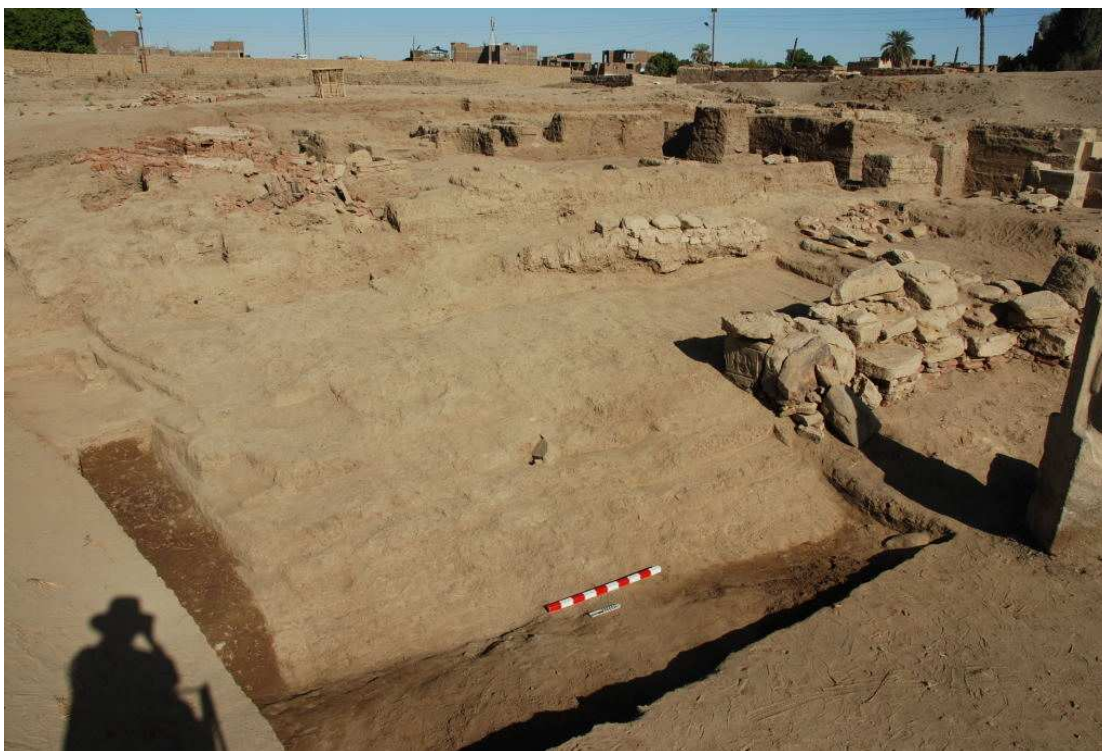
Fig. 36b The southeast corner of the Tuthmoside enclosure wall.

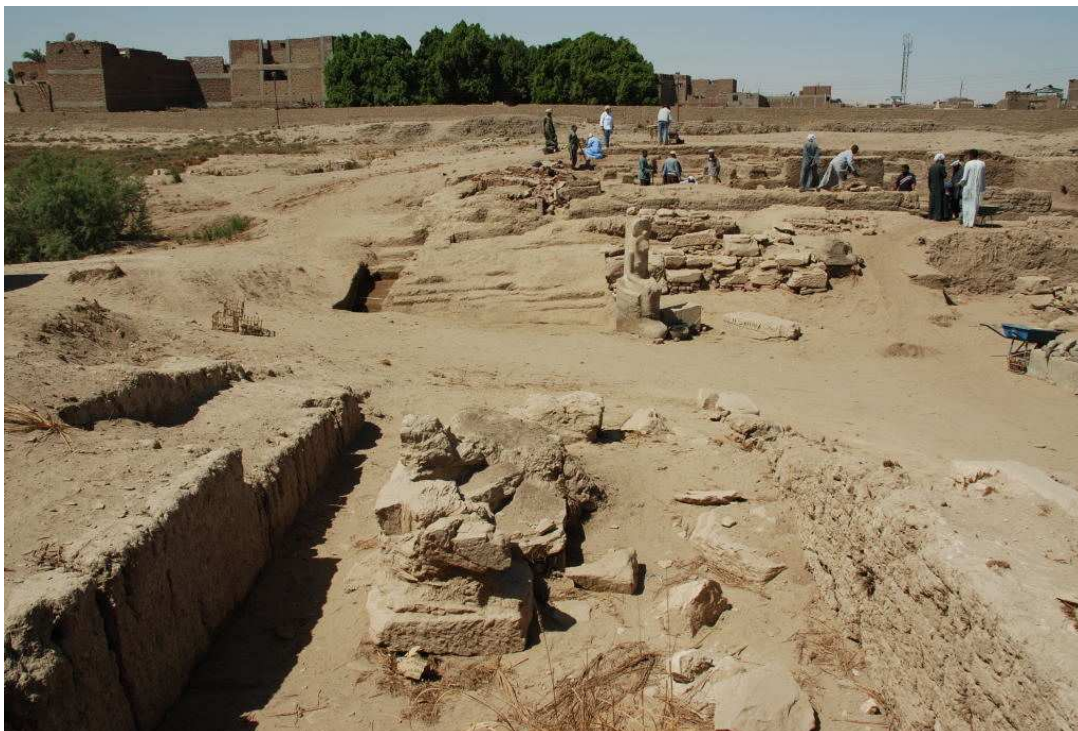
Fig. 36c Looking west at the Tuthmoside enclosure wall from the Mut Temple's First Pylon.

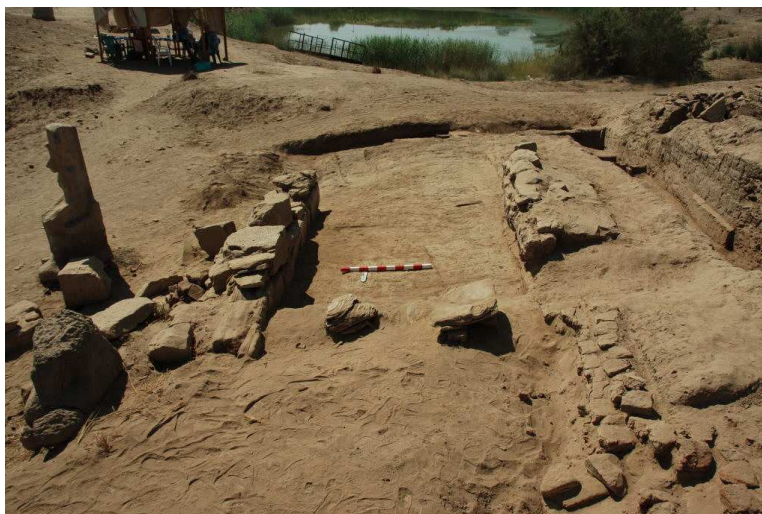
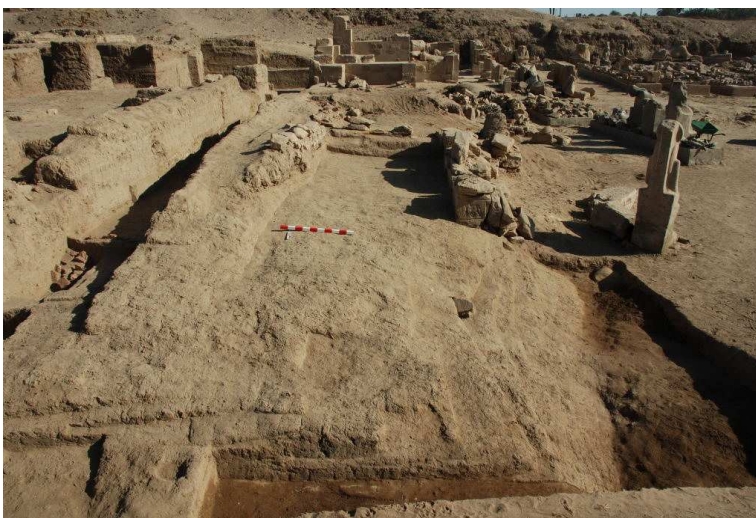
Fig. 37 View south (top) and north (bottom) of the later stone and brick walls built atop the Taharqa Gate's south wall.

On top of the southern Taharqa Gate wall are two parallel walls with a connecting cross-wall (fig. 37a-b), all built of a mixture of baked brick and stone, mainly re-used blocks that include a pillar with the names of Ramesses II. Cleaning between these walls demonstrated that they are built on top of the mud brick of the Taharqa Gate wall. The cross walls incorporated a re-used Dynasty 25 block, confirming that the stone and brick walls are later than the wall on which they are built. It is possible that this construction is a repair to the Taharqa Gate wall that is contemporary with the remodeling of the west end of the Mut Temple's 1st Pylon (fig. 38), which consists of re-used blocks, some bearing the names of Ramesses II and Nectanebo II. Centuries of flooding by the sacred lake has eroded the space between this structure and the construction on top of the Taharqa Gate wall. It is possible, however, that they were built during the Ptolemaic Period to create direct access from Chapel D to the lake by cutting through the still-existing Tuthmoside enclosure wall. Fig. 39 is two panoramic views of the gap between the Mut Temple's First Pylon and the Taharqa Gate wall; one looks south to the sacred lake, the other north to Chapel D.

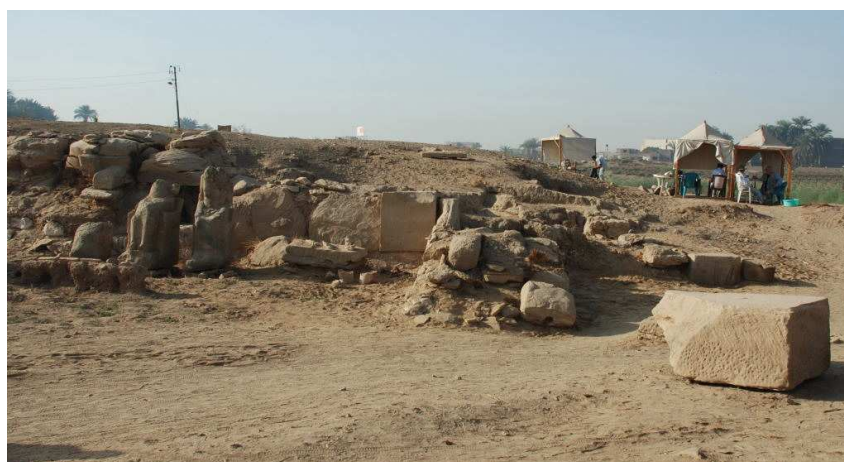
Fig. 38 The west end of the Mut Temple's 1st Pylon showing the possibly Ptolemaic construction.

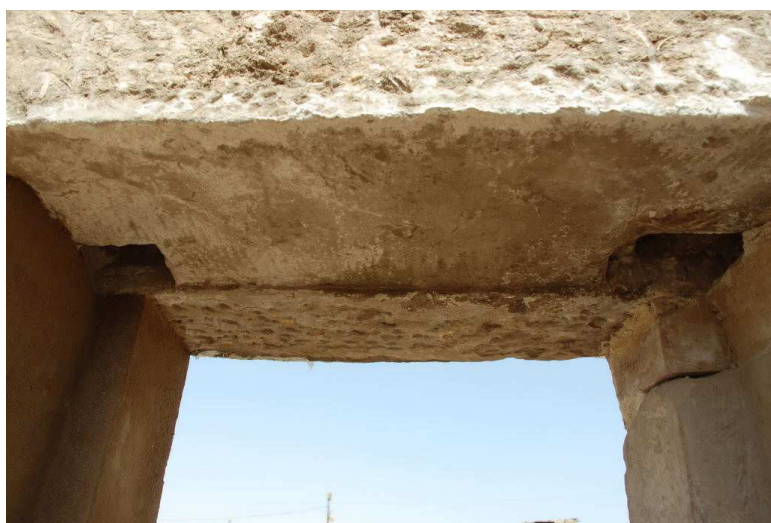
Fig. 41b The fittings for the chapel doors on the underside of the lintel.

The lintel block was removed from the rear of the sphinx and restored (fig. 41a) before being reinstalled. During the restoration the two sockets for the chapel's doors and the line against which they closed were found on the lintel's underside (fig. 41b). The gap in the rear of the sphinx base was cleaned and filled with new stone (fig. 42a-b).

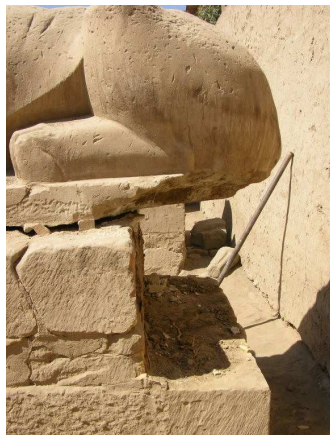
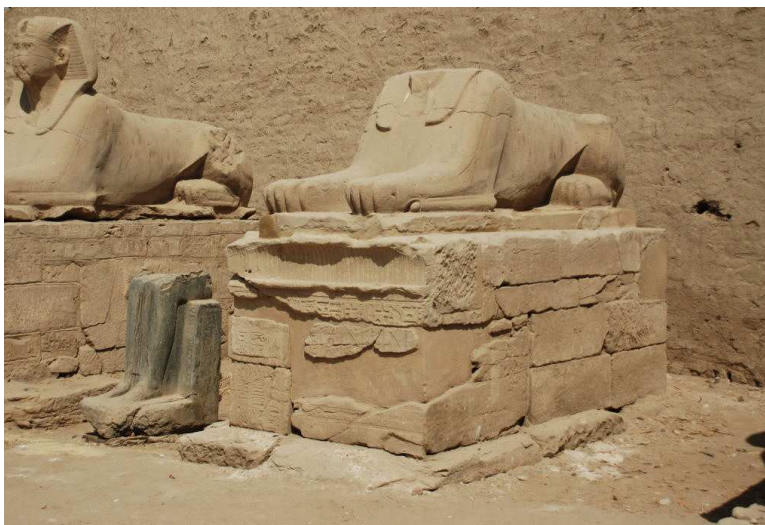
Fig. 42a-b The sphinx base with the lintel block removed (left) and with the missing area restored.

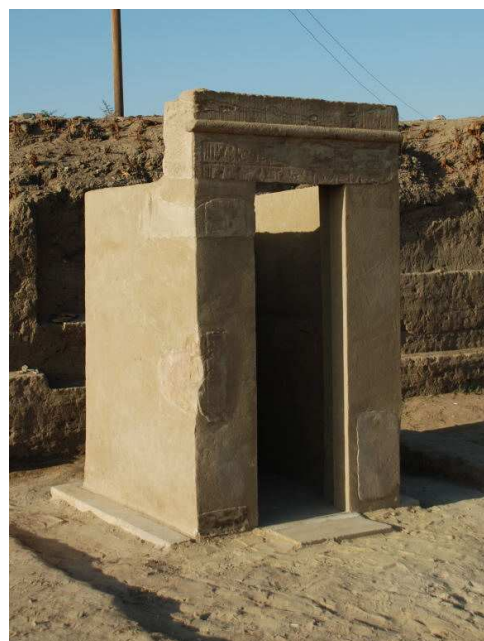
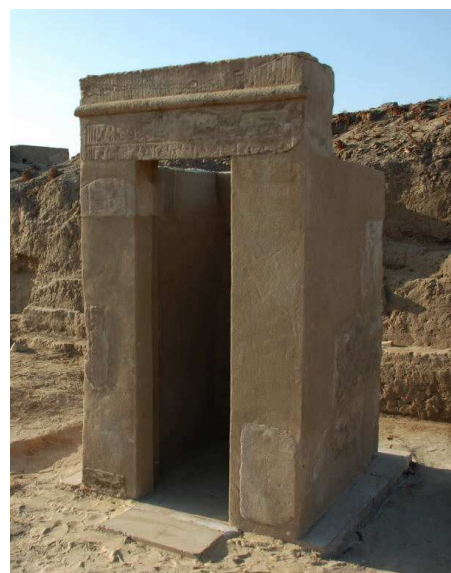
Fig. 43 Three views of Horwedja's healing magic chapel, rebuilt in front of the Mut Temple's First Pylon.

The chapel's new sandstone floor was separated by an impermeable barrier from the foundation of sand, gravel and reinforced concrete. The missing sections of the walls were replaced with blocks of newly-cut sandstone. Break edges were consolidated with Paraloid B-72 and the breaks joined with SikaDur 52. A finishing coat of the mix used by the SCA (Portland cement, sand and lime) tinted to match the color of the original blocks was applied to reconstructed but undecorated areas.
